# REPORT OF TEST PIT: TP606

PROJECT: Gold Coast Rapid Transit SURFACE RL: 1.70 m DATUM: AHD

LOCATION: Zone 5 PIT DEPTH: 1.90 m

JOB NO: 117632047 BUCKET TYPE: 600 mm Scraper

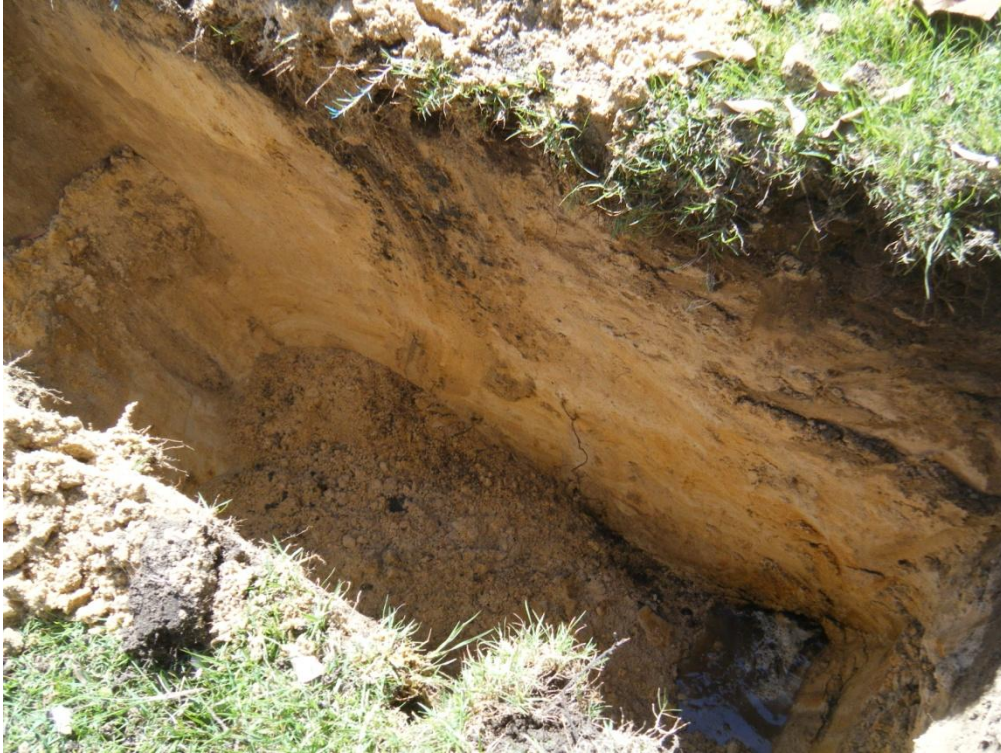
Photo 1 : Side Wall

| Excavation | | | Sampling | | Field Material Description | | | | | |
|---|---|---|---|---|---|---|---|---|---|---|
| | | | 0.20 | 1.50 | | | | SAND fine to medium grained, trace medium sub-rounded to sub-angular gravel, trace dark brown clay pockets noted to 0.5 m depth, brown and pale yellow brown with orange staining | D - M | L |
| L-M | | | 0.5 | 1.60 | | | CH | Sandy CLAY high plasticity, dark grey black, clay content increasing with depth, decomposing organic peaty material noted | M (>PL) | F |
| | | | 1.0 | 0.10 | | | | TEST PIT DISCONTINUED @ 1.90 m COLLAPSE GROUNDWATER ENCOUNTERED @ 1.60 m DEPTH | | |
