ENGINEERING BOREHOLE LOG

BOREHOLE No	<u>BH57</u>
SHEET	<u>1</u> of <u>2</u>
REFERENCE No	<u>H11096</u>

PROJECT Moreton Bay Rail Link LOCATION Cut 6, Ch.6500 COORDINATES 503116.0 E; 6986909.2 N
 PROJECT No FG5921 SURFACE R.L. 25.40m PLUNGE _____ DATE STARTED 20/7/11 GRID DATUM MGA94 Zone 56
 JOB No 250/120/3 HEIGHT DATUM AHD BEARING _____ DATE COMPLETED 20/7/11 DRILLER R&D Drilling Pty Ltd

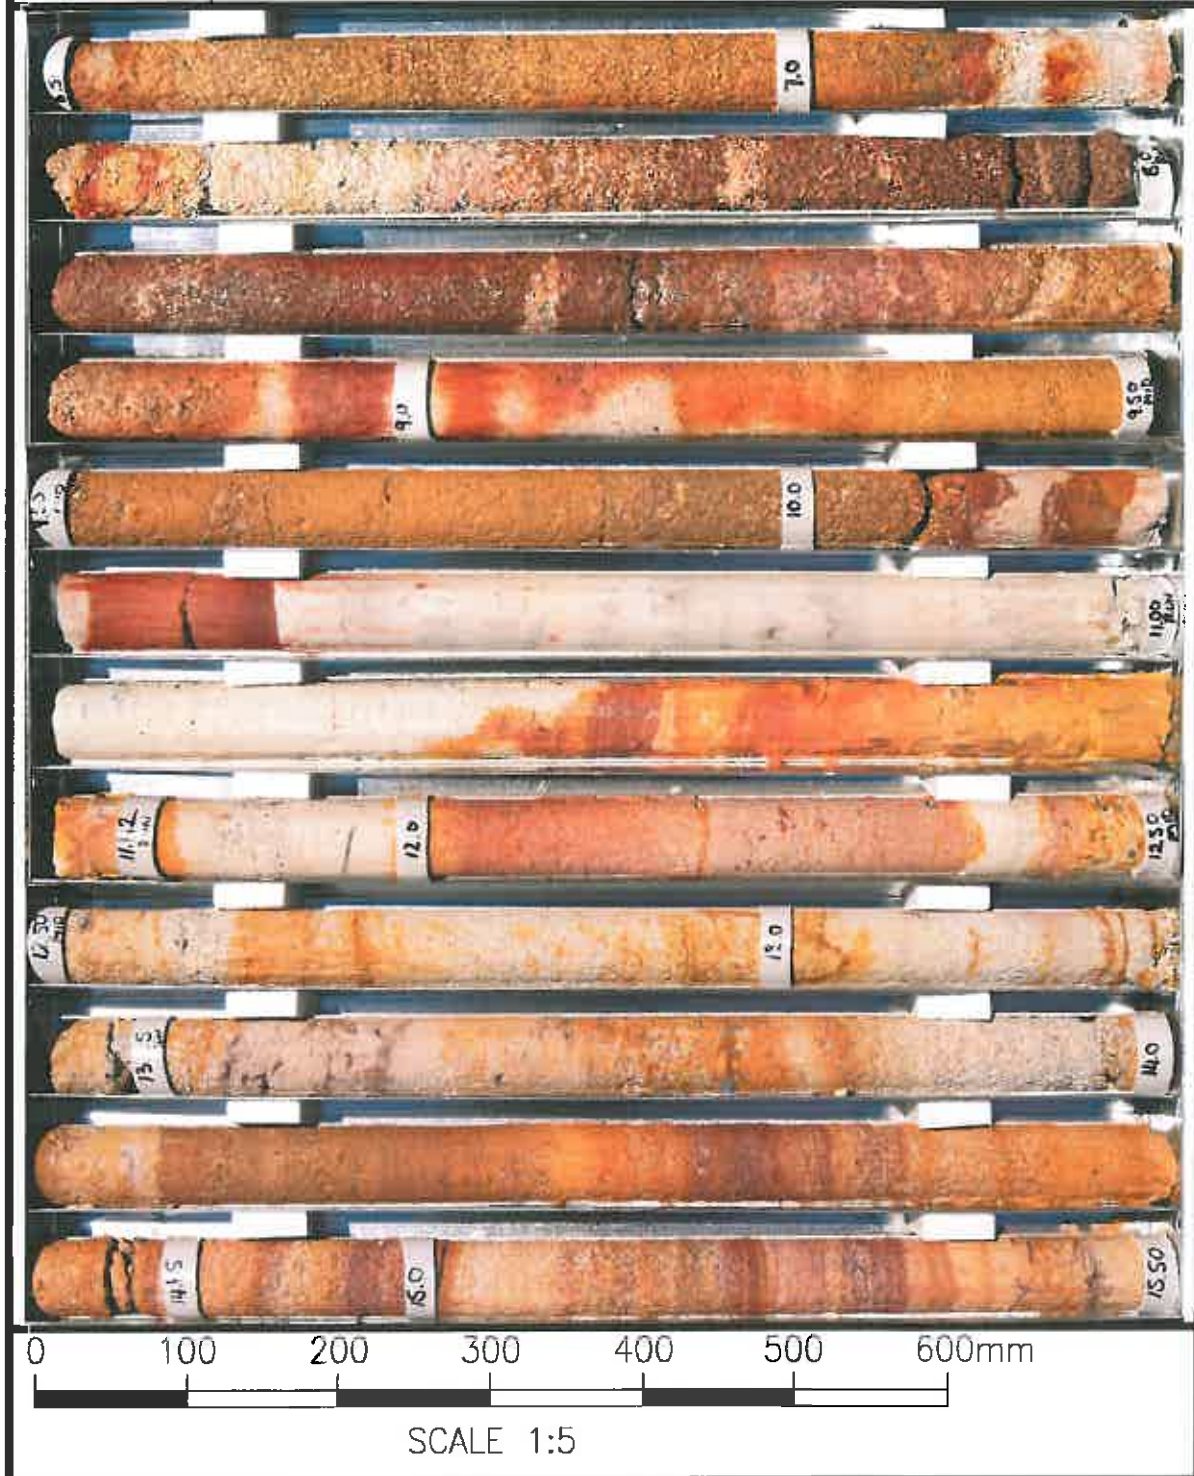
Project Name	Moreton Bay Rail Link (MBRL)		
Project No	FG5921	Date	20/07/11
Borehole No	BH 57	TMR H No	
Location	Cut	Start Depth (m)	6.50
Detail	Cut	Finish Depth (m)	17.80
Chainage	6535	Submitted By	BW
Remarks

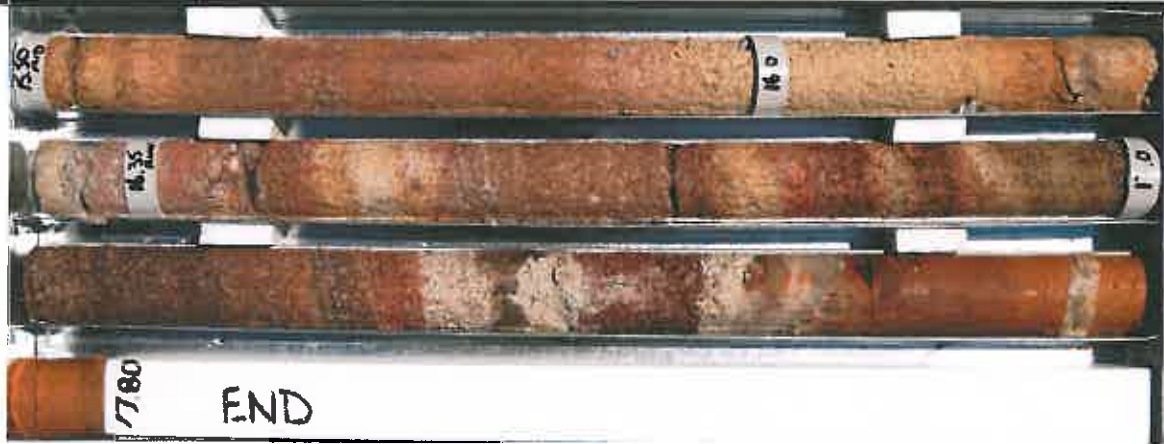
Project Name	Moreton Bay Rail Link (MBRL)		
Project No	FG5921	Date	20/07/11
Borehole No	BH 57	TMR H No	
Location	Cut	Start Depth (m)	6.50
Detail	Cut	Finish Depth (m)	17.80
Chainage	6535	Submitted By	BW
Remarks
