REPORT OF BOREHOLE: CRR 211

CLIENT: Aecom Australia Pty Ltd
 PROJECT: Cross River Rail
 LOCATION: Fairfield Rd / Brougham St
 JOB NO: 107632034

REPORT OF CORE PHOTOGRAPHS: CRR 211

GEOPHYSICAL RECORD OF BOREHOLE: CRR 211

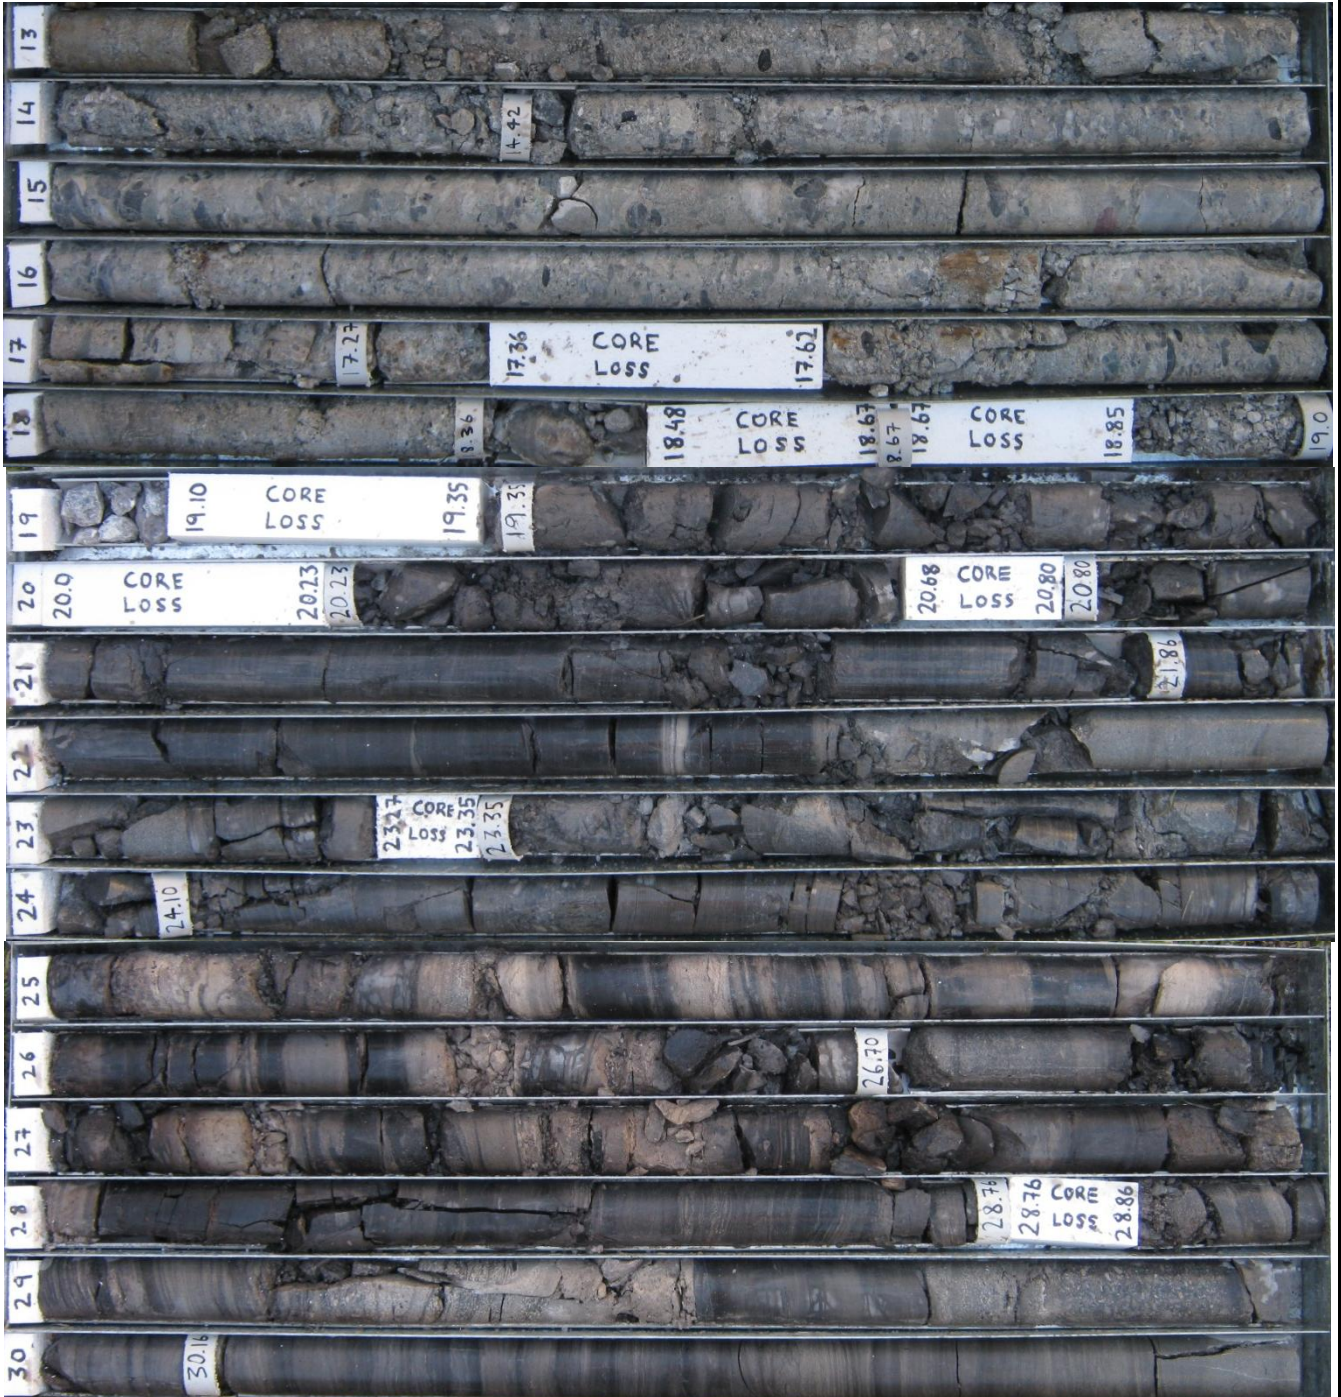
DEPTH RANGE: 13.0-31.0 m
DRILL RIG: FD500
DRILLER: Foundril Pty Ltd
LOGGED: CA DATE: 26/08/10
CHECKED: NK DATE: 4/10/10

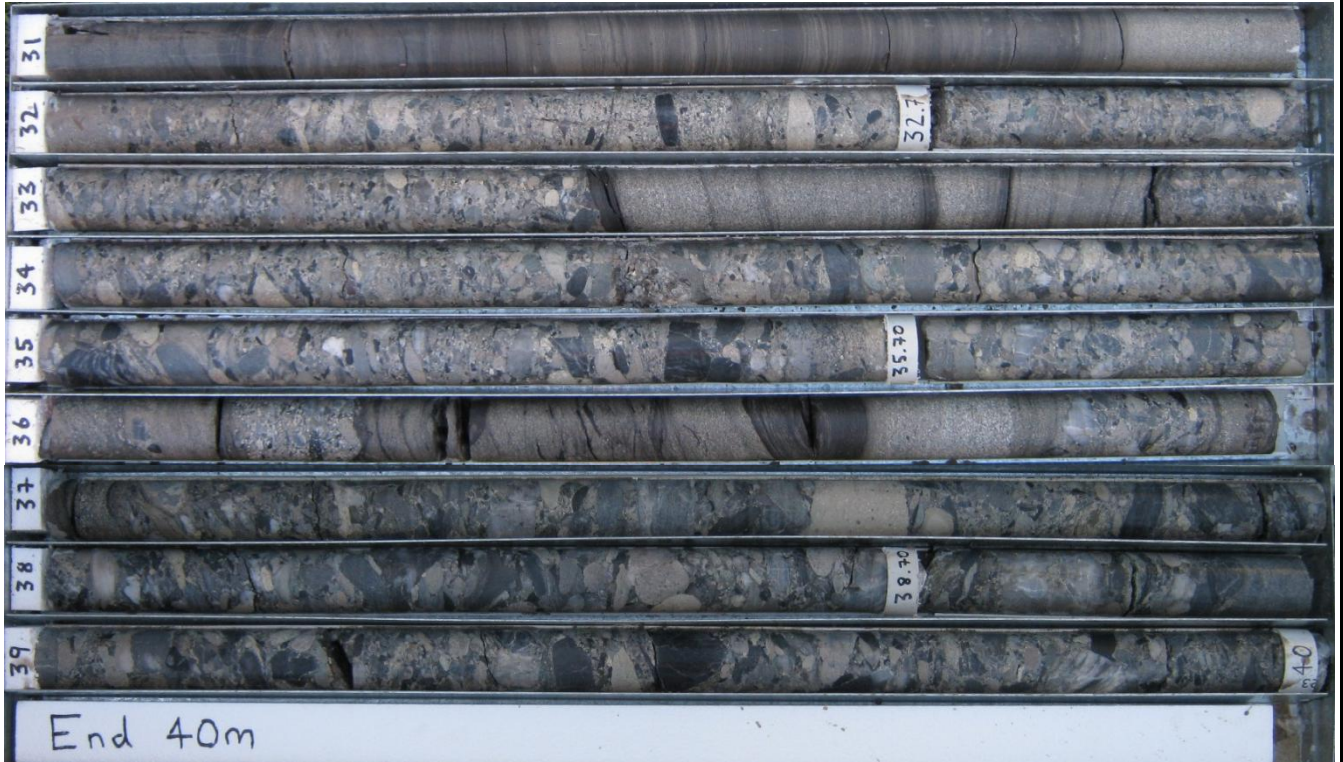
REPORT OF CORE PHOTOGRAPHS: CRR 211

DEPTH RANGE: 31.0-40.5 m
DRILL RIG: FD500
DRILLER: Foundril Pty Ltd
LOGGED: CA DATE: 26/08/10
CHECKED: NK DATE: 4/10/10

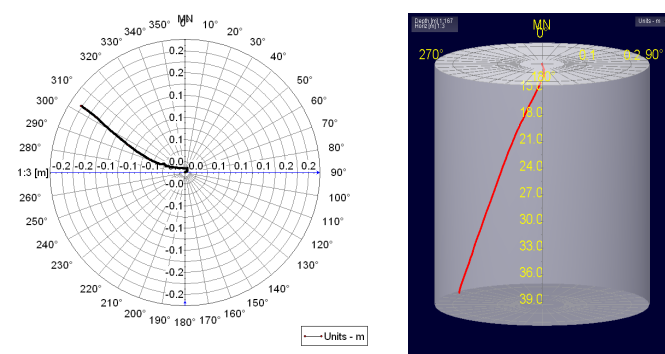
DEVIATION DATA

LOCATION- **Fairfield Rd** LOGGED BY- **CA**
 EASTING- **502410.00 m E** LOGGED DATE- **26/8/10**
 NORTHING- **6957251.00 m N** LOGGING DATUM-
 ELEVATION- LOGGED DEPTH- **39.22 m**
 DRILLED DEPTH- **40.00 m** DIAMETER- DRAWN BY- **RCD**
 PLUNGE- **-90°** AZIMUTH- **000** REVIEWED BY- **TR**
 CASING- DEPTH- FILE NAME- **CRR211-U.HED.WCL**

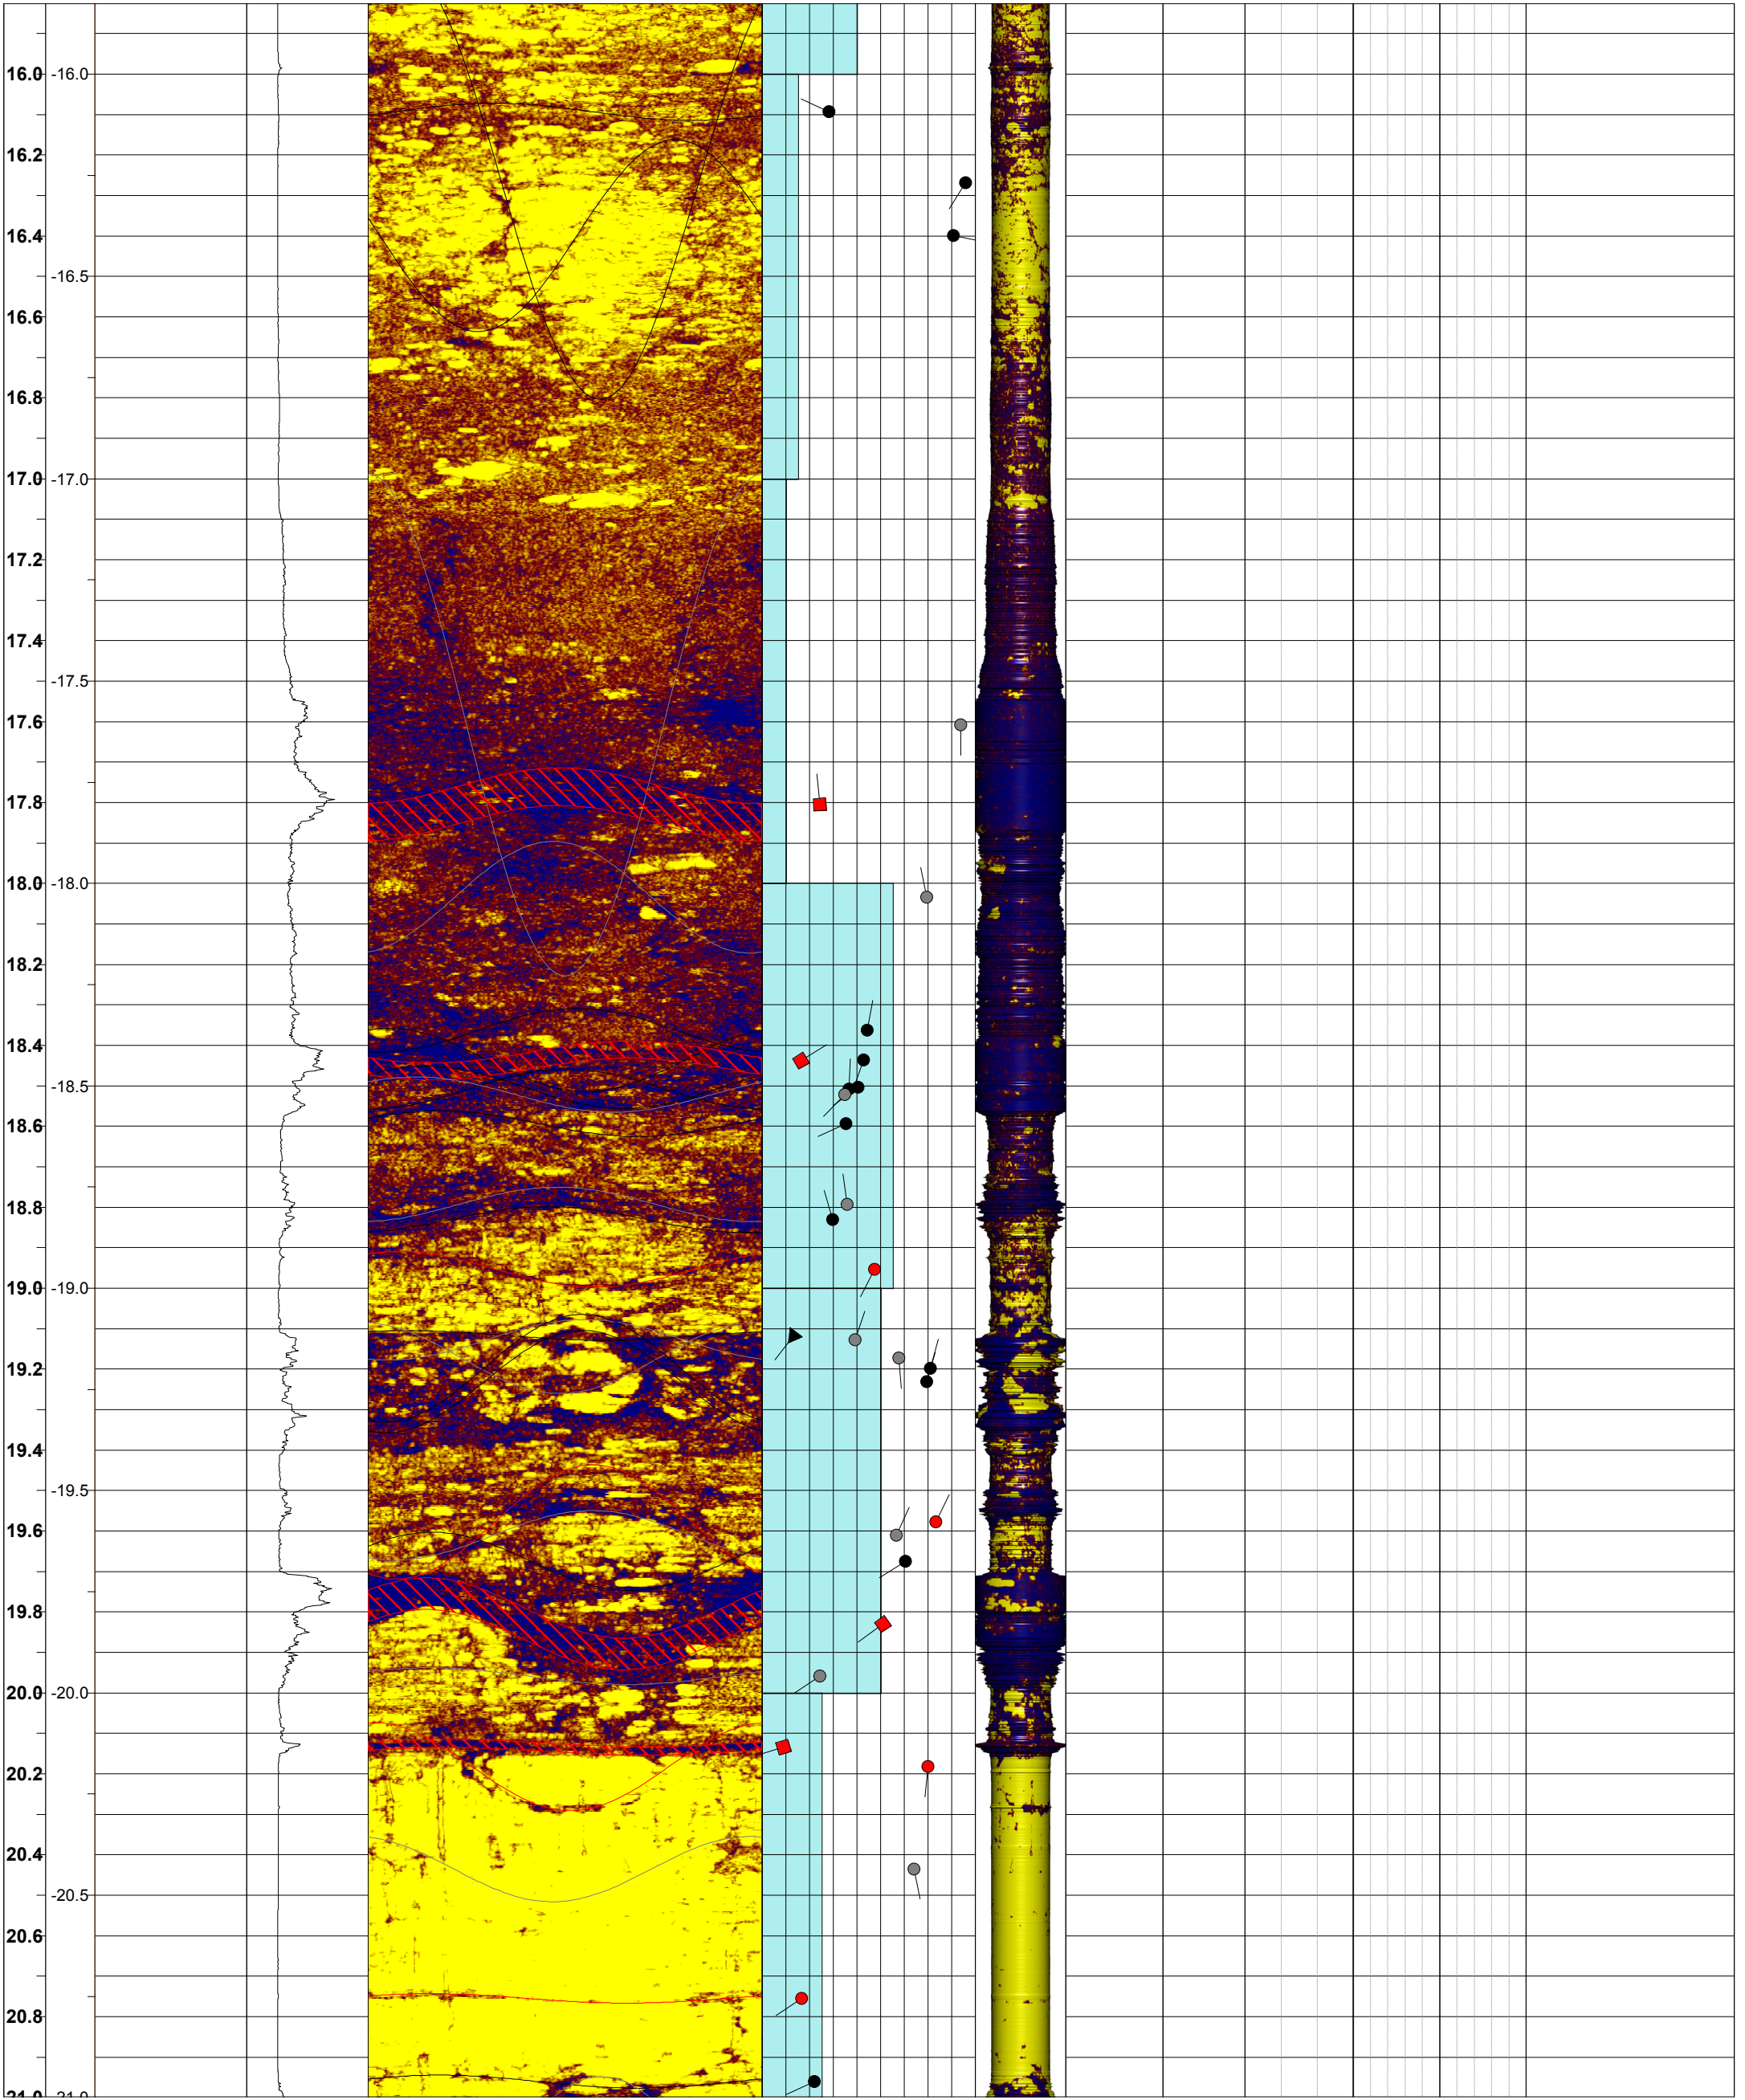
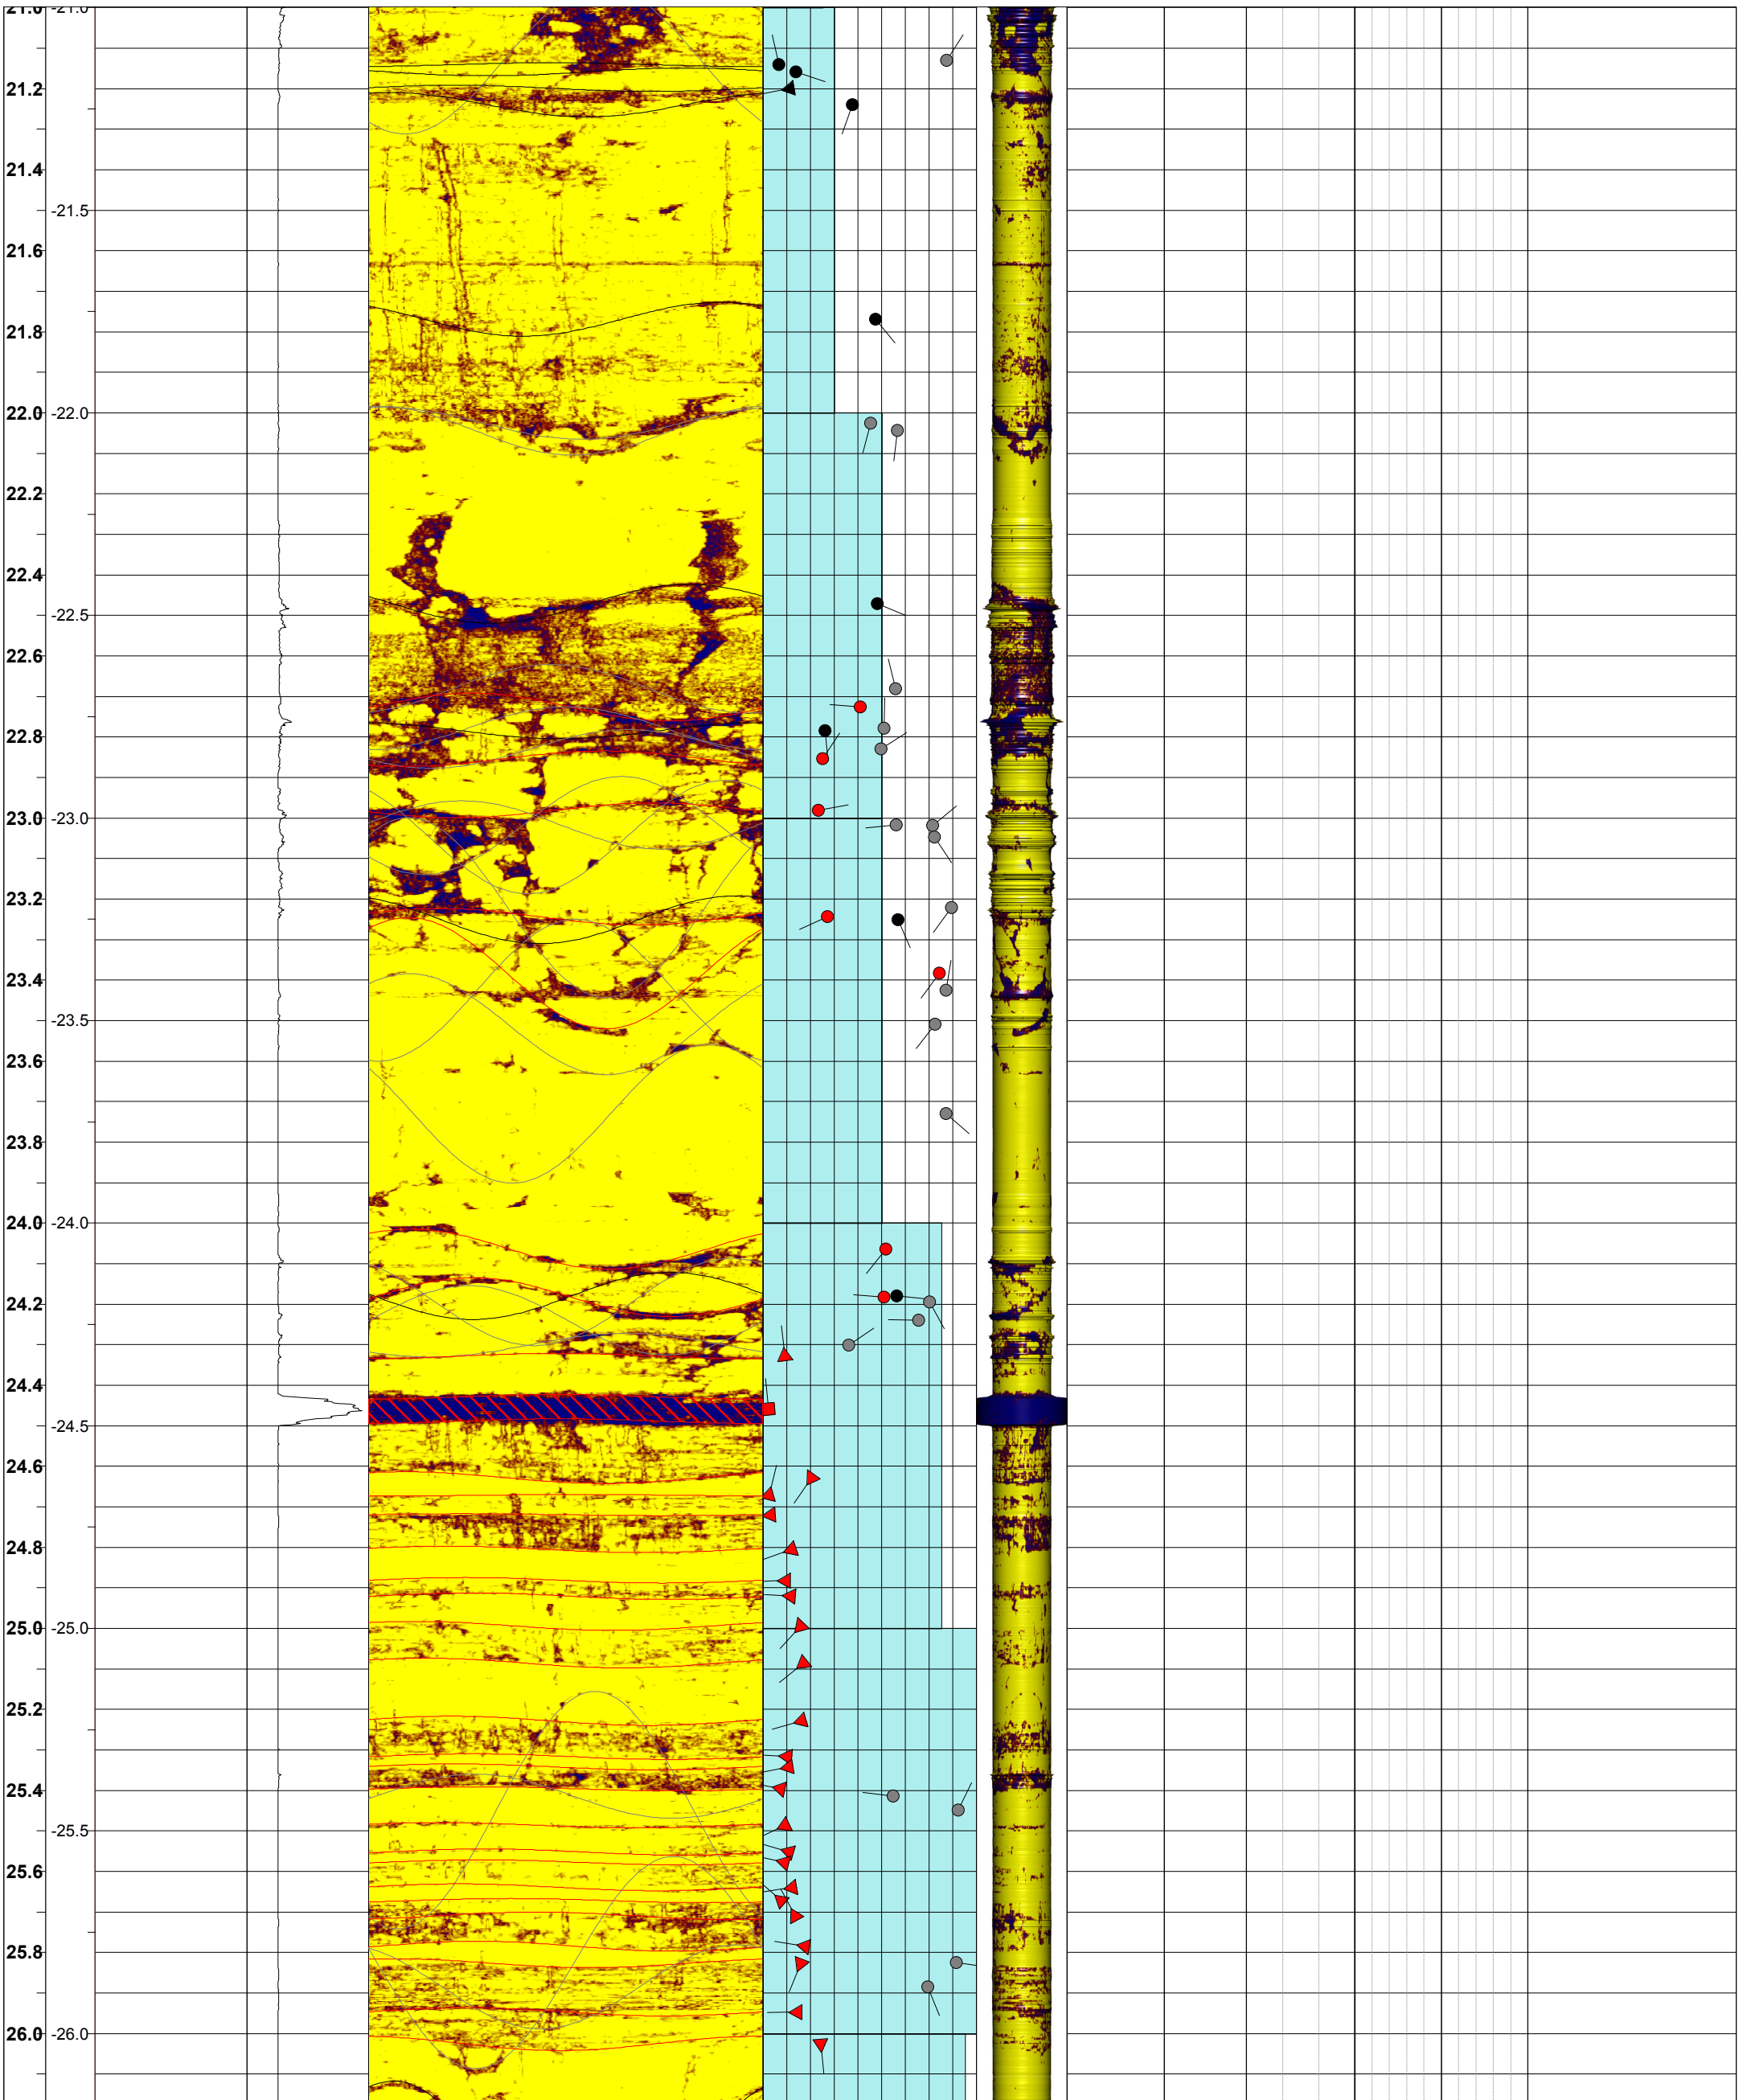
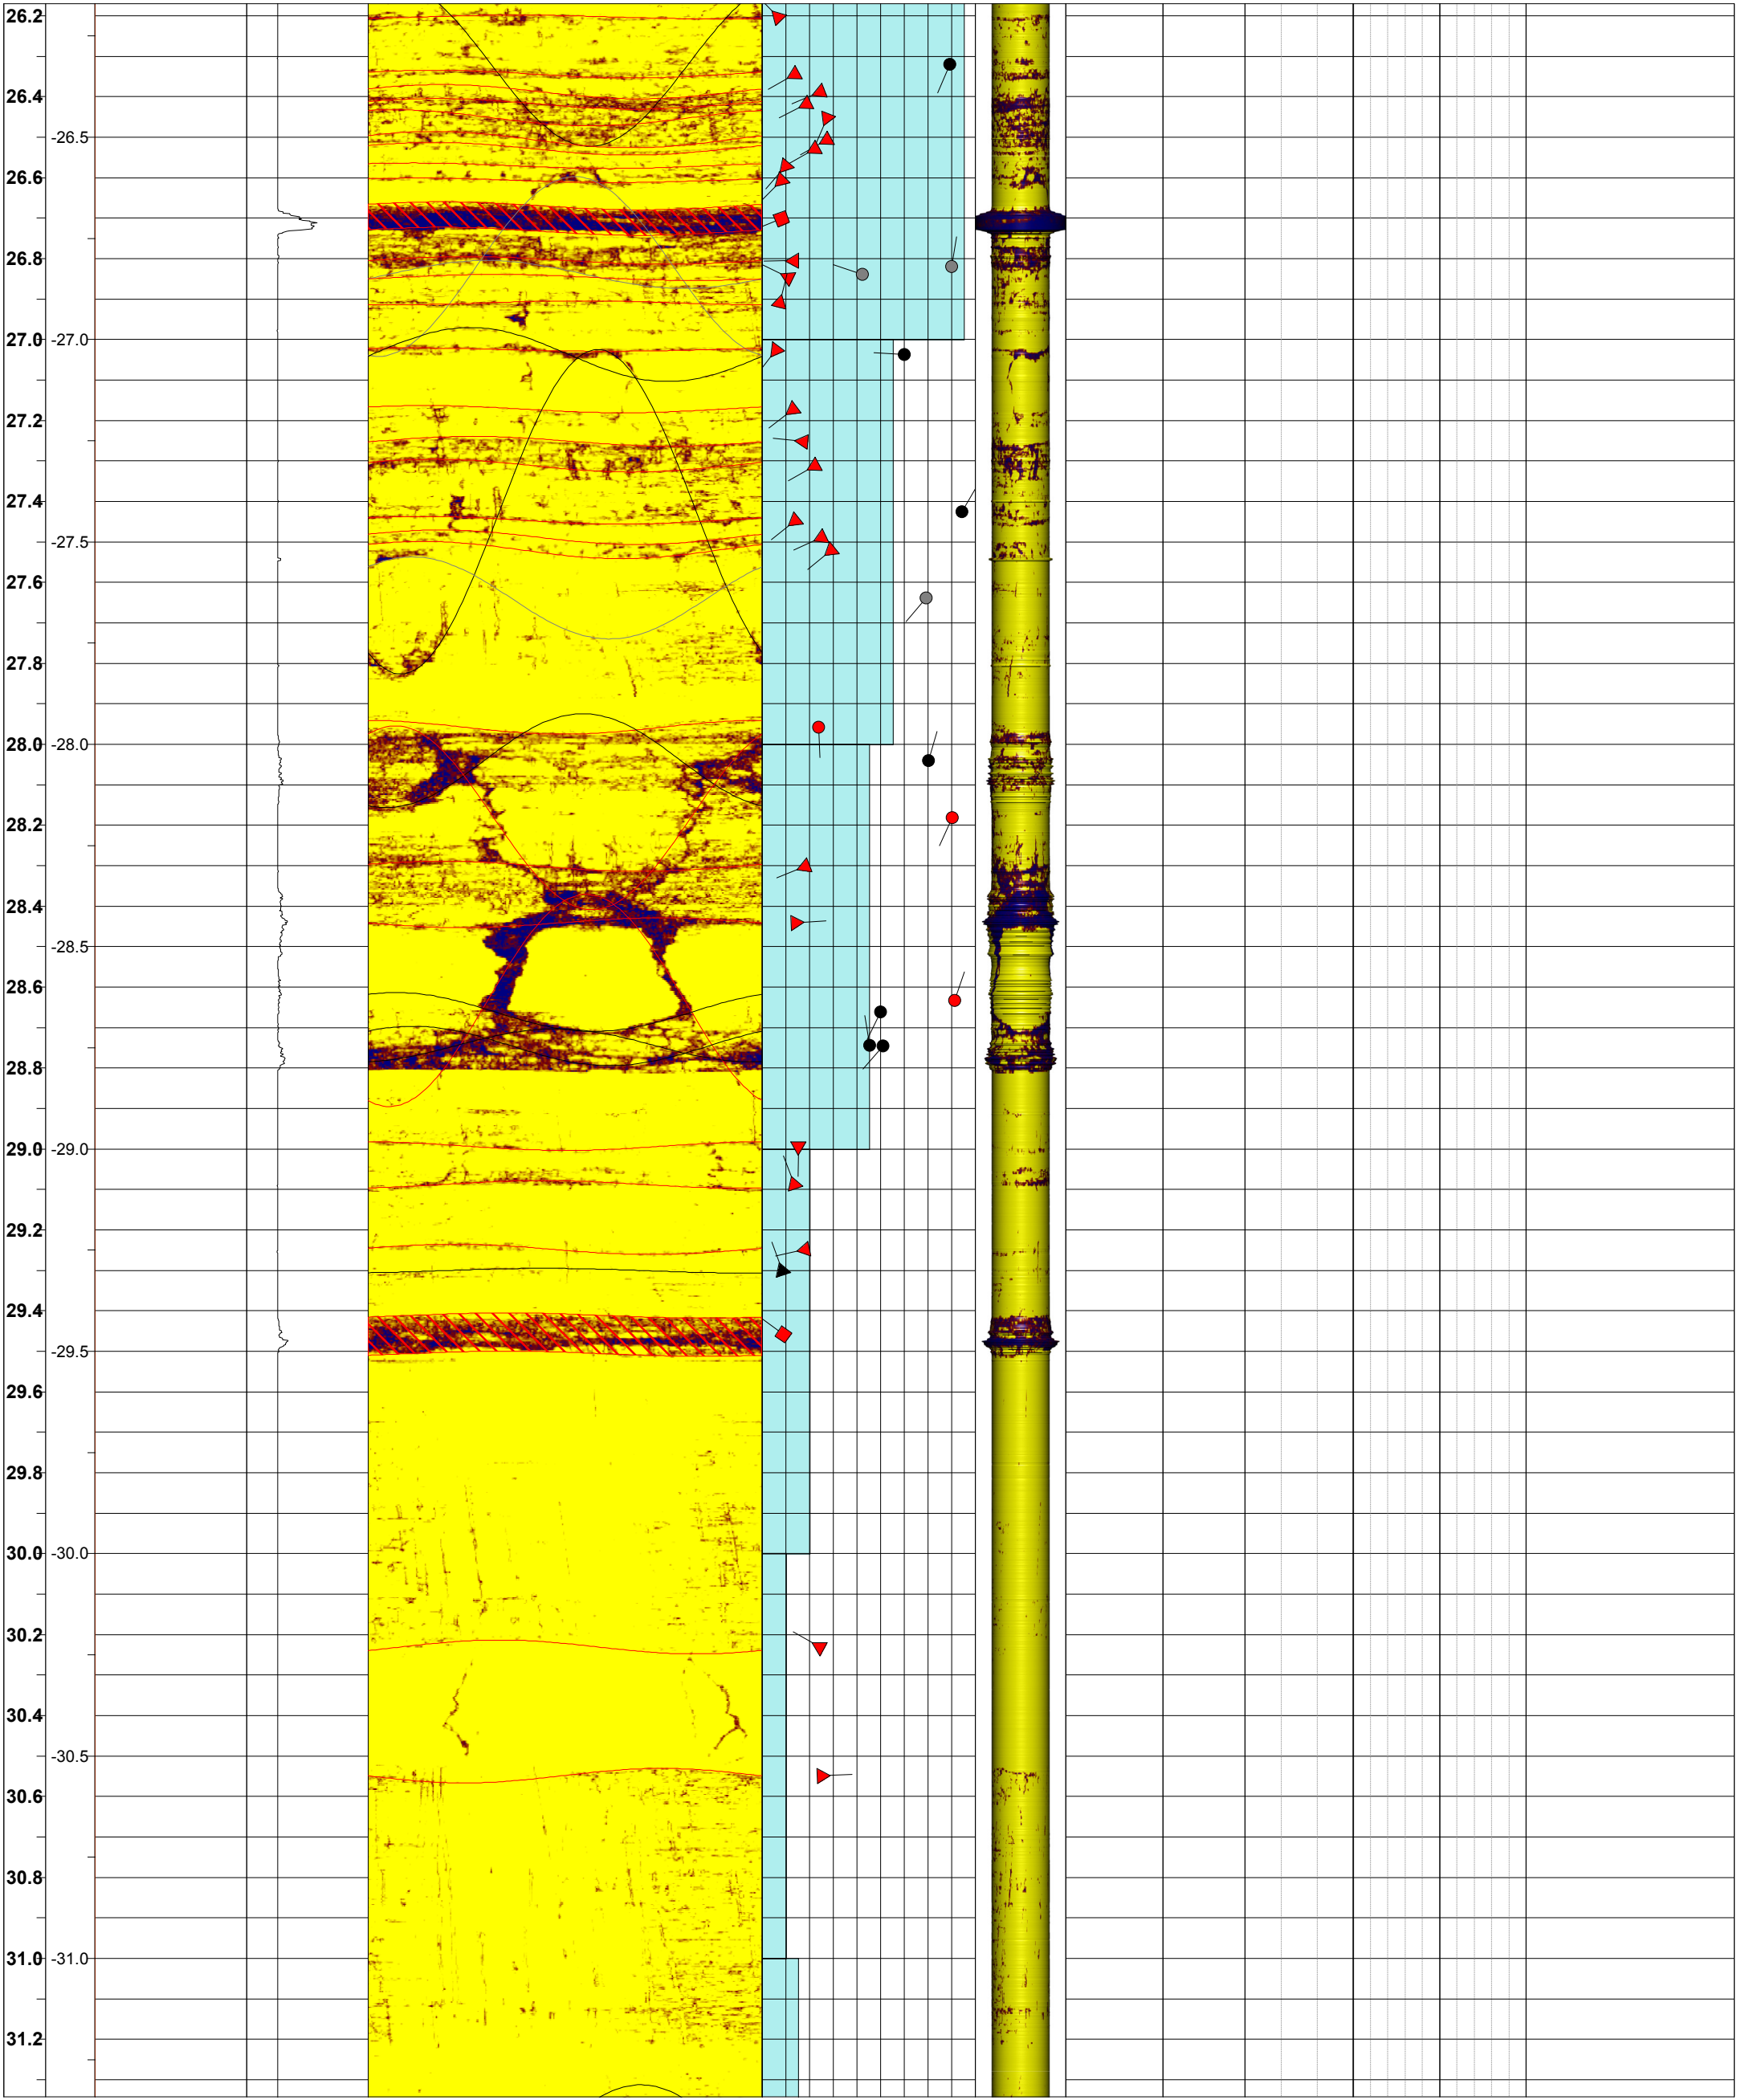
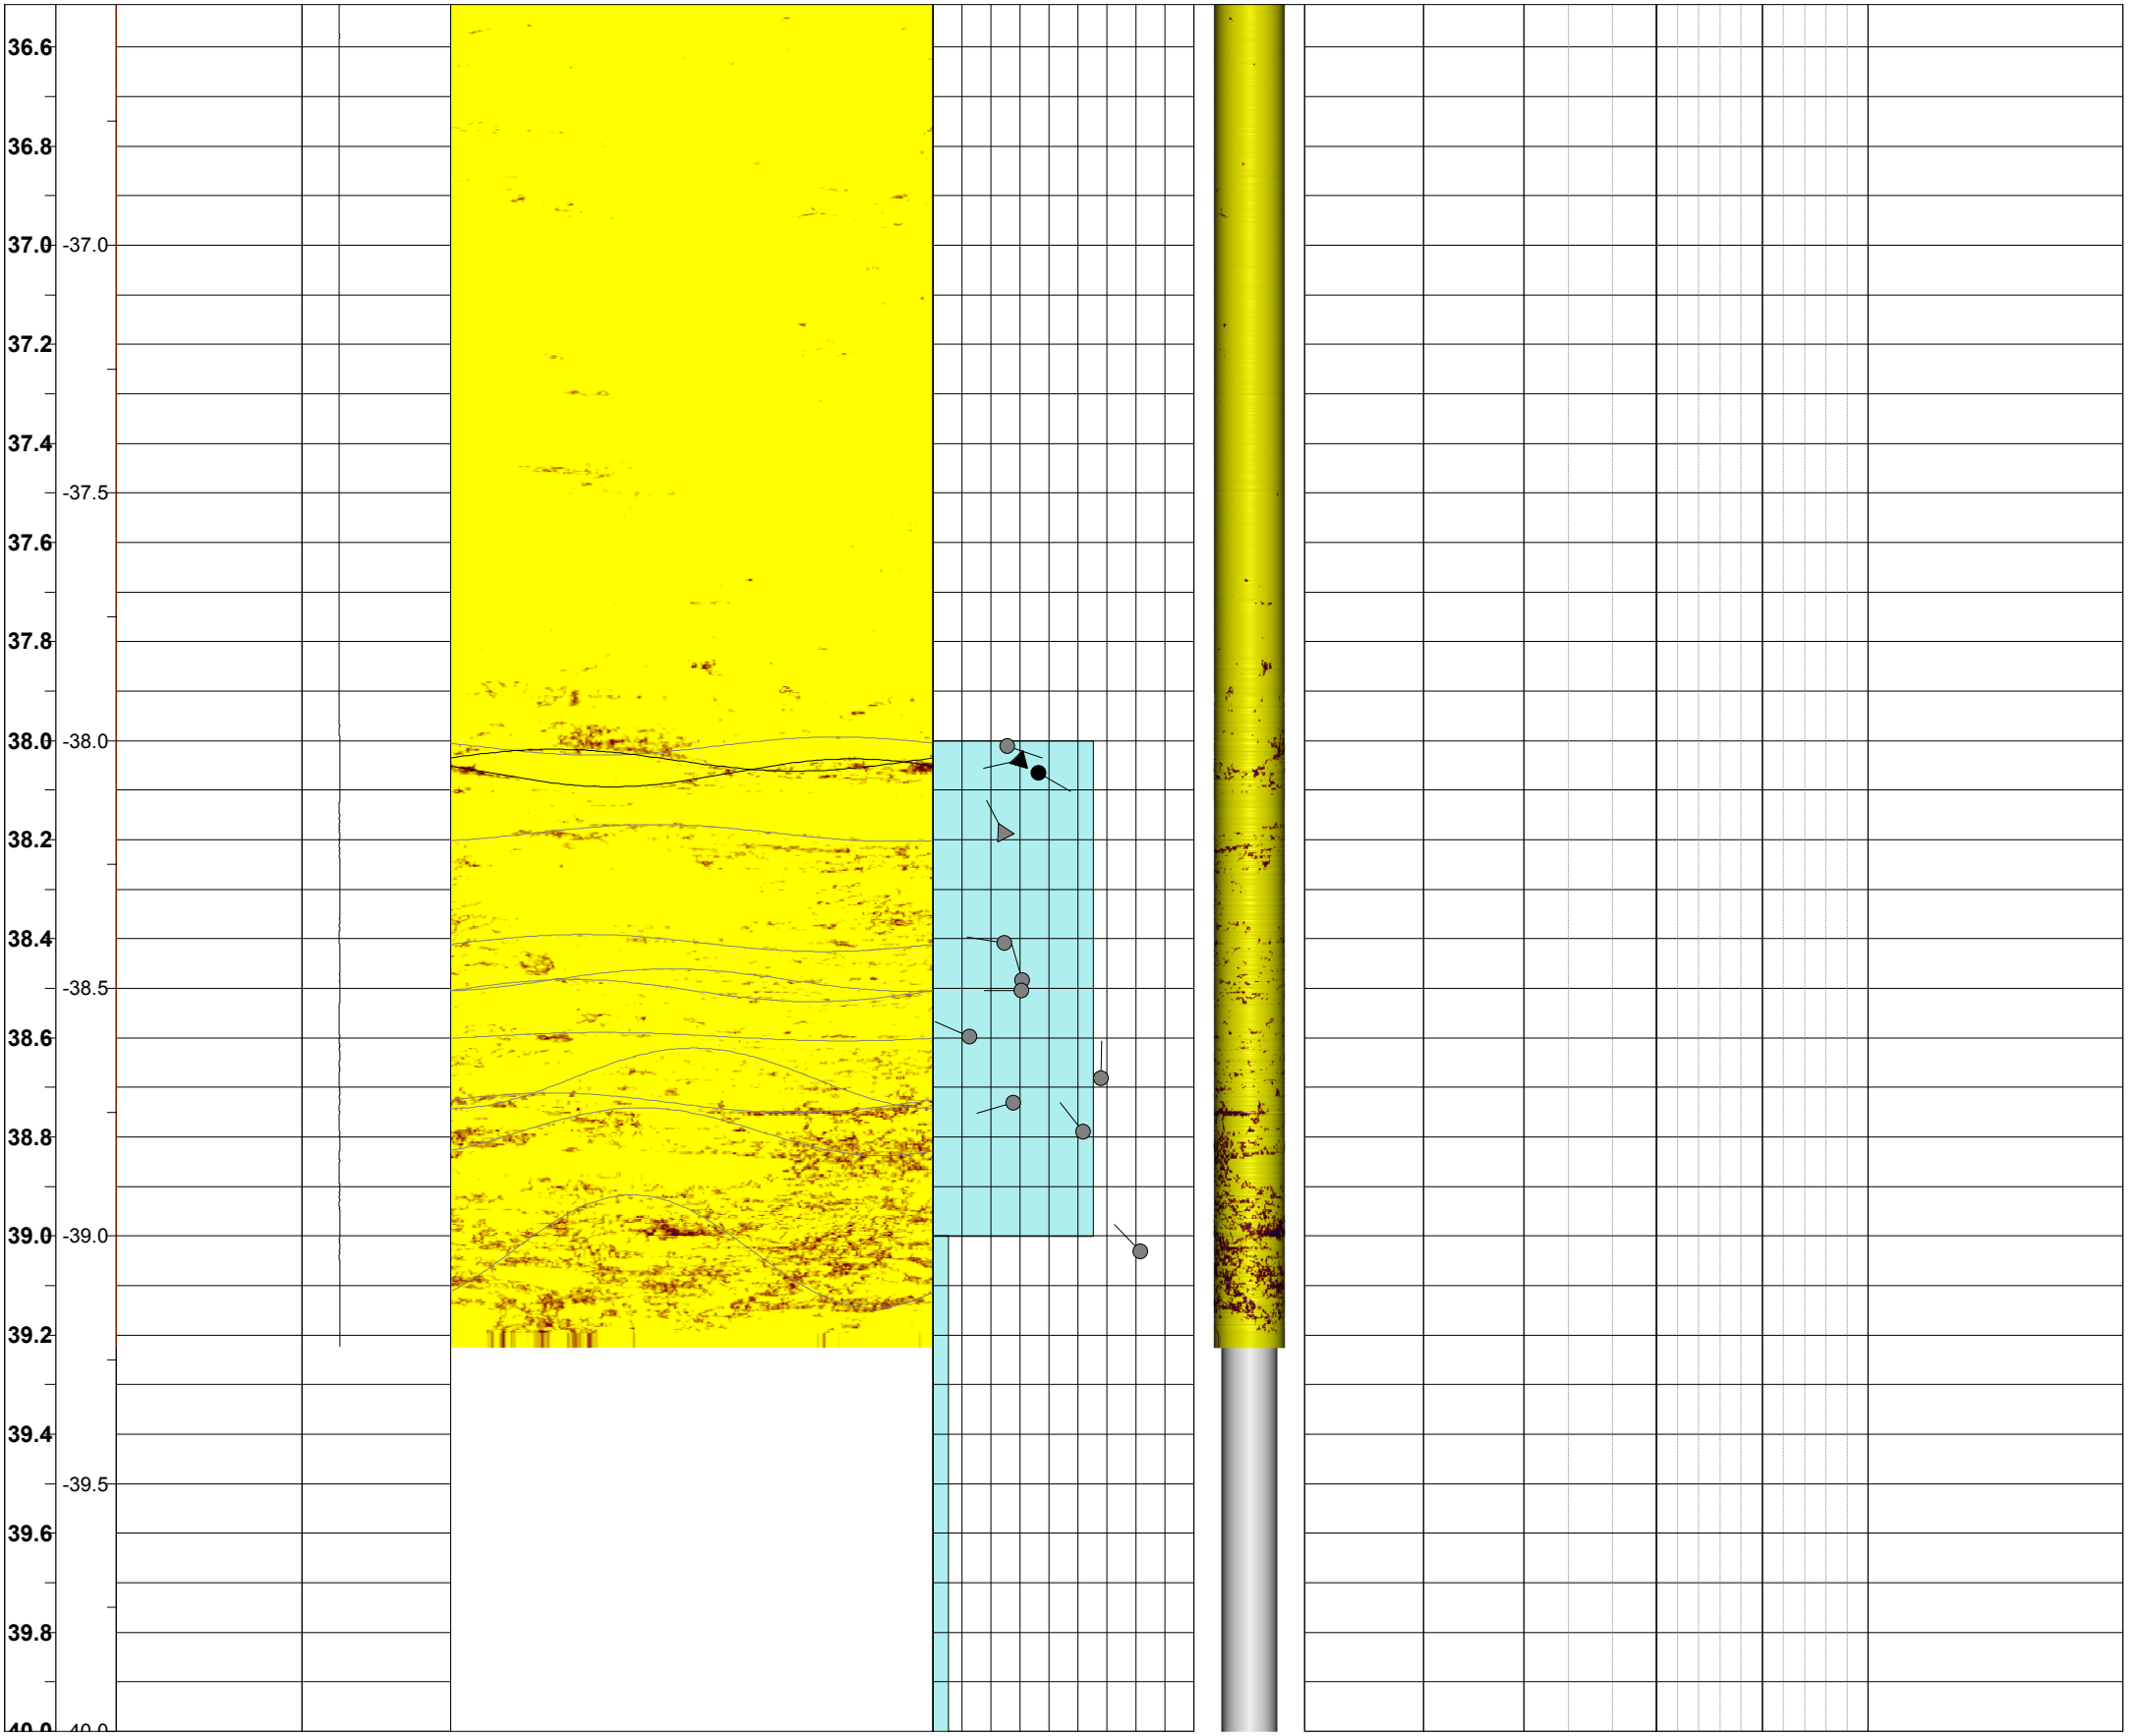
Interpreted Structures

Depth 1:15	RL	TELEVIEWER DATA					CORE DATA					
		NATURAL GAMMA 0 cps 300	ATV - Caliper 0 mm 300	Amplitude 0° 90° 180° 270° 0°	ATV FF 0 counts/m 18	3D log 219°	Core Photo	Lithology	Logged FF 0 30	RQD 0 100	TCR 0 100	Defect Description
		Interpreted Structures					Structure Orientations					
		0° 90° 180° 270° 0°					0 90					
(Refer to detailed core log, provided separately)												
12.4	-12.5											
12.6												
12.8												
13.0	-13.0											
13.2												
13.4												
13.6	-13.5											
13.8												
14.0	-14.0											
14.2												
14.4												
14.6	-14.5											
14.8												
15.0	-15.0											
15.2												
15.4												
15.6	-15.5											
15.8

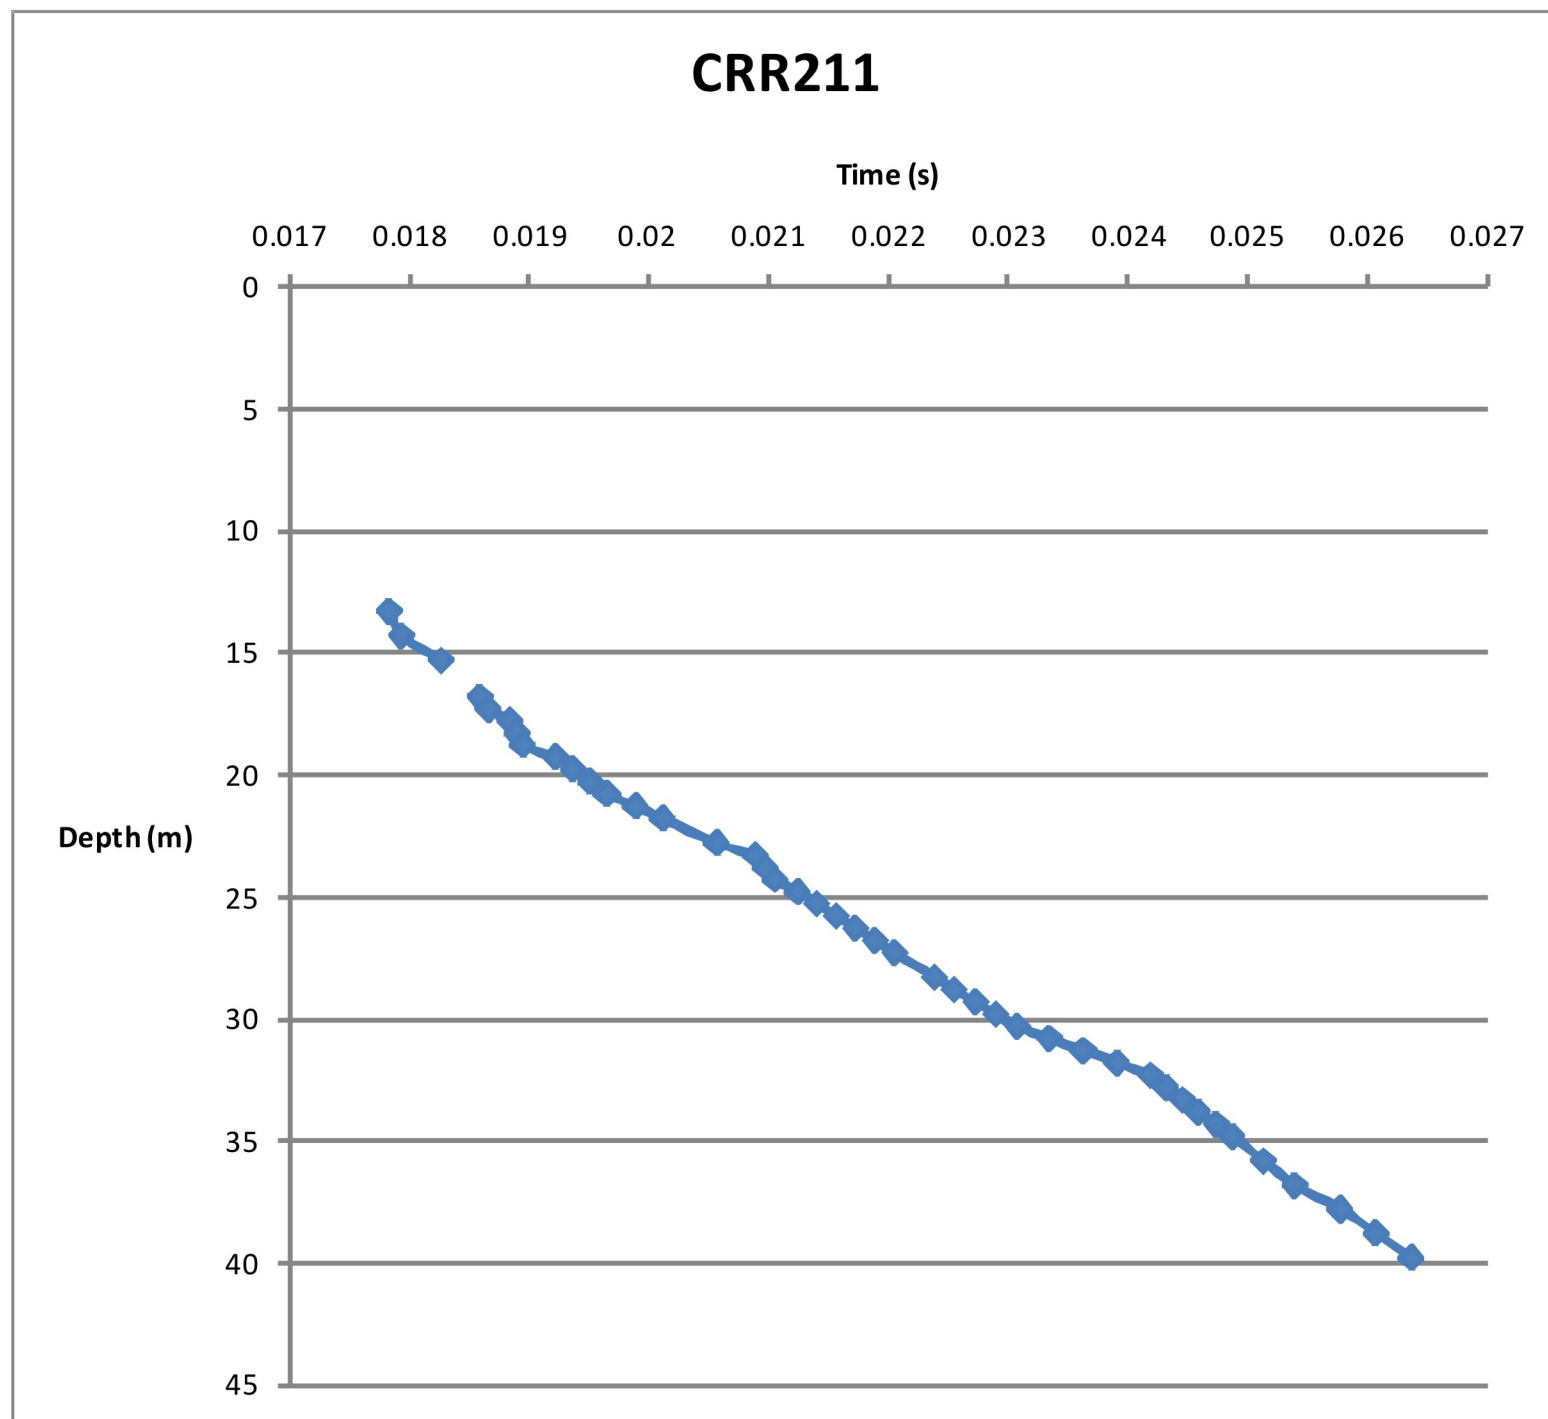
CLIENT Department of Transport and Main Roads		PROJECT Cross River Rail	
	DRAWN GDK	DATE OCT 4	TITLE CRR211 VSP	
	CHECKED TR	DATE		
	SCALE NTS	PROJECT No 000-107632034	FIGURE No	REV No A3

Geophone Depth (m)		Interval velocity (P wave m/s)
from	to	
13.3	14.3	9584
14.3	15.3	2994
15.3	16.3	*
16.3	16.8	*
16.8	17.3	6606
17.3	17.8	2764
17.8	18.3	9106
18.3	18.8	9757
18.8	19.3	1801
19.3	19.8	3540
19.8	20.3	3542
20.3	20.8	3544
20.8	21.3	2069
21.3	21.8	2228
21.8	22.8	2229
22.8	23.3	1528
23.3	23.8	6112
23.8	24.3	6115
24.3	24.8	2690
24.8	25.3	3111
25.3	25.8	3112
25.8	26.3	3110
26.3	26.8	3029
26.8	27.3	3029
27.3	28.3	3030
28.3	28.8	3036
28.8	29.3	2852
29.3	29.8	2852
29.8	30.3	2853
30.3	30.8	1875
30.8	31.3	1762
31.3	31.8	1762
31.8	32.3	1789
32.3	32.8	3777
32.8	33.3	3777
33.3	33.8	3777
33.8	34.3	3339
34.3	34.8	3780
34.8	35.8	3780
35.8	36.8	3863
36.8	37.8	2632
37.8	38.8	3398
38.8	39.8	3305

* - 1st arrival not clear due to noise

Calculations done without accounting for borehole deviation
