Commenced: 22/09/2015
 Completed: 22/09/2015
 Logged By: DJ
 Checked By: PM

Client: Seymour Whyte Constructions Pty Ltd
 Project: M1 Exit 54 Coomera Interchange Upgrade
 Project No.: 1831
 Location: W202 pile P11

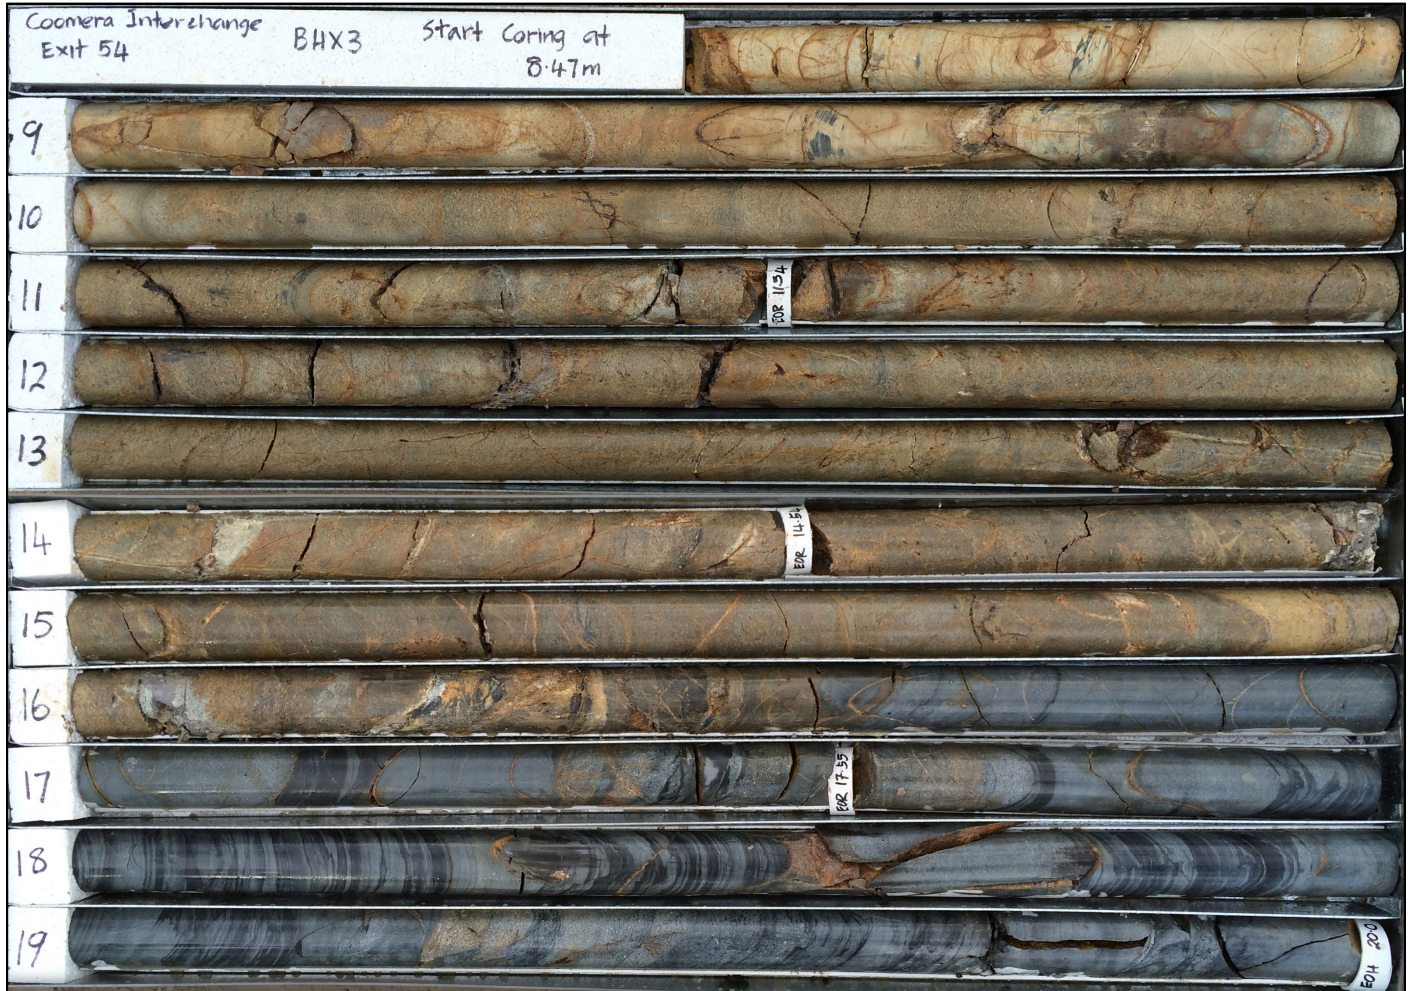
Start Depth (m): 8.47
End Depth (m): 20.00

Start RL (AHD): 9.37
End RL (AHD): -2.16
