Commenced: 23/09/2015
 Completed: 24/09/2015
 Logged By: DJ
 Checked By: PM

Client: Seymour Whyte Constructions Pty Ltd
 Project: M1 Exit 54 Coomera Interchange Upgrade
 Project No.: 1831
 Location: Abutment A pile A2

Start Depth (m): 5.60
End Depth (m): 17.00

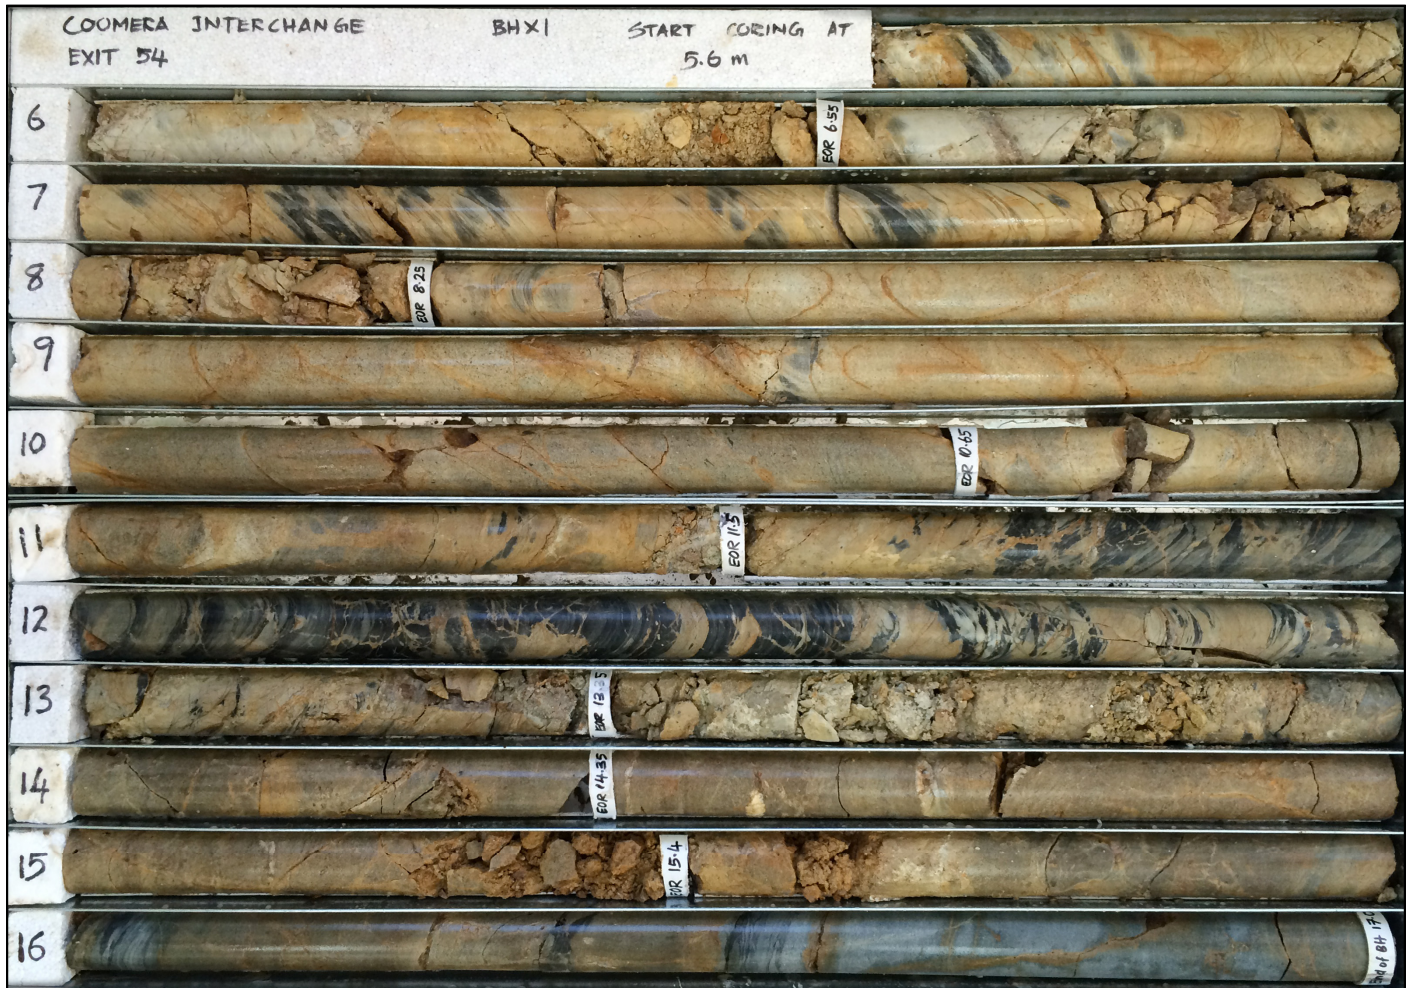
Start RL (AHD): 9.41
End RL (AHD): -1.99
