ENGINEERING BOREHOLE LOG

BOREHOLE No	<u>BH155</u>
SHEET	<u>3</u> of <u>3</u>
REFERENCE No	<u>12096</u>

PROJECT Mackay Ring Road Geotechnical Investigation - Stage 1
 LOCATION Sugarshed Road Overpass Abutment A; CH: 10008m; COORDINATES 721585.7 E; 7662318.7 N
 PROJECT No FG6184 SURFACE R.L. 10.85m PLUNGE _____ DATE STARTED 31/10/14 GRID DATUM GDA 94 /MGA Zone 55
 JOB No _____ HEIGHT DATUM AHD BEARING _____ DATE COMPLETED 31/10/14 DRILLER Saxon Drilling

CORE PHOTO LOG

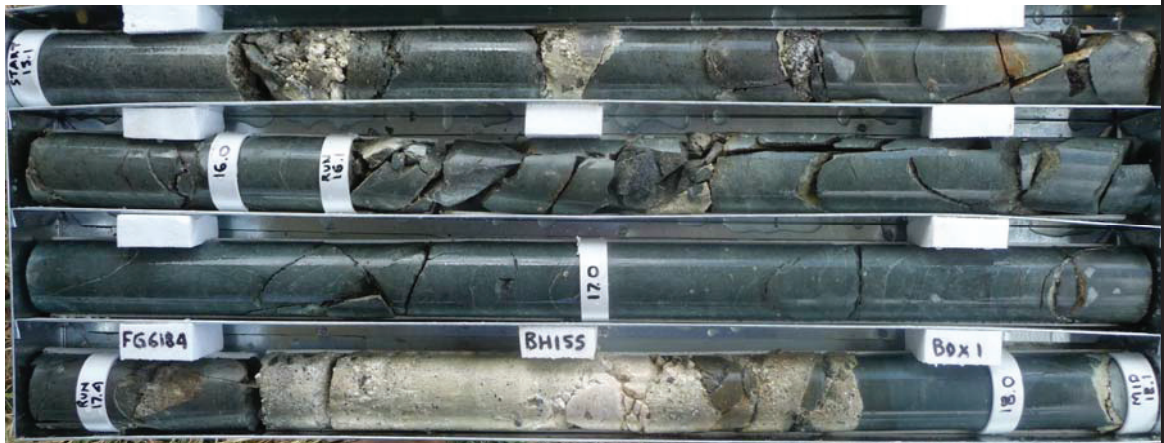
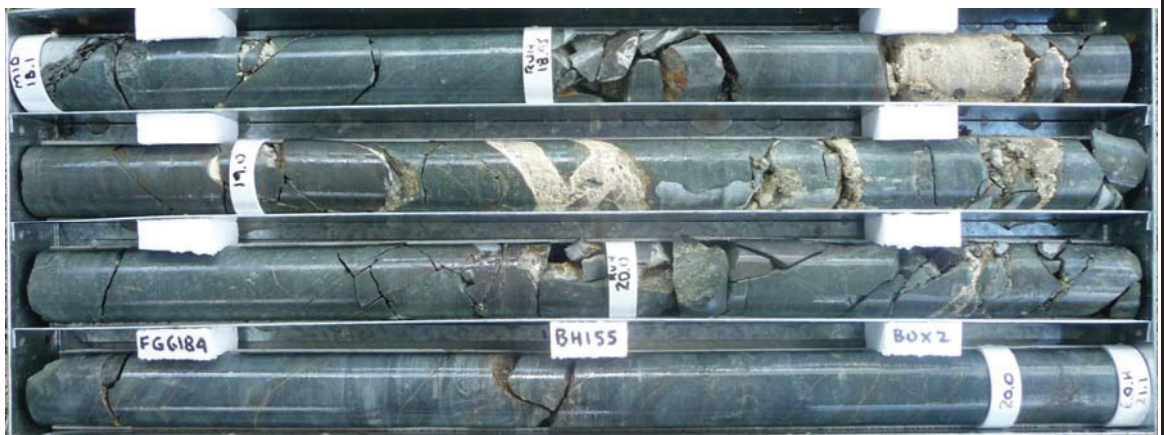
Project Name	Mackay – Ring Road		
Project No	FG6184	Date	31/10/14
Borehole No	BH155	TMR H No	12096
Location	Sugarshed Road Overpass	Start Depth (m)	15.1
Detail	Abutment A	Finish Depth (m)	21.1
Chainage	10008m	Submitted By	J. Lopez
Remarks
