Client: **Test No: S - 07 (E) McConnell Consulting**

Project: Stockland - Bermuda Street

Location: **ROBINA**

Tested By: SW & GB Test Date: 02/09/2003 IGS No: 1364 Job No: 0309-01 Tested in accordance with AS 1289.6.5.1-1999. Page No: 1 of 1

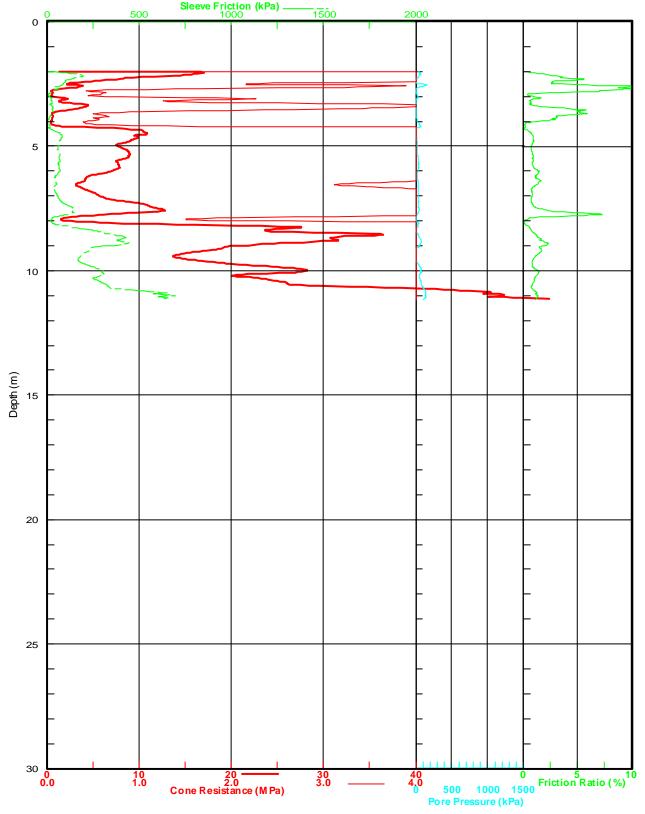
R.L.: -DGPS Position: 56J 0541486, 6894084 W.L.: -

Predrilling Depth: 2.00m S.P.: -
