REPORT ON CONE PENETROMETER TEST

Client **Main Roads**
 Project **Brisbane Port Road Stage 3**
 Job Ref.
 Location **Easting 46718.000 Northing 34417.100**
 Chainage
 Sounding **CPTU115**
 Test Date **29/11/1999**
 Remarks

REPORT ON CPT_u DISSIPATION TEST

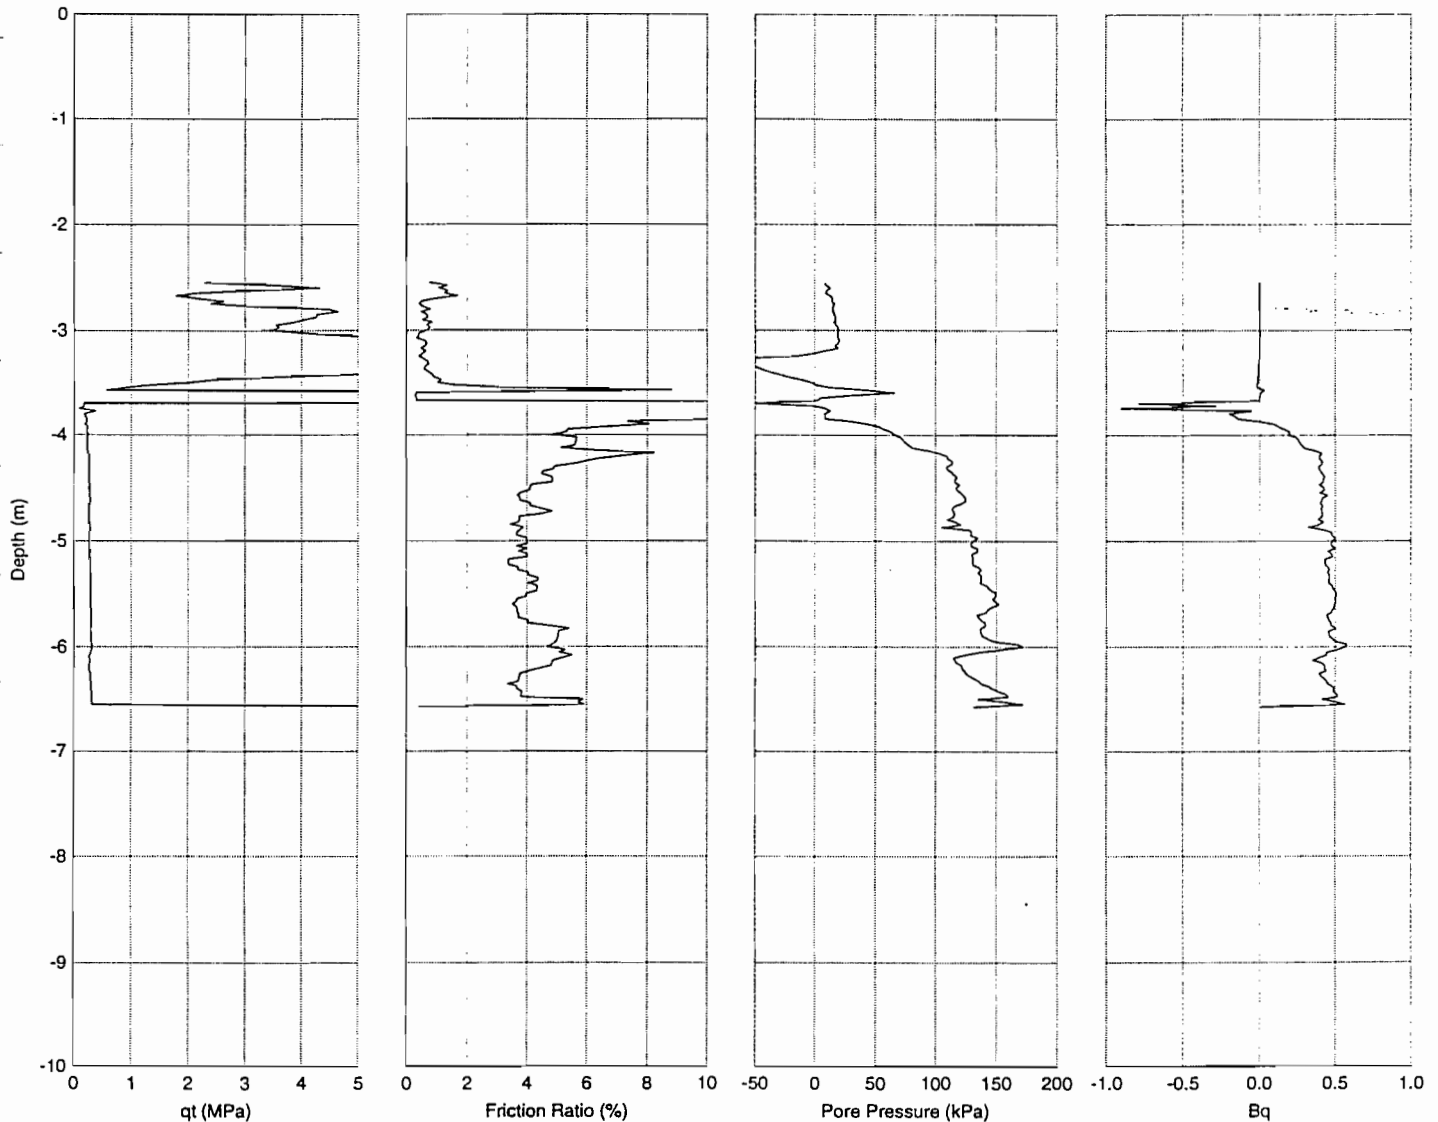
Project No. **C60323**
 Surface RL **2.176**
 Water Table **0.700**
 Start Depth **2.500**
 Refusal **6.575**

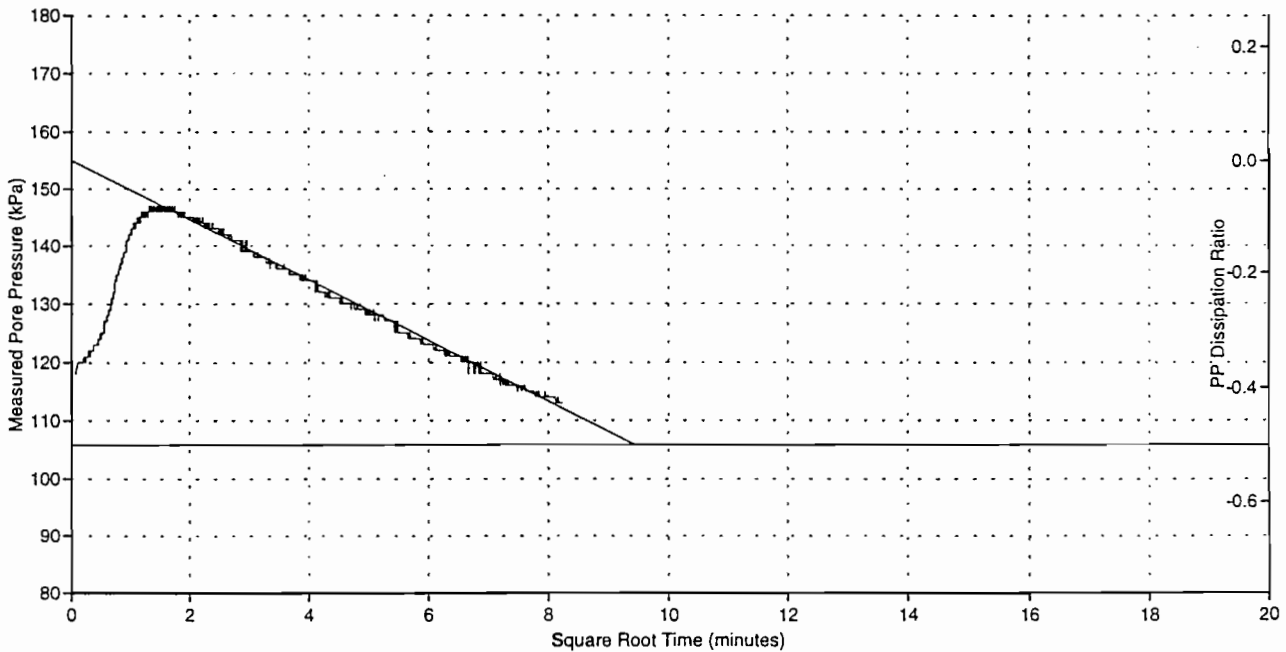
Depth (m) **6.47**
 Start Pressure (kPa) **155**
 Dissipation (%) **50**
 Dissipation Pressure (kPa) **106**
 Time for Dissipation (min) **89.0**

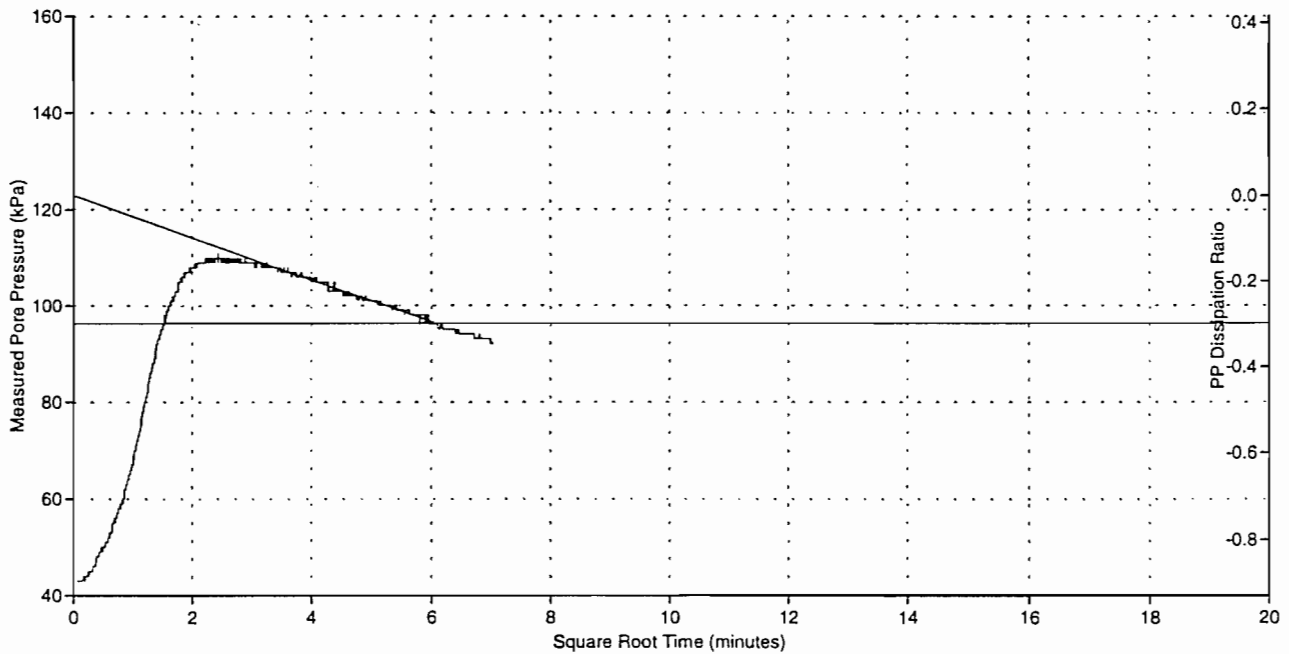
REPORT ON CPT_u DISSIPATION TEST

Depth (m) **4.14**
 Start Pressure (kPa) **123**
 Dissipation (%) **30**
 Dissipation Pressure (kPa) **96**
 Time for Dissipation (min) **37.0**
