# Engineering Borehole Log

**BHX2**

**Client:** Seymour Whyte Constructions Pty Ltd  
**Project:** M1 Exit 54 Coomera Interchange Upgrade  
**Project No.:** 1831  
**Location:** W202 pile P16

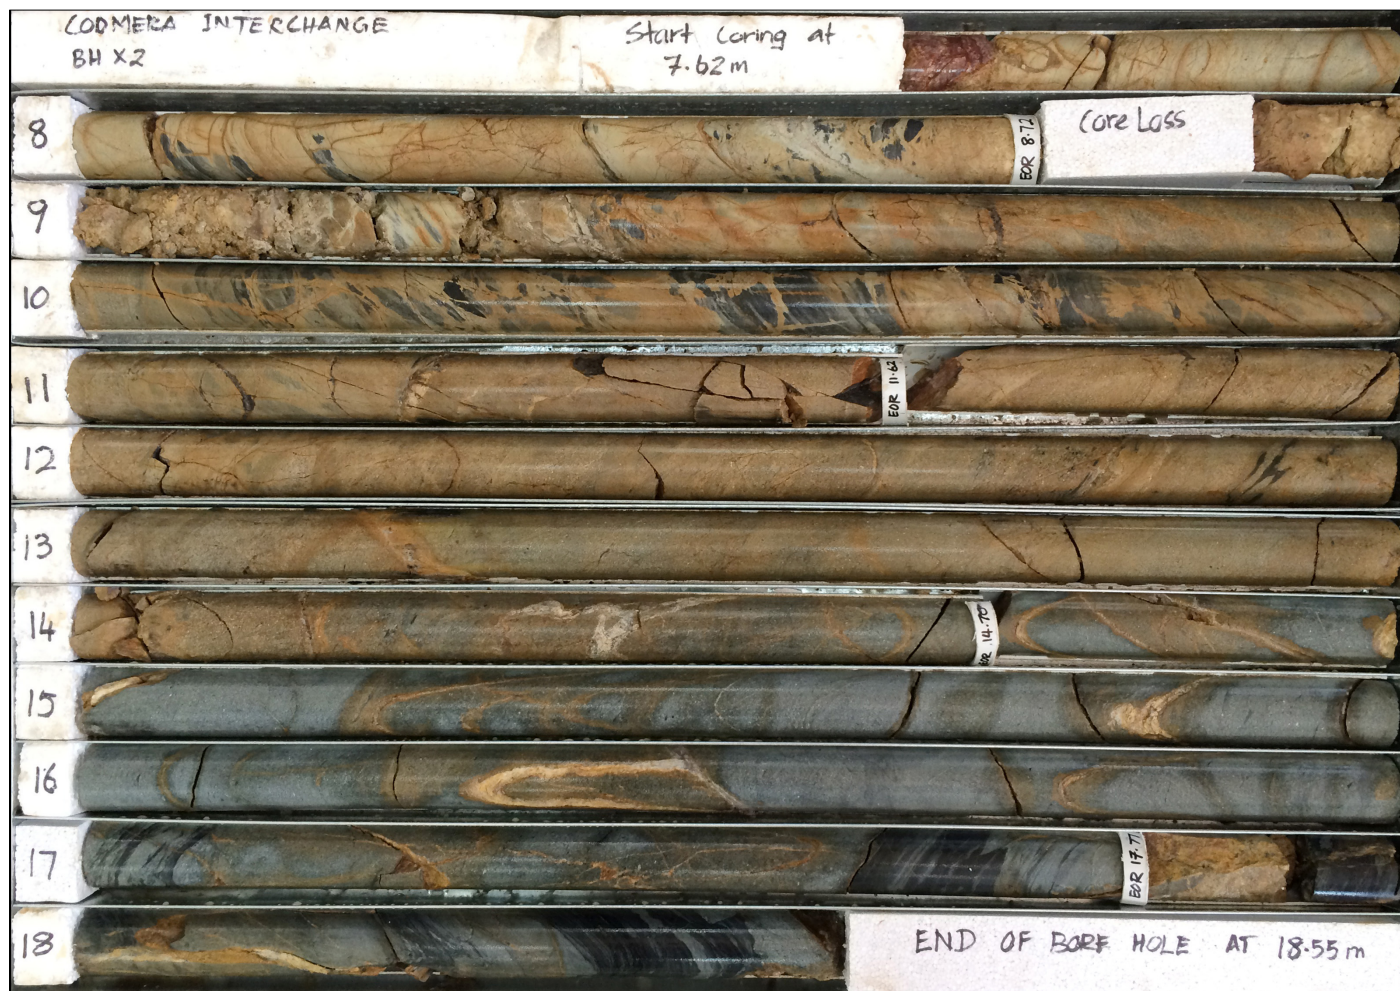
Start Depth (m): 7.62  
End Depth (m): 18.55

Start RL (AHD): 10.14  
End RL (AHD): -0.79
