# REPORT OF TEST PIT: TP401

CLIENT: McConnell Dowell Constructors (Aust) P/L COORDS: 85327.8 m E 60616.3 m N GCCC  
PROJECT: Gold Coast Rapid Transit SURFACE RL: 1.90 m DATUM: AHD  
LOCATION: Zone 4 PIT DEPTH: 1.80 m  
JOB NO: 117632047 BUCKET TYPE: 600 mm Scraper

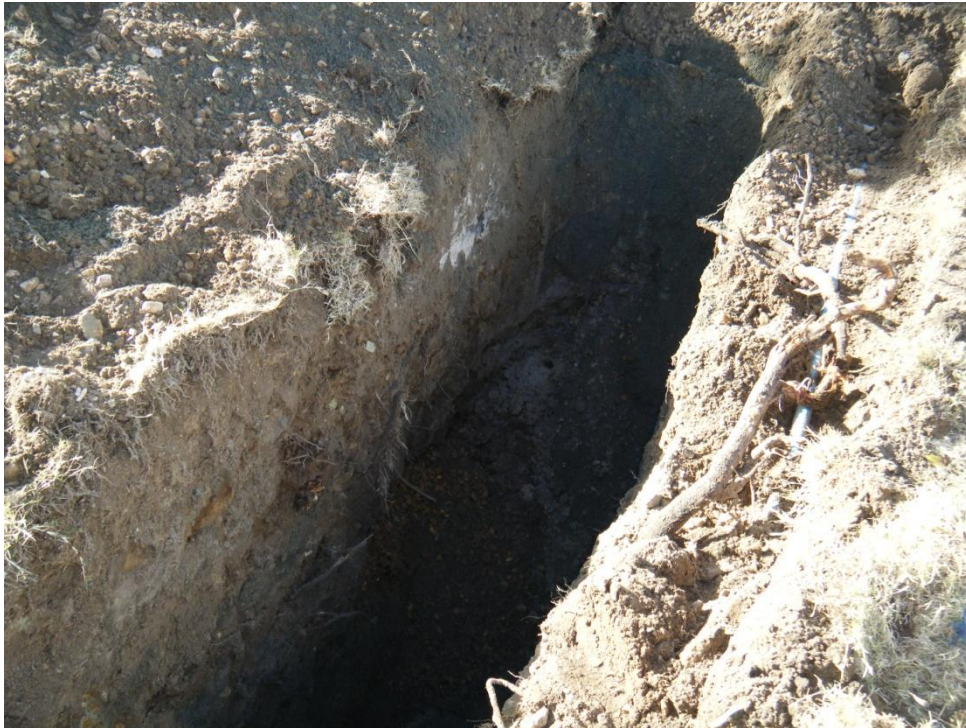
Photo 1 : Side Wall

| Excavation | | | | Sampling | | Field Material Description | | | | | |
|---|---|---|---|---|---|---|---|---|---|---|---|
| EX | L-M | Groundwater not encountered | 0.0 | 1.90 | | | SP | FILL: Gravelly Clayey SAND<br>fine to medium grained, rounded to sub-rounded, dark brown, trace rubbish including plastic and wood, roots, brick pieces, with some pockets of pale brown fine to medium grained sand noted | | | |
| | | | 0.5 | 0.70<br>1.20 | | | SP | FILL: Gravelly SAND<br>fine to coarse grained, dark grey, fine to coarse gravel, roots noted, pocket of orange brown gravels noted at 1.6 m depth | | | |
| | | | 2.0 | 0.10 | | | | TEST PIT DISCONTINUED @ 1.80 m<br>COLLAPSE<br>GROUNDWATER NOT ENCOUNTERED<br>Front end of pit was collapsing during excavation<br>Test pit terminated due to safety concerns | | | |
