CONE PENETROMETER TEST RESULT

Client : McConnell Consulting
Project : Stockland Residential
Location : Bermuda St, Robina

Test No : **MC-R15-S1**

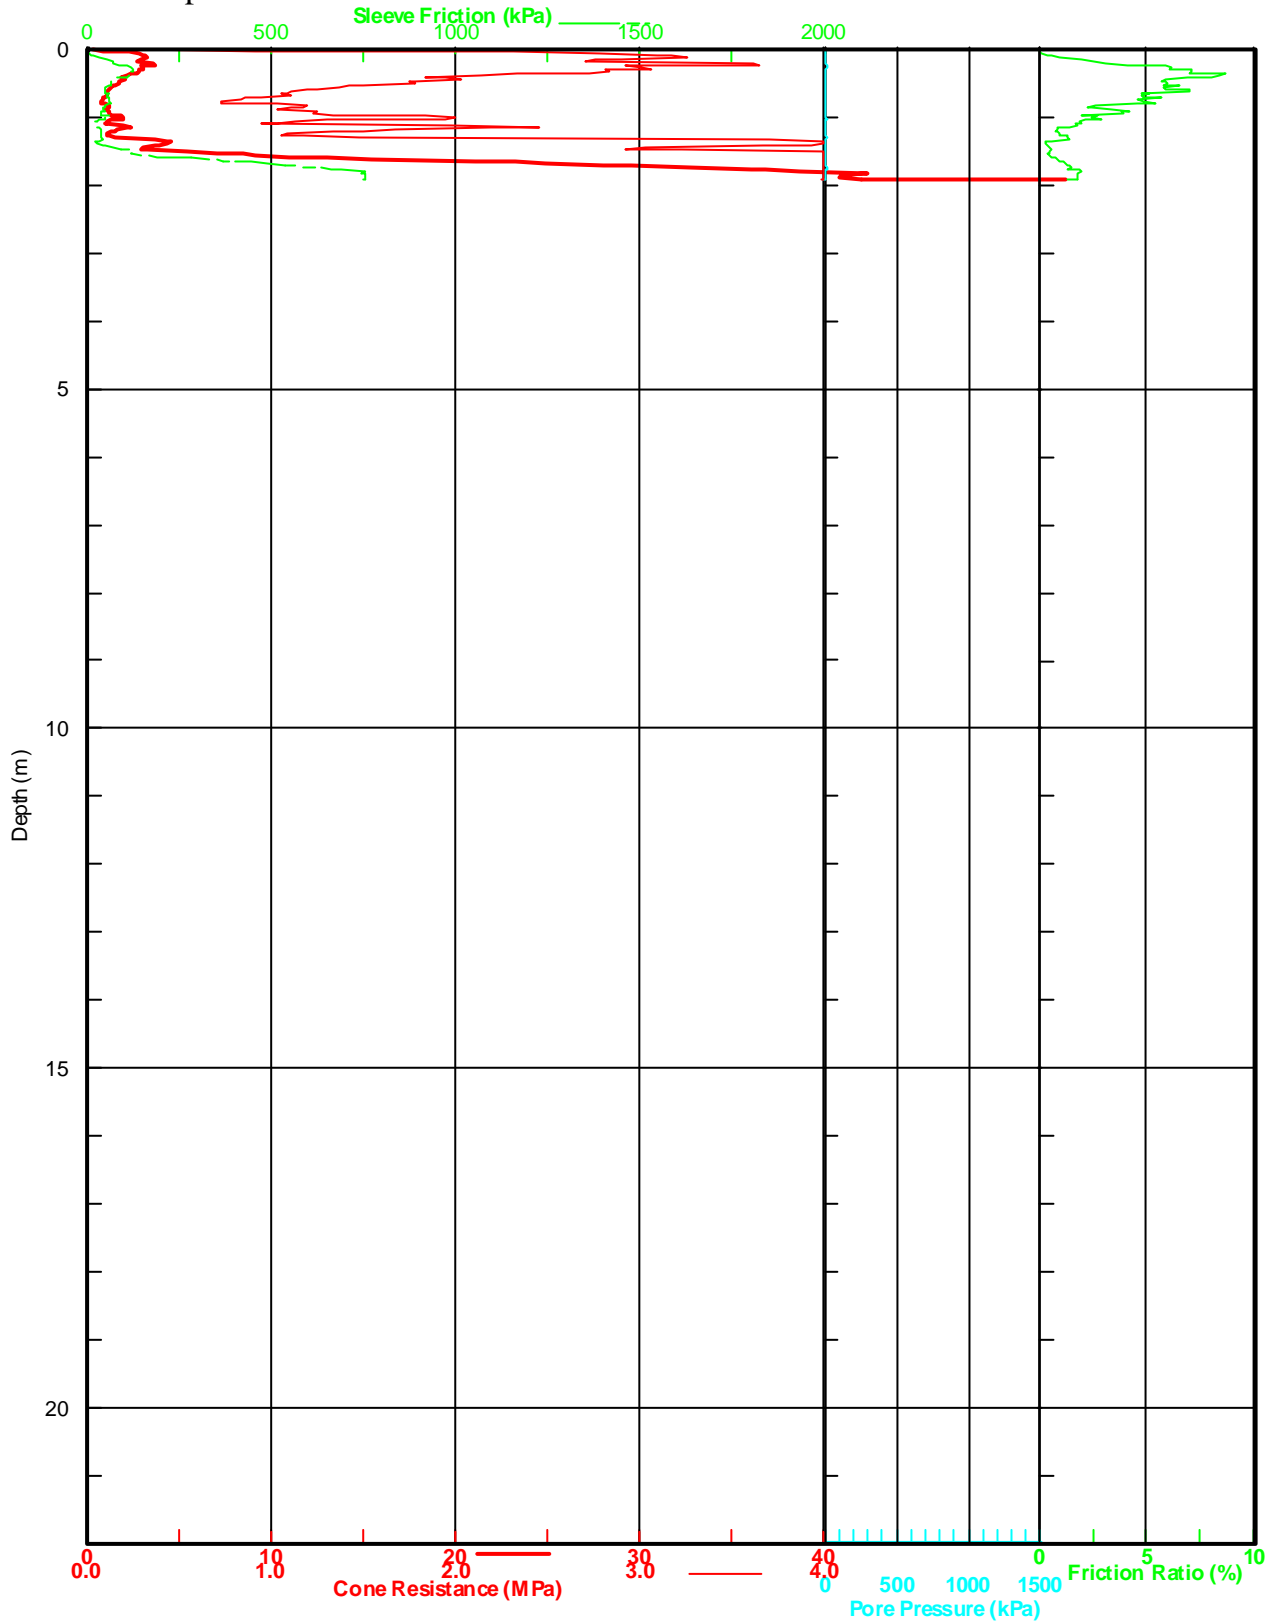
DGPS Position : 56J 0541480, 6894362
Predrill Depth : 0.00m

Tested in accordance with AS 1289.6.5.1-1999.
