REPORT OF BOREHOLE: CRR 203

PROJECT: Cross River Rail

LOCATION: Margaret St, W of Albert St

REPORT OF CORE PHOTOGRAPHS: CRR 203

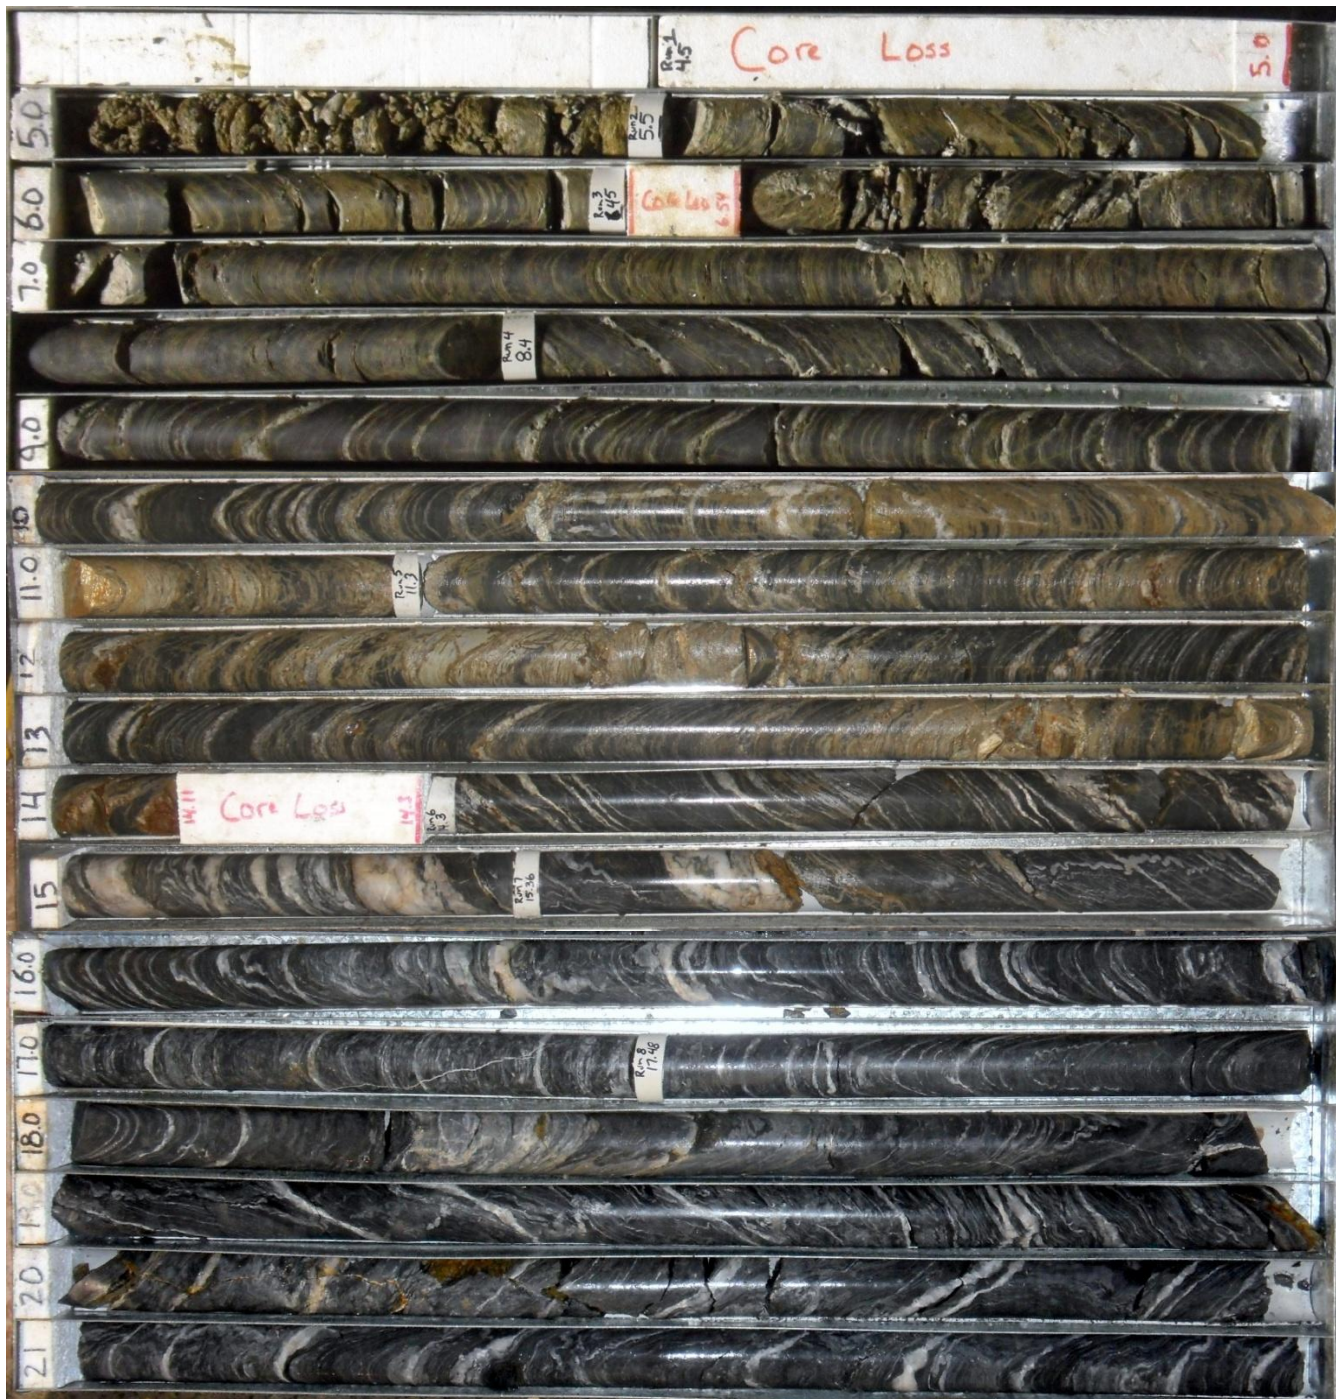
DEPTH RANGE: 4.5-22.0 m
DRILL RIG: Fox B40
DRILLER: Schneider Drilling Pty Ltd
LOGGED: MGM DATE: 2/08/10
CHECKED: NK DATE: 4/10/10

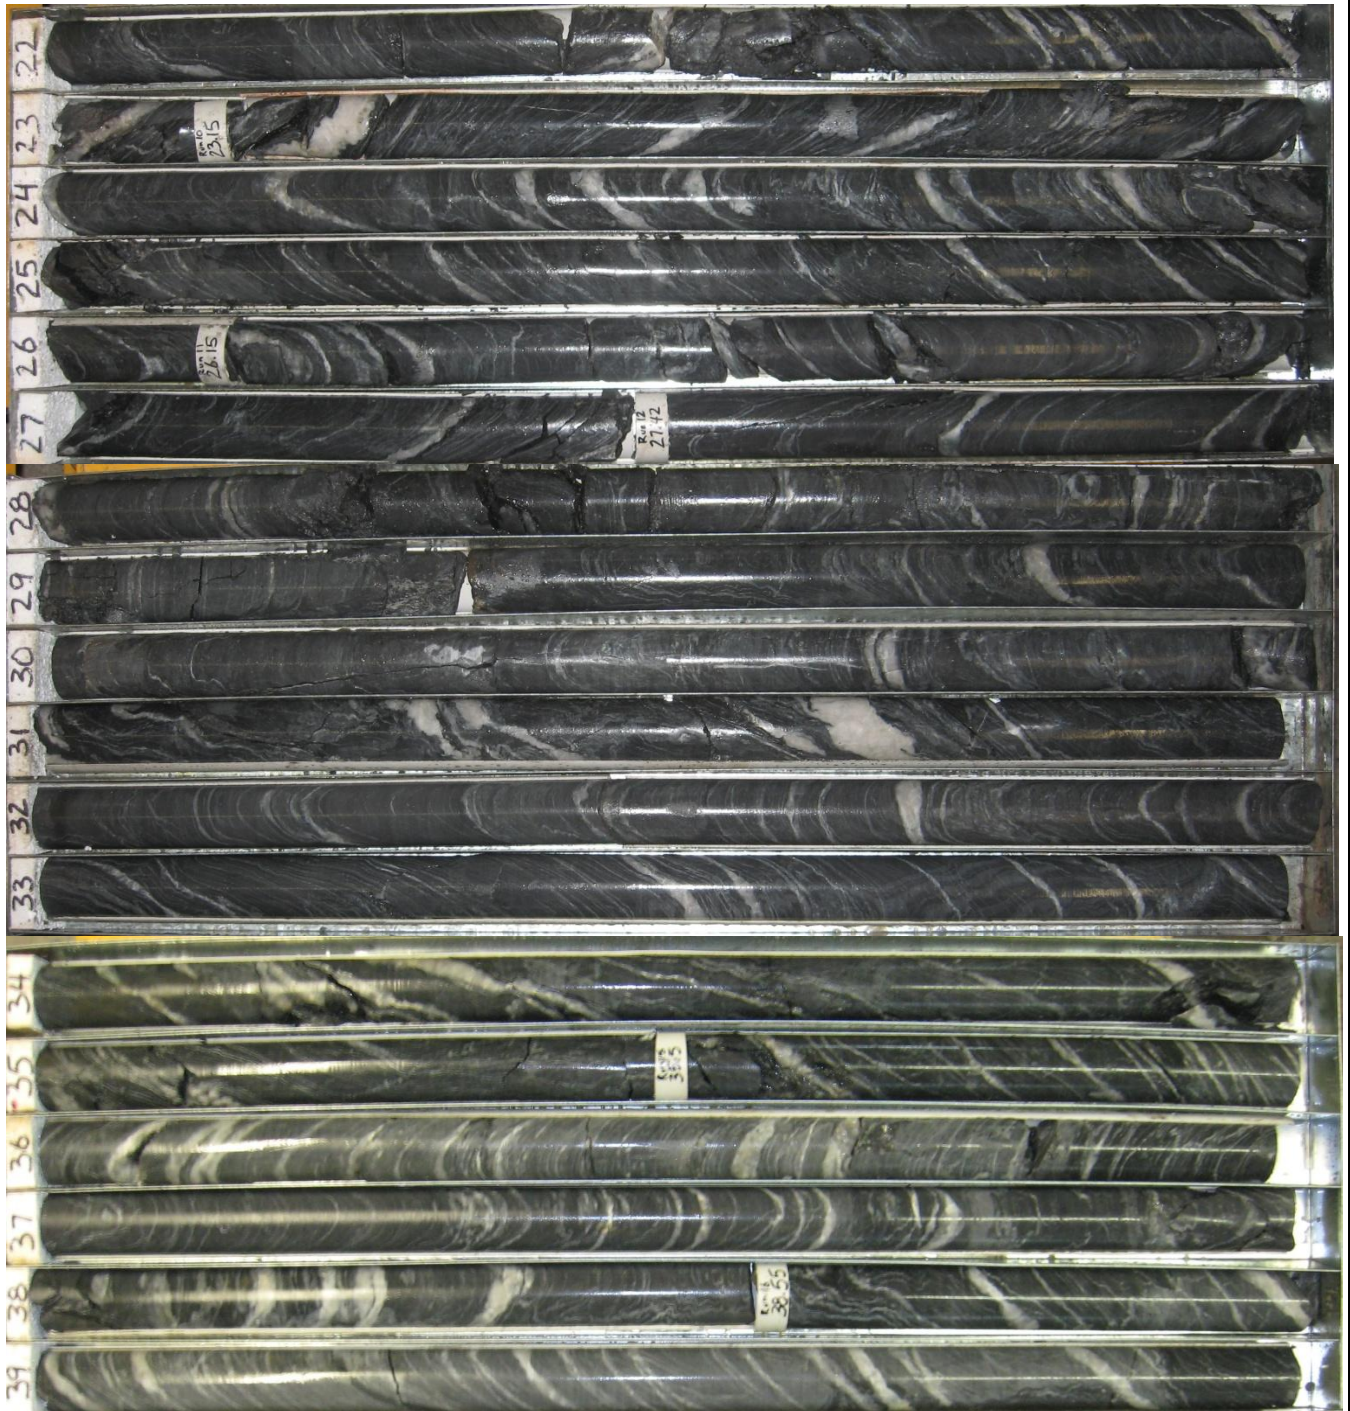
REPORT OF CORE PHOTOGRAPHS: CRR 203

DEPTH RANGE: 22.0-40.0 m

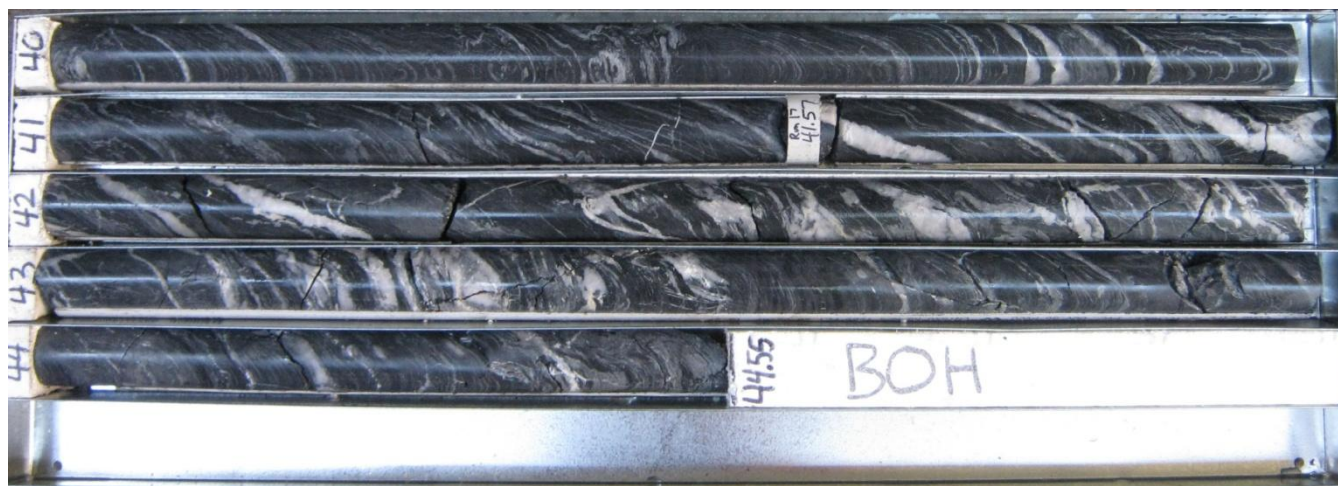
REPORT OF CORE PHOTOGRAPHS: CRR 203

DEPTH RANGE: 40.0-44.55 m

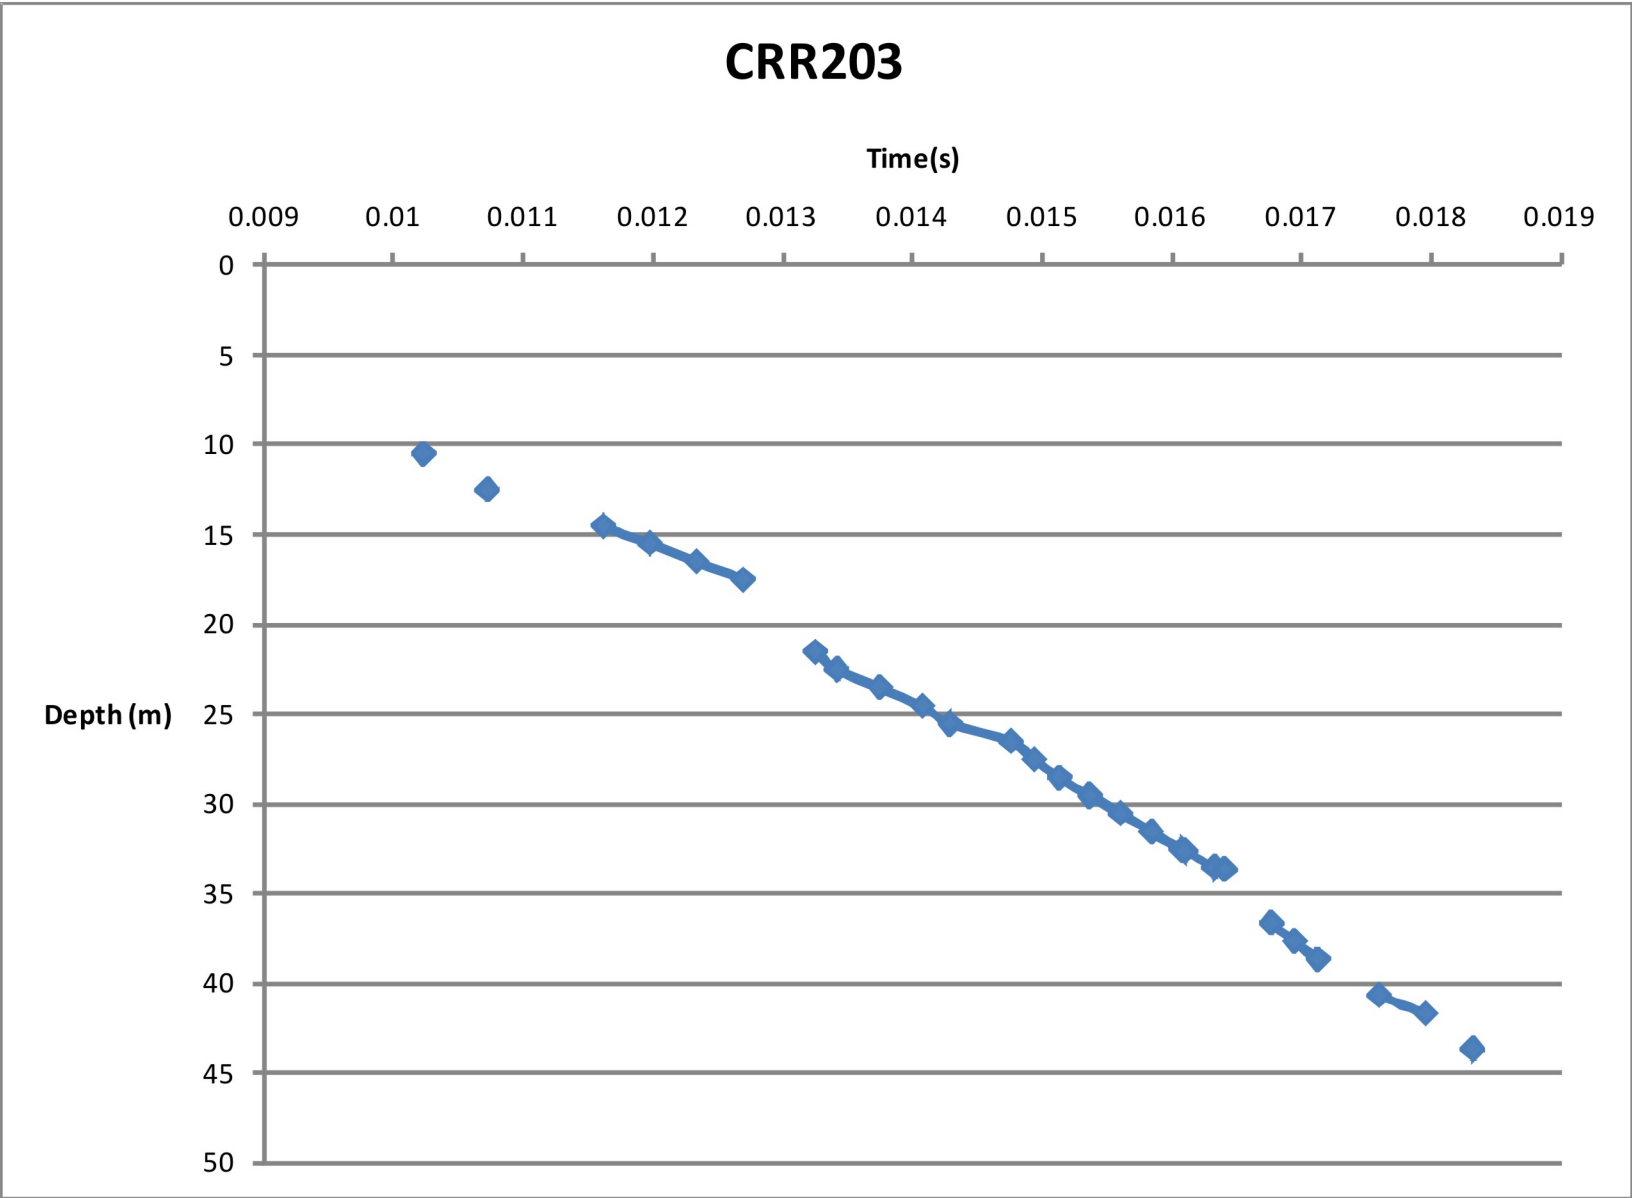
Calculations done without accounting for borehole deviation

Geophone Depth (m)		Interval velocity (P wave m/s)
from	to	
10.6	11.6	*
11.6	12.6	*
12.6	13.6	*
13.6	14.6	*
14.6	15.6	2778
15.6	16.6	2781
16.6	17.6	2783
17.6	18.6	*
18.6	19.6	*
19.6	20.6	*
20.6	21.6	*
21.6	22.6	5958
22.6	23.6	3045
23.6	24.6	3046
24.6	25.6	4648
25.6	26.6	2134
26.6	27.6	5473
27.6	28.6	5272
28.6	29.6	4207
29.6	30.6	4208
30.6	31.6	4208
31.6	32.6	4209
32.6	32.7	4209
32.7	33.6	3965
33.6	33.7	1266
33.7	34.7	*
34.7	35.7	*
35.7	36.7	*
36.7	37.7	5484
37.7	38.7	5485
38.7	39.7	*
39.7	40.7	*
40.7	41.7	2745
41.7	42.7	*
42.7	43.7	*

CLIENT Department of Transport and Main Roads		PROJECT Cross River Rail	
DRAWN GDK	DATE OCT 4	TITLE CRR203 VSP	
CHECKED TR	DATE		
SCALE NTS	PROJECT No 000-107632034	FIGURE No	REV No A3
