# ENGINEERING BORELOG

BOREHOLE No : 221  
 SHEET : 1 OF 1  
 REFERENCE No : H8162

PROJECT : SOUTH EAST TRANSIT BUS LANE PROJECT - SECTION 2  
 LOCATION : 3712.224E 162582.044N  
 PROJECT No : C60117 SURFACE R.L. : 7.64 DRILLER : DALY BROTHERS PTY LTD  
 JOB No : 650302CN DATUM : AHD DATE DRILLED : 10/12/97

BUS TRANSIT TUNNEL - PACKAGE TWO

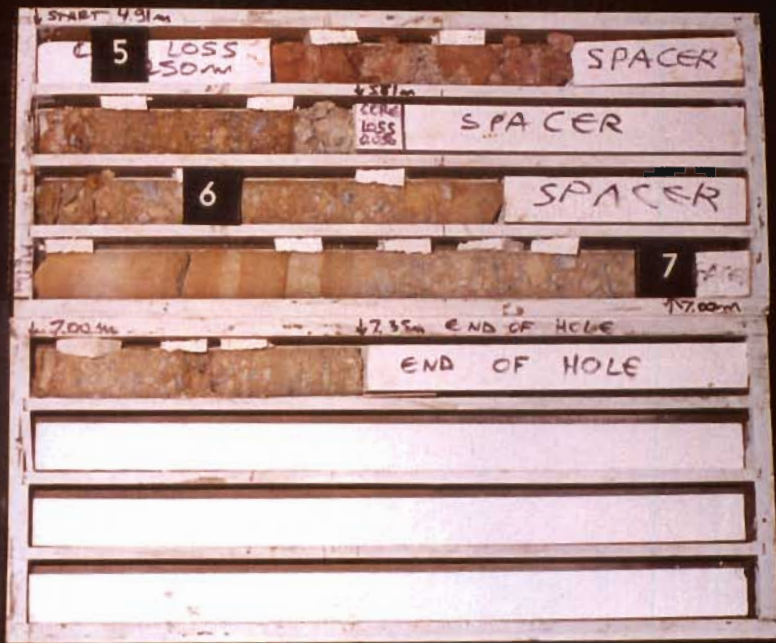
HOLE 221  
START 4.91  
END 7.35

H 8162  
1 OF 1  
DEC 1997
