# REPORT OF BOREHOLE: BH404

PROJECT: Gold Coast Rapid Transit SURFACE RL: -3.04 m DATUM: AHD

## REPORT OF CORE PHOTOGRAPHS: BH404

CLIENT: McConnell Dowell Constructors  
PROJECT: Gold Coast Rapid Transit  
LOCATION: Zone 4  
JOB NO: 117632047

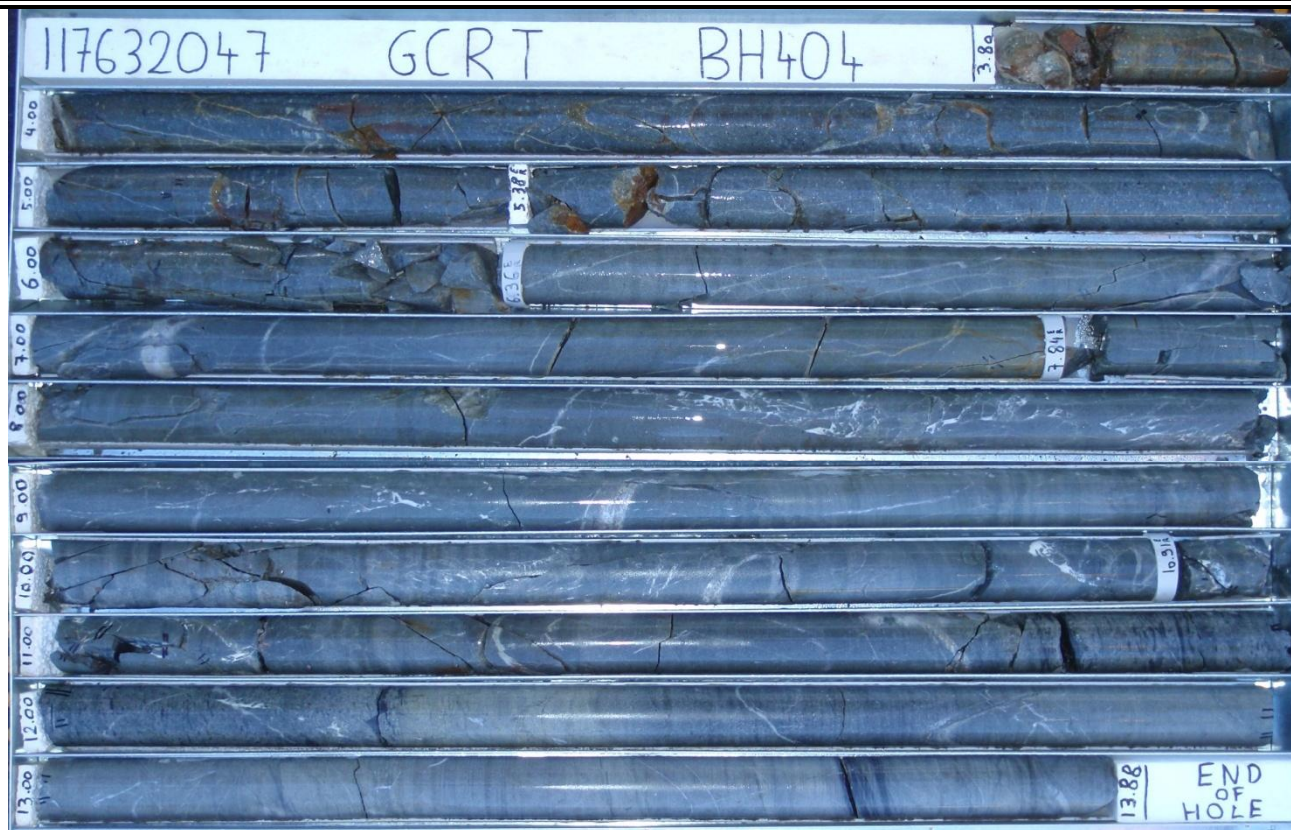
DEPTH RANGE: 3.80 – 13.88 m  
DRILL RIG: FOX B40  
DRILLER: Schneider Drilling Pty Ltd  
LOGGED: FHH DATE: 17/08/11  
CHECKED: NK DATE: 16/9/11

| Drilling | | | | | | Field Material Description | | | | Defect Information | | | |
|---|---|---|---|---|---|---|---|---|---|---|--|---|--|
| NMLC | | | 100 | 71 | 10 | -13.04 | ARGILLITE<br>fine grained, pale green grey to green grey,<br>numerous quartz veins | SW | | 7.42 m: J, 40°, Pl-St, Ro, Vr<br>7.43 m: J, 90°, Pl, Ro, Cn<br>7.65 m: V, 85°, 1 mm, quartz<br>7.68 m: J, 20°, Pl, Ro, Cn<br>7.70 m: V, 75°, 1 mm, quartz<br>7.73 m: J, 90°, Un, Sn-Vr, FeO<br>7.84-8.17 m: multiple handling breaks, core recovered<br>without breaks<br>8.24 m: J, 80°, Pl, Ro, Cn<br>8.43 m: V, 40°, 5 mm, quartz<br>10.02 m: J, 75°, Pl, Cn<br>10.07 m: J, 70°, Pl, Sm, Cn<br>10.16 m: J, 70°, Pl, Sm, Cn<br>10.24 m: J, 80°, Pl, Cn<br>10.27 m: J, 40°, Pl-St, Sm, Cn<br>10.48 m: V, 20°, 20 mm, quartz<br>10.50 m: J, Pl, Sm, Cn<br>10.65 m: J, 70°, Pl, Sm, Cn<br>10.70 m: V, 80°, 3 mm<br>10.76 m: J, 30°, Pl, Ro, Cn<br>10.83 m: V, 60°, 10 mm, quartz<br>10.84 m: V, 30°, 3 mm, quartz<br>11.14 m: V, 50°, 8 mm, quartz<br>11.31 m: J, 60°, Pl, Sm, Cn<br>11.35 m: V, 65°, 5 mm, quartz<br>11.38 m: IS, 75°, Pl, Ro, Vr<br>11.49 m: DB<br>11.74 m: DB<br>11.78 m: DB<br>11.82 m: J, 15°, Pl, Sm, Cn, possible drilling break<br>11.93 m: DB<br>12.09 m: V, 70°, 3 mm, quartz<br>12.27 m: DB<br>12.58 m: V, 45°, 2 mm, quartz<br>12.65 m: DB | | | |
