ENGINEERING BORELOG

BOREHOLE No : 392
SHEET : 1 OF 1
REFERENCE No : H7981

PROJECT : PACIFIC MOTORWAY - FOXWELL ROAD OVERPASS FOUNDATION INVESTIGATION
 LOCATION : Grid Reference 30810.0 E, 122142.5 N
 PROJECT No : MP1006 SURFACE R.L. : 11.21 DRILLER : Schneider
 JOB No : DATUM : AHD DATE DRILLED : 26/3/97

PACIFIC MOTORWAY - FOXWELL ROAD O'PASS

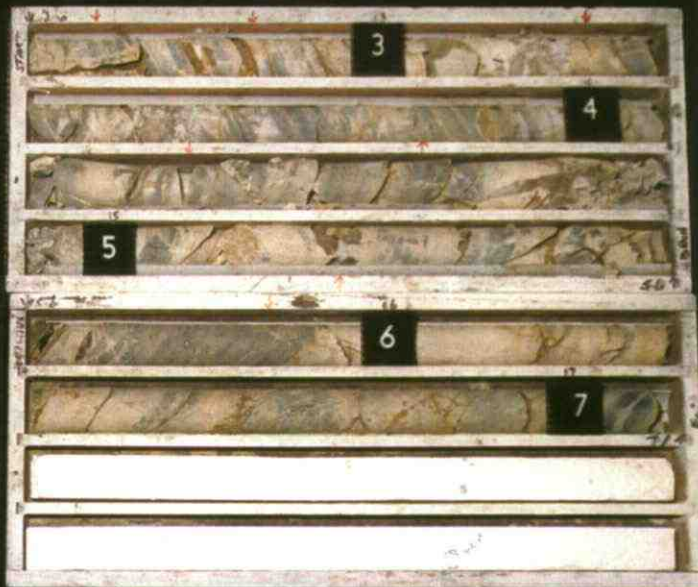
HOLE 392
START 2.6
END 7.1

H 7981
1 OF 1
APRIL 1997
