TEST PIT: TPL-10

Project: Pioneer-Burdekin PHES

Job No.: PS138693

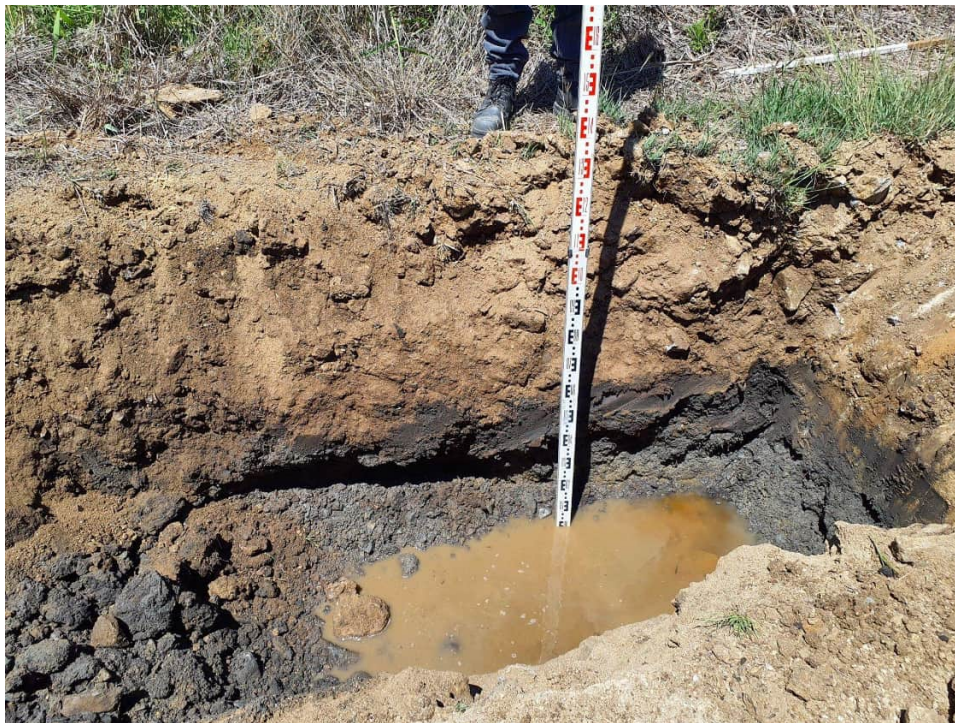
2.5														
				3.0								D						
				3.20	152.57				Hole Terminated at 3.20 m Target depth sidewall collapse occurred below 0.9 m depth Backfilled

TPL-10-1 - Test pit excavation - sidewall collapse occurring below 0.9 m below ground level

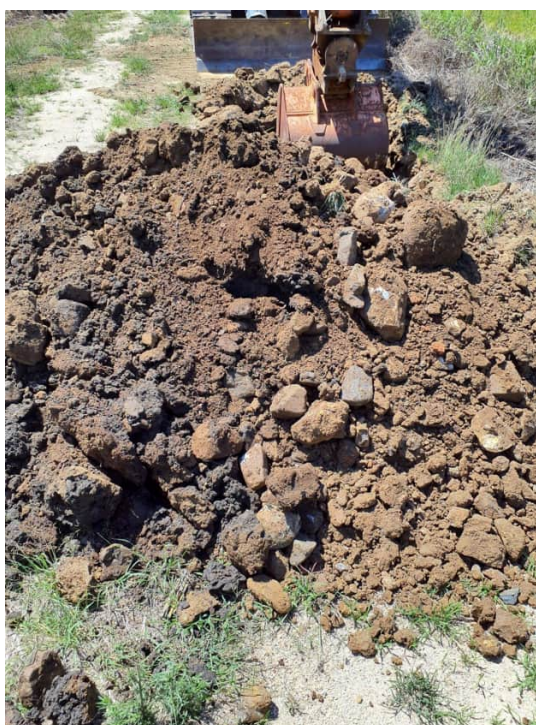
TPL-10-2 Test pit excavated spoil
