# CONE PENETROMETER TEST RESULT

# CPTU113

TMR Geotechnical  
R2D  
Oxley Creek QLD

U1 tip  
center of Oxley Creek overflow

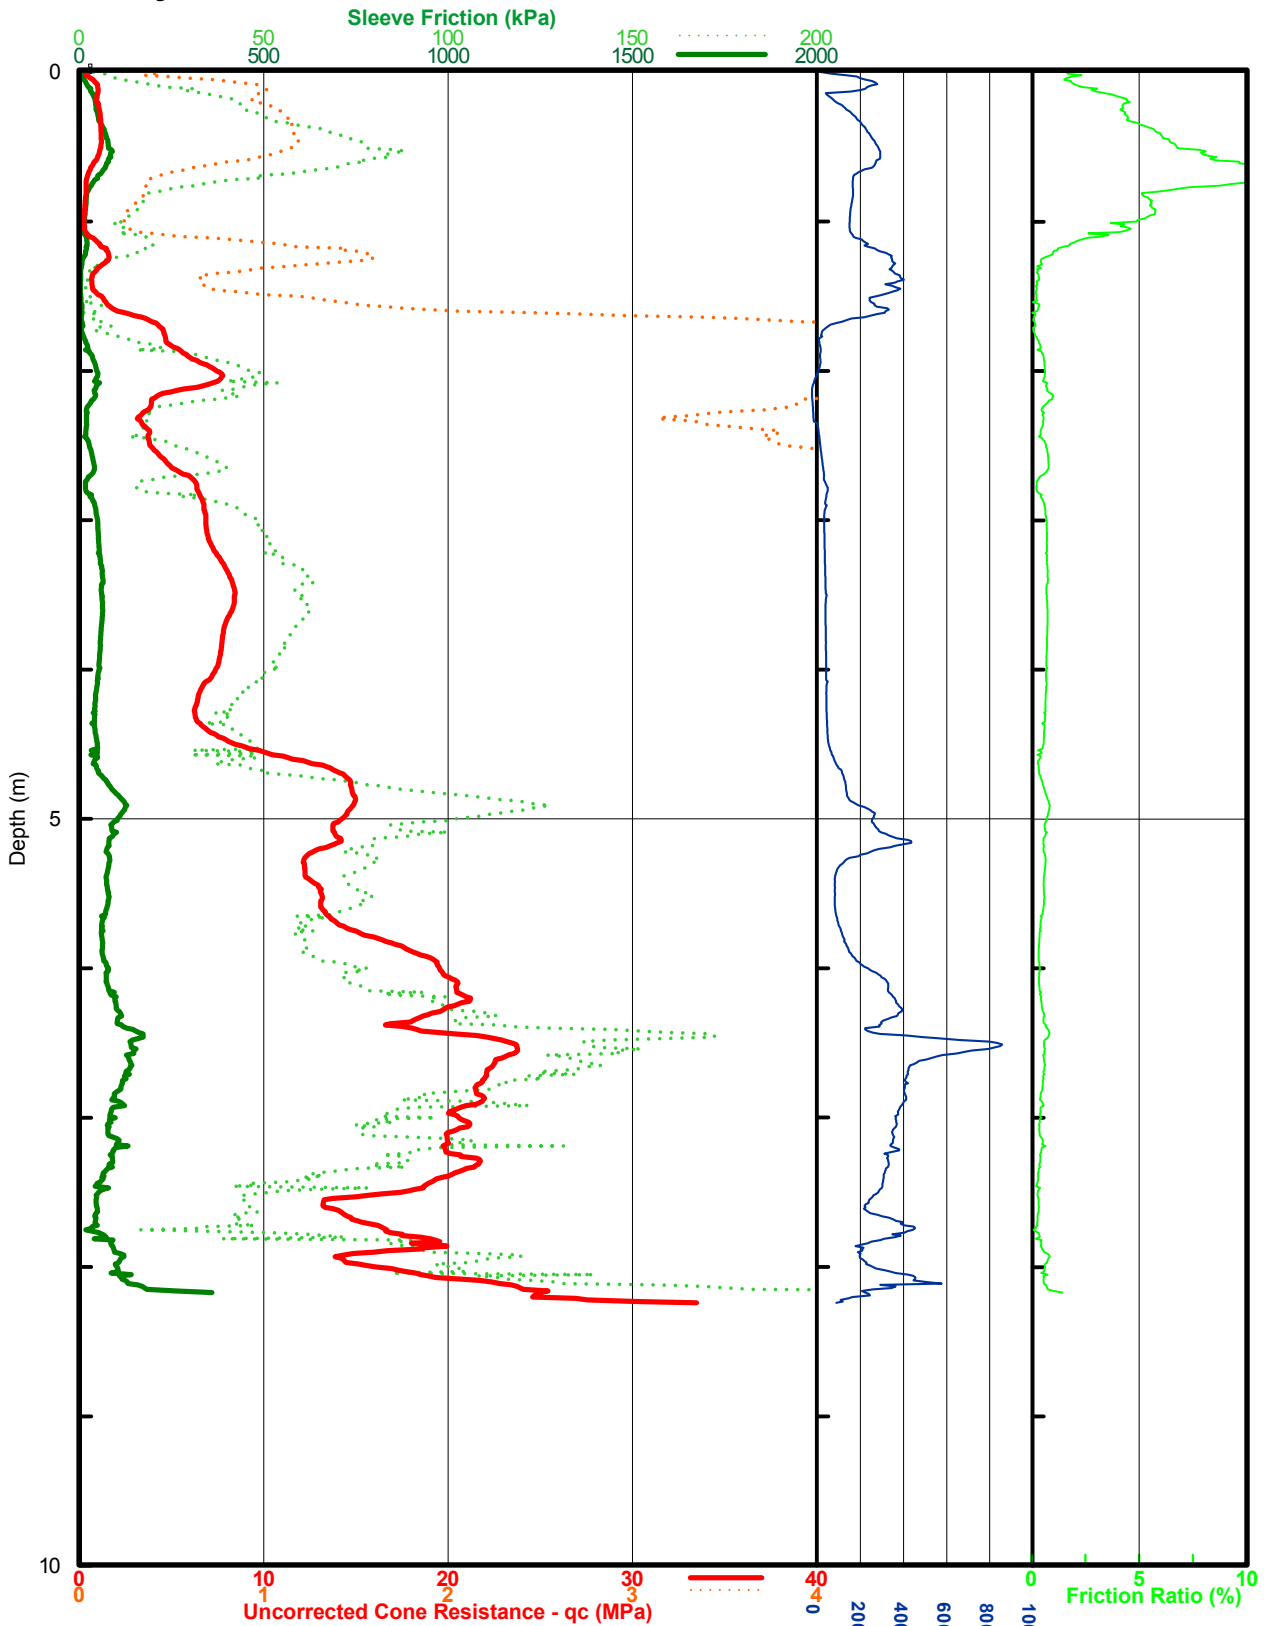
Job Number : G15-04-04  
Test Date : 24/04/2015  
DGPS Position : 56 J 0498732, 6951001  
DGPS Format : GDA  
Rig : Eileen  
Cone Number : S15CFIIP.S11105  
Predrill Depth : 0.00m  
Dissipation Tests @ : N/A  
Terminated Due To : Equipment at Risk

Pore Pressure (kPa)
