# CONE PENETROMETER TEST RESULT

Client : McConnell Consulting  
Project : Queensland Cotton  
Location : Hemmant

Test No : **HS-02**

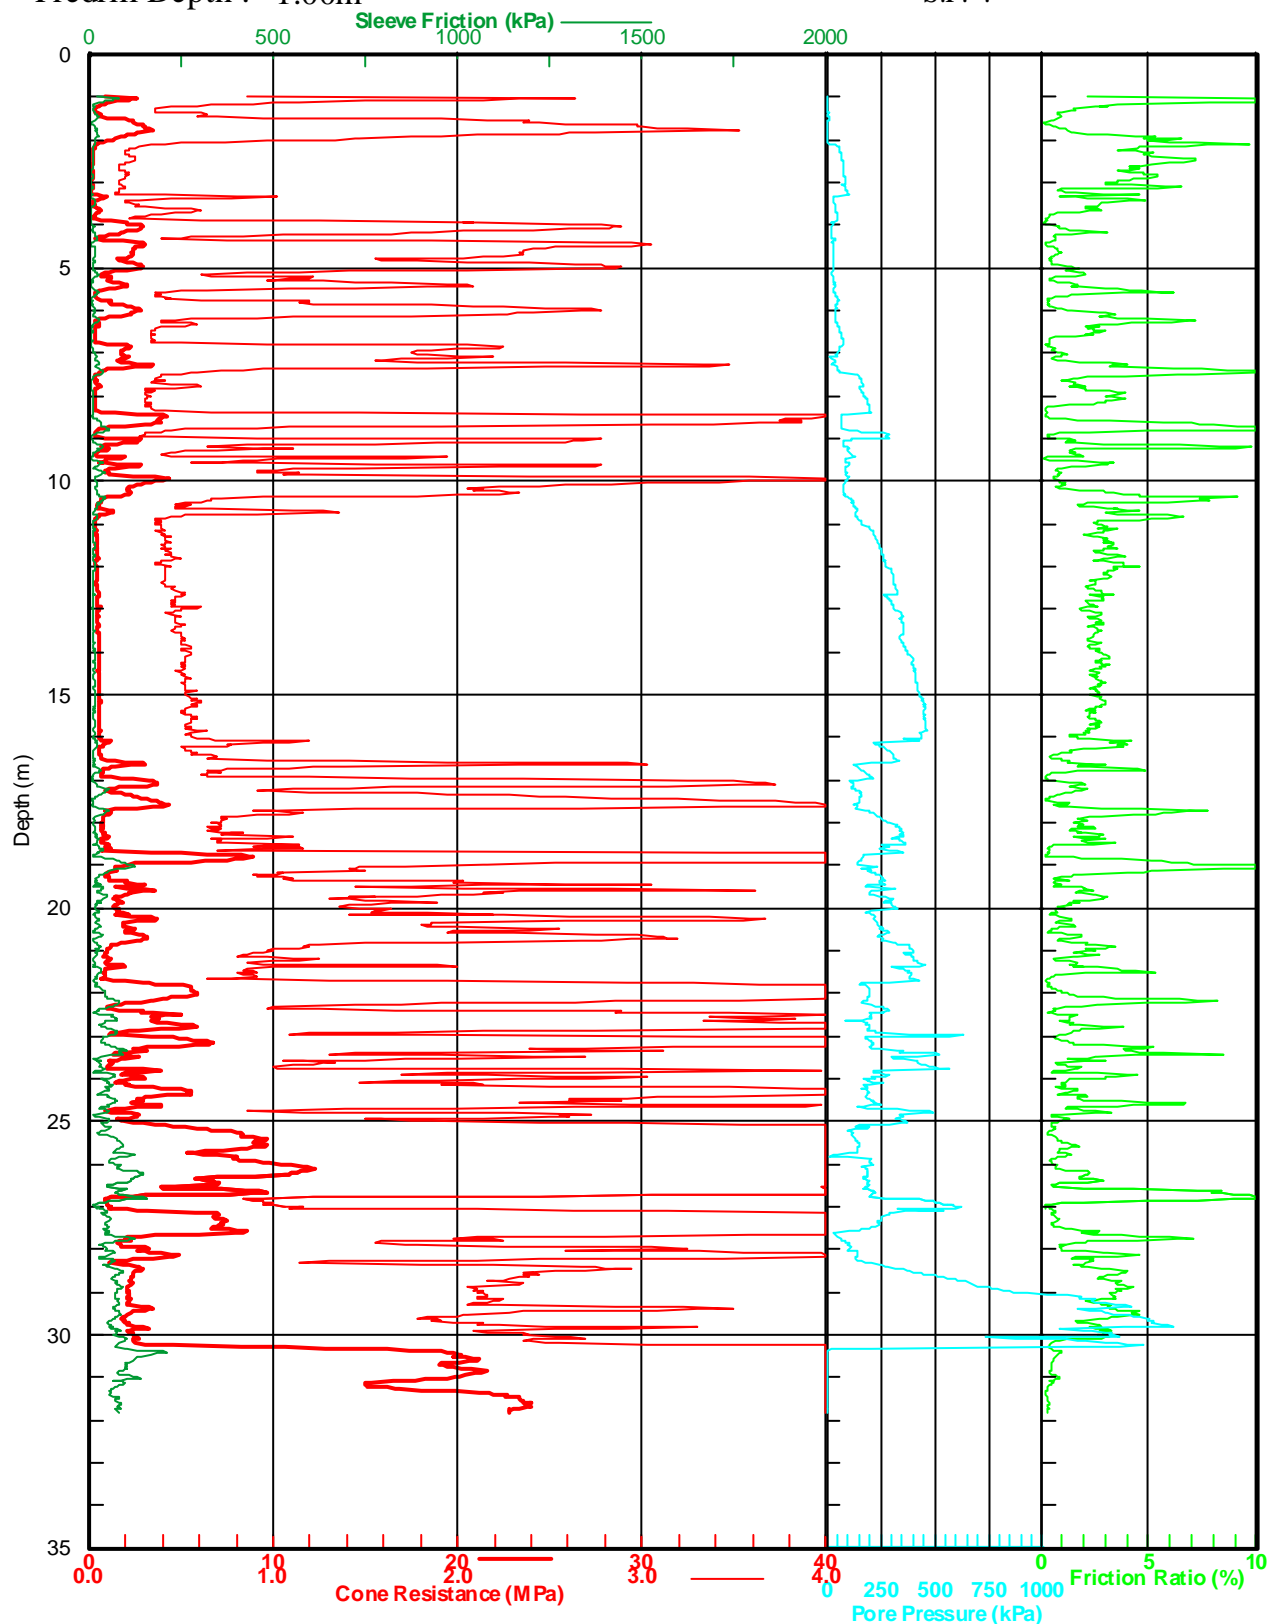
DGPS Position : 56J 0513299, 6965600 (AMG84)

Predrill Depth : 1.00m

Tested in accordance with AS 1289.6.5.1 -1999.
