TEST PIT LOG

FEATURE No TP088

PROJECT Bruce Highway Cooroy to Curra Section A Geotechnical Investigation

LOCATION Southern I/C, Embankment 1B COORDINATES 491253.2 E; 7076438.2 N

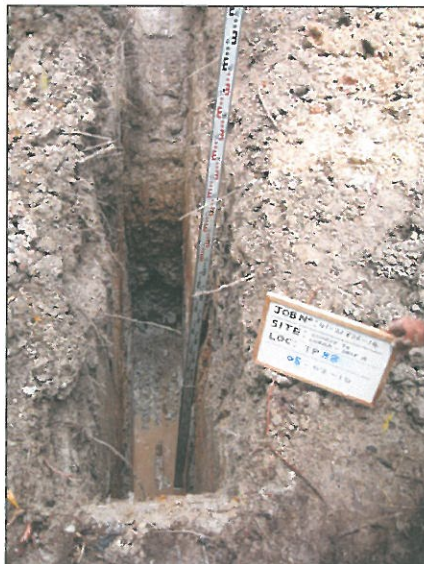
Testpit Profile

109.78		OL	Silty CLAY (Topsoil) Pale brown to red brown, moist, firm, low to intermediate plasticity		Seepage 0.6 to 1.2m fast inflow in all pit faces.		
			CL-CI	Silty CLAY (Fill?) Pale grey to brown, wet, stiff. Low to intermediate plasticity; trace fine to medium gravel consisting of subangular to angular chert and quartz; rootlets; occasional wood fragments up to 150mm dia

108.73		MH	Clayey SILT (Residual Soil?) Red brown to pale and orange brown with pale grey mottling, moist, stiff to very stiff. High plasticity; occasional rootlets; becoming dry to moist below 1.5m.		Pit spalling at 1.2m; seepage fast inflow. LL = 60; PI = 29; LS = 15.6; MC = 30.5%; WPI = 2654	A	D,Bulk
				Below 2.0m: Becoming very stiff to hard.		Pit spalling from 2.1 to 3.1m. MC = 25.3%

107.83		CL	Gravelly CLAY with Silt (Residual Soil) Pale grey with orange brown and red brown mottling, moist, very stiff to hard. Low plasticity; gravel fraction is angular, fine to coarse grained consisting predominantly of quartz. At 3.0m: Possible seepage at base of gravel; slight organic odour and dark brown pockets.

106.83		CI	Silty CLAY (Residual Soil) Pale grey with red brown and orange brown mottling, moist, very stiff to hard. Intermediate plasticity; trace fine to coarse grained, subangular to angular quartz gravel; slight organic odour.			B	D,Bulk
