**GEOTECHNICAL
BOREHOLE LOG**

BOREHOLE No **BH218**

PROJECT	Mackay Ring Road		
LOCATION	Pioneer River Bridge, Pier 5 (RHS)	COORDINATES 721310.9 E; 7660177.6 N	
PROJECT No	FG6184	SURFACE RL 7.50m	PLUNGE 90°
			DATE STARTED 30/08/2015
			GRID DATUM GDA 94 / MGA Z55
JOB No	242/10G/906	HEIGHT DATUM A.H.D.	BEARING °
			DATE COMPLETED 31/08/2015
			DRILLER Saxon Drilling

CORE PHOTO LOG

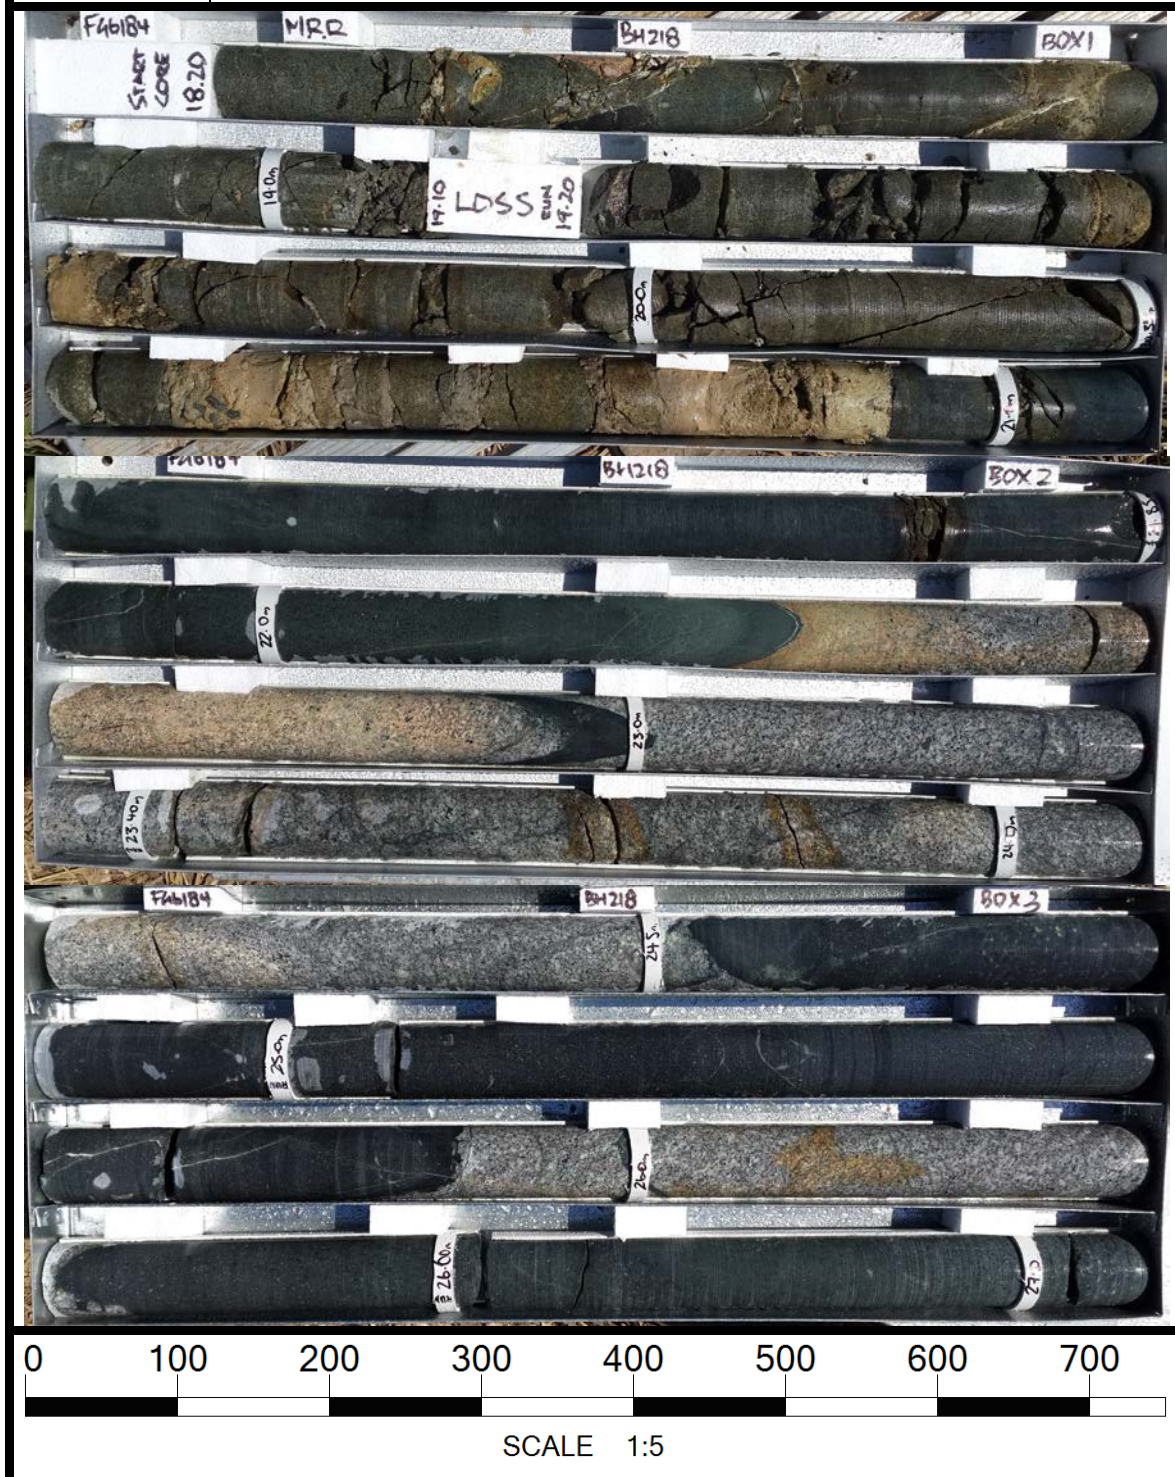
Project Name	Mackay – Ring Road (Stage 2)		
Project No.	FG6184	Date	31/08/15
Borehole No.	BH 218	TMR H No.	H12227
Location	Pioneer River Bridge	Start Depth (m)	18.20
Detail	Pier 5, RHS	Finish Depth (m)	31.34
Chainage		Submitted By	M.Ensor
Remarks

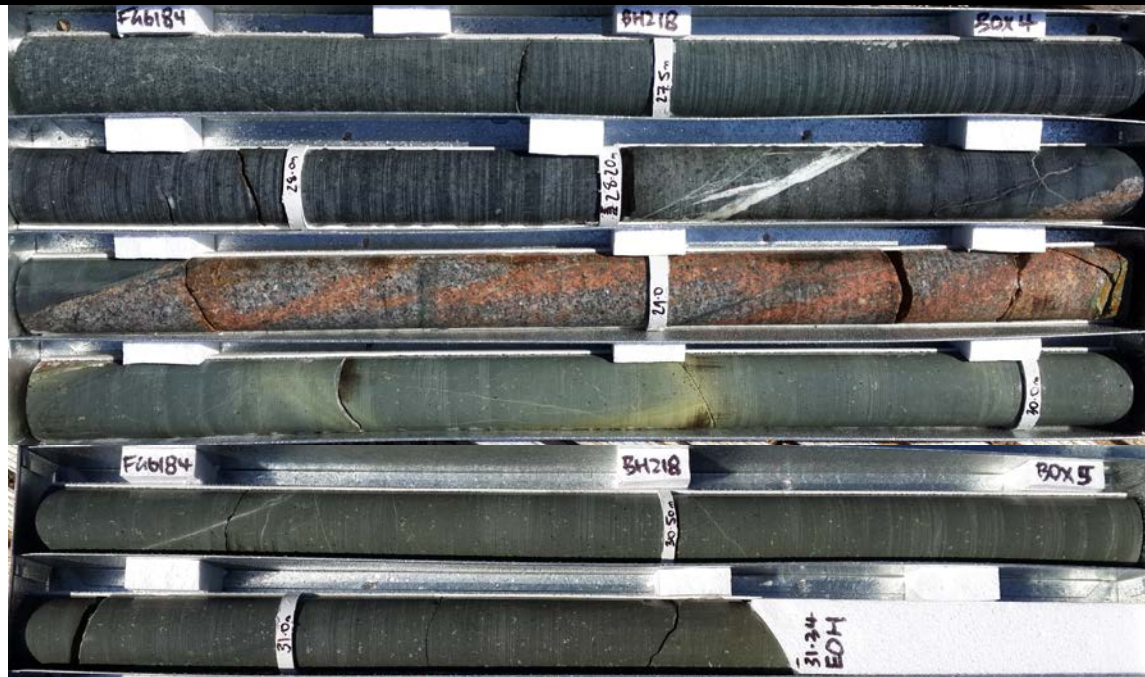
CORE PHOTO LOG

Project Name	Mackay – Ring Road (Stage 2)		
Project No.	FG6184	Date	31/08/15
Borehole No.	BH 218	TMR H No.	H12227
Location	Pioneer River Bridge	Start Depth (m)	18.20
Detail	Pier 5, RHS	Finish Depth (m)	31.34
Chainage		Submitted By	M.Ensor
Remarks
