REPORT OF BOREHOLE: CRR 212

CLIENT: Aecom Australia Pty Ltd
 PROJECT: Cross River Rail
 LOCATION: Fairfield and Park Rd
 JOB NO: 107632034

REPORT OF CORE PHOTOGRAPHS: CRR 212

GEOPHYSICAL RECORD OF BOREHOLE: CRR 212

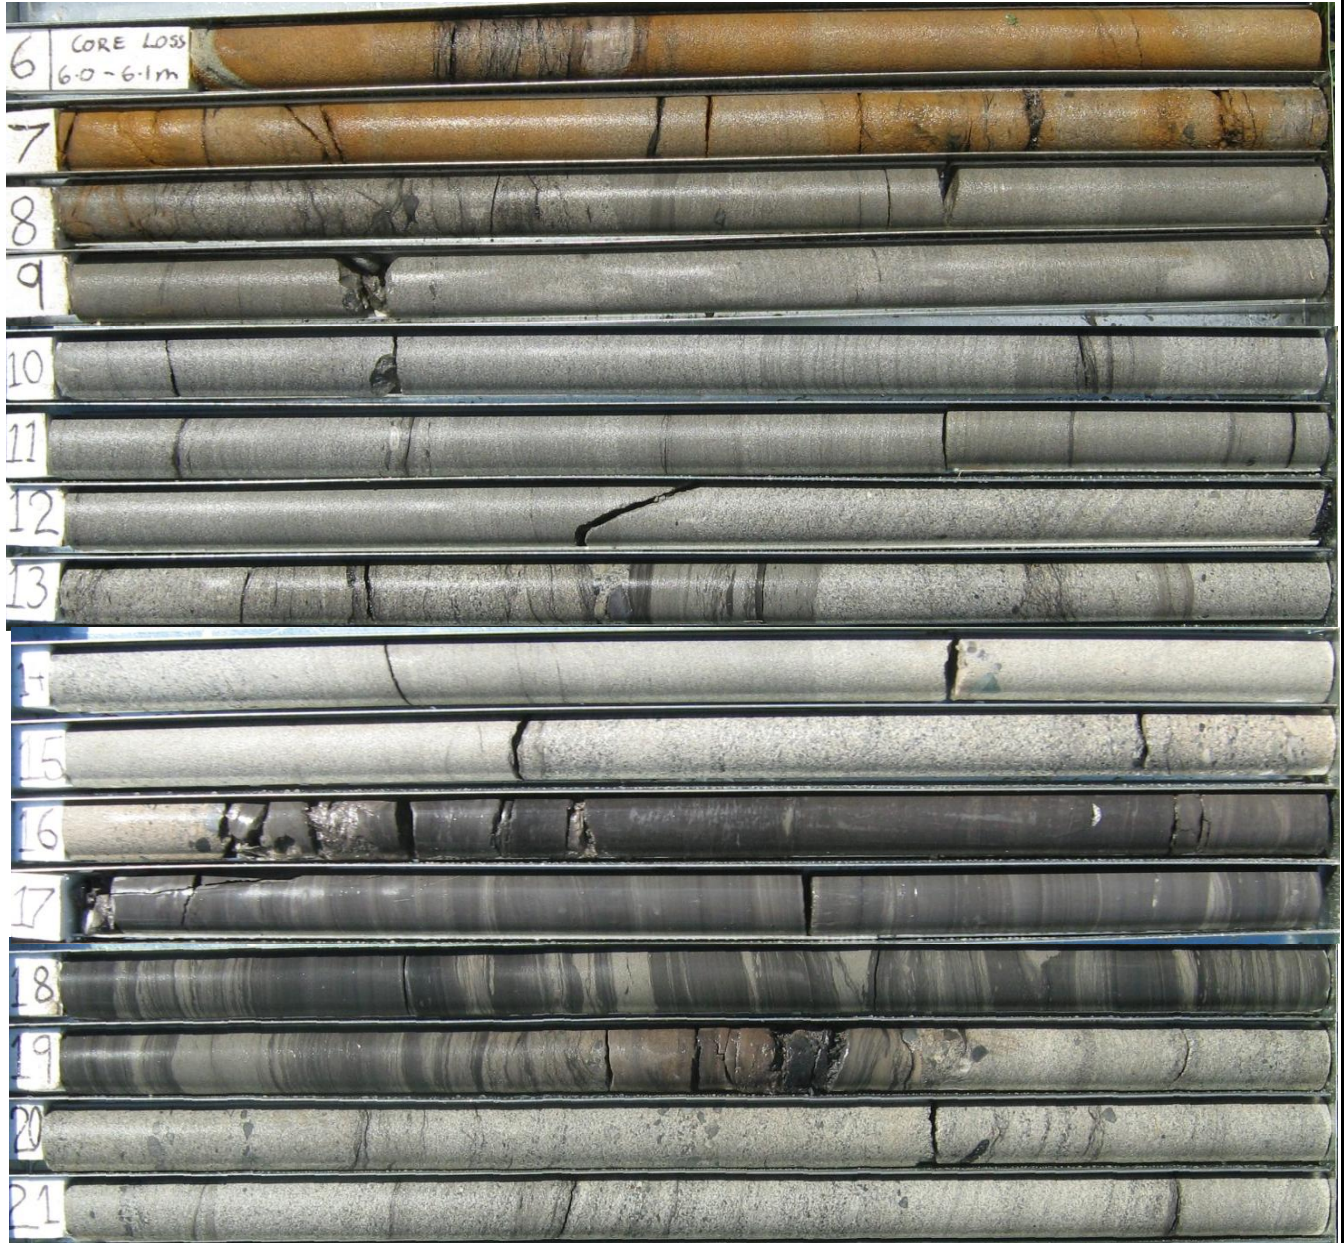
DEPTH RANGE: 6.0-22.0 m
DRILL RIG: Fox B40
DRILLER: Schneider Drilling Pty Ltd
LOGGED: RCD DATE: 26/08/10
CHECKED: NK DATE: 4/10/10

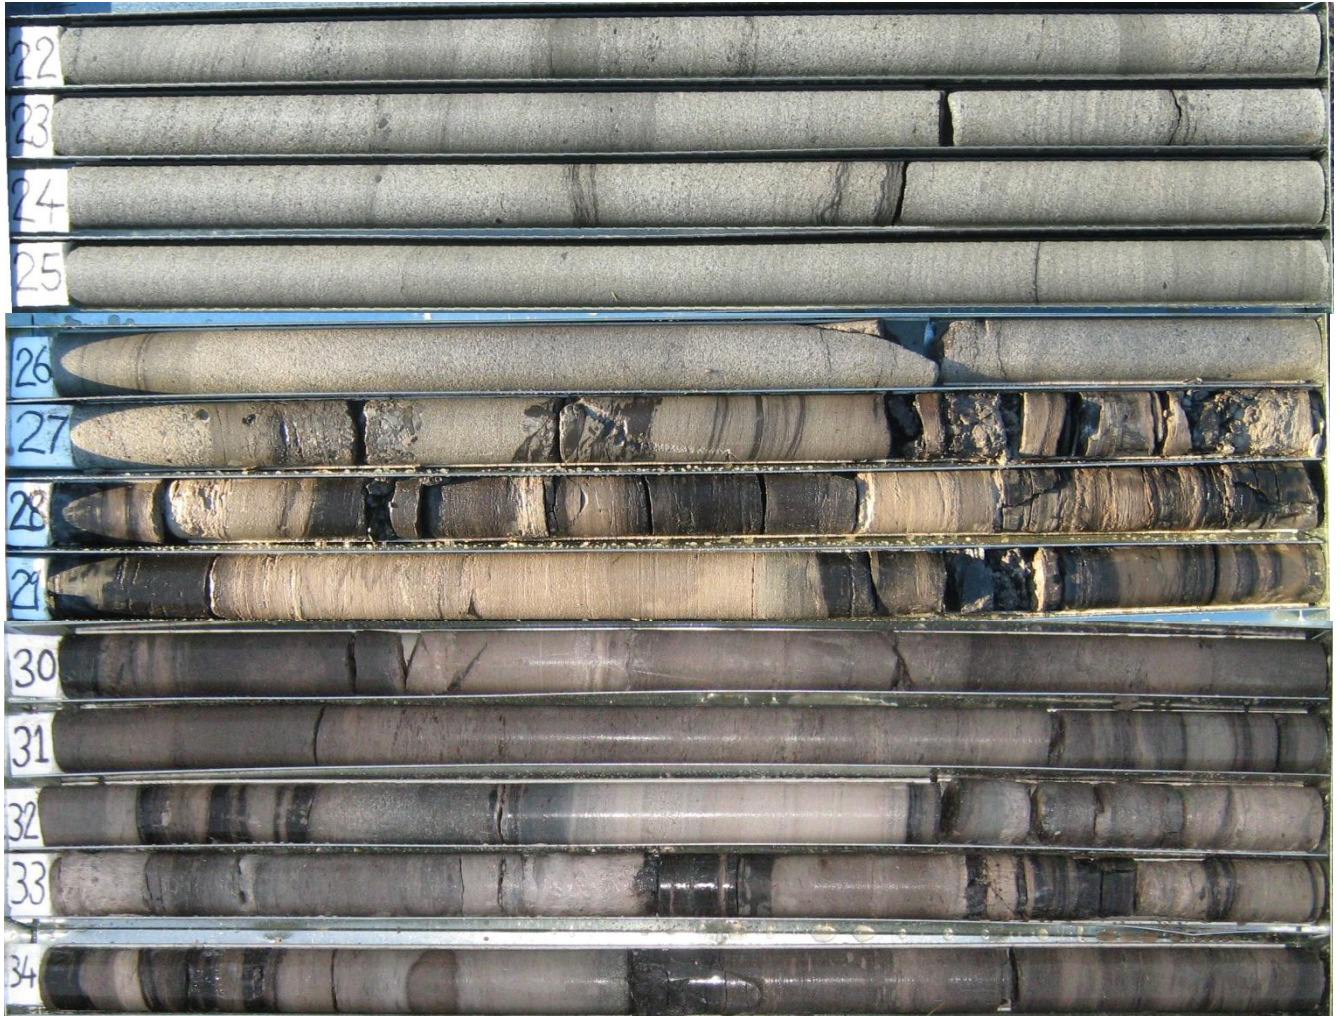
REPORT OF CORE PHOTOGRAPHS: CRR 212

DEPTH RANGE: 22.0-35.2 m
DRILL RIG: Fox B40
DRILLER: Schneider Drilling Pty Ltd
LOGGED: RCD DATE: 26/08/10
CHECKED: NK DATE: 4/10/10
