ENGINEERING BOREHOLE LOG

BOREHOLE No BH C22

PROJECT Bruce Highway Upgrade (Cooroy to Curra) Section C

LOCATION Cut 7 COORDINATES 472498.5 E; 7092563.0 N

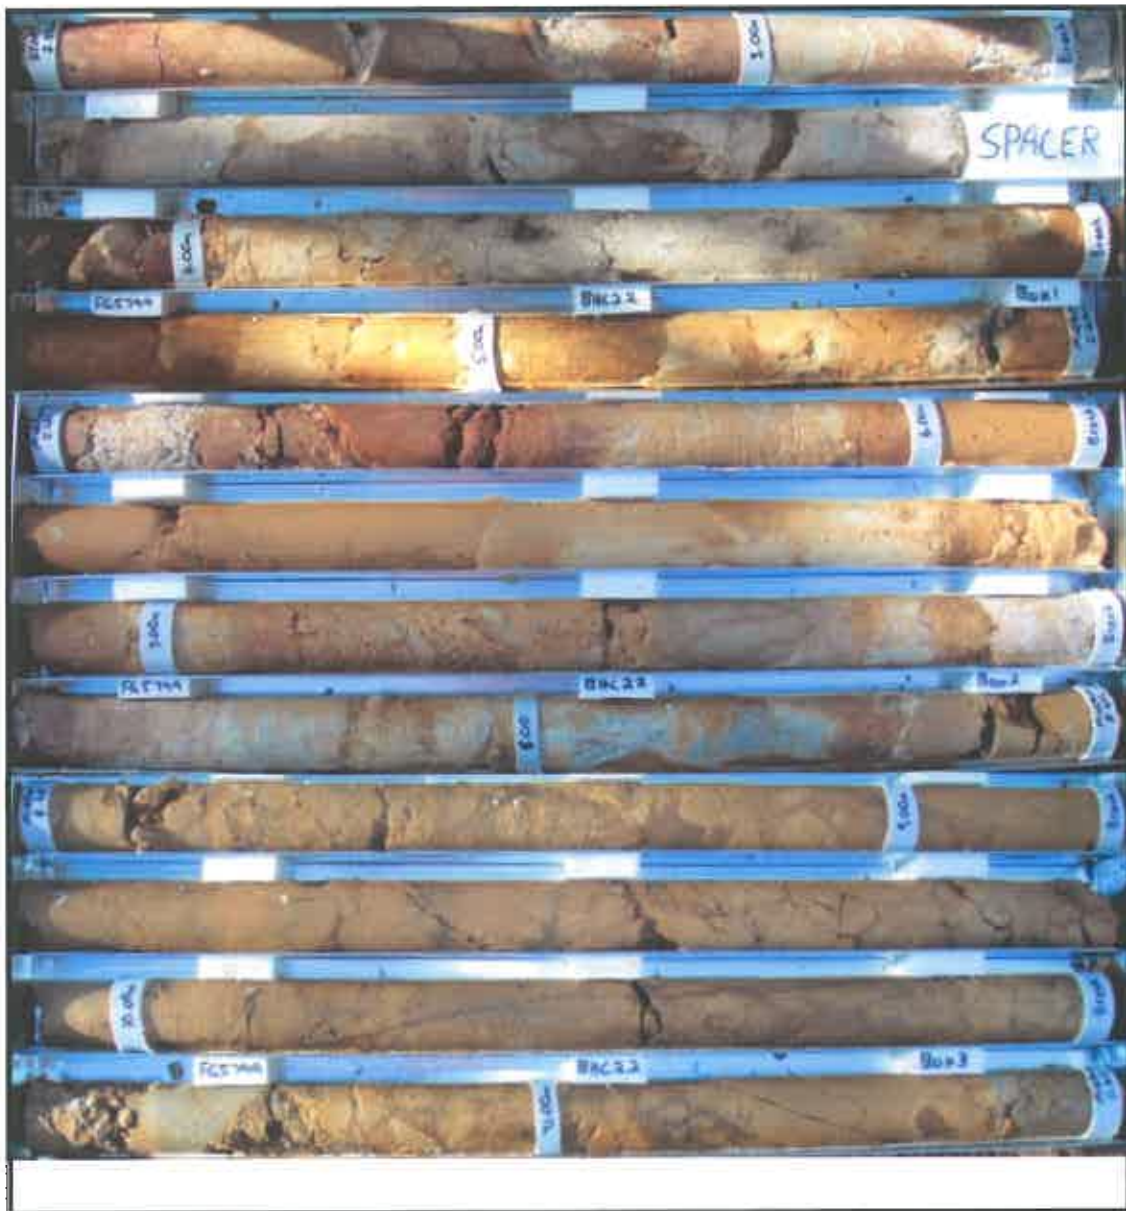
CORE PHOTO LOG - BH C22

Project Name:	BRUCE HIGHWAY UPGRADE - SECTION C		
Project No.:	FG5799	Date:	06/09/2011
Details:	Cut 7	Start Depth (m):	2.50
Reference No.:	H11115	Finish Depth (m):	15.50

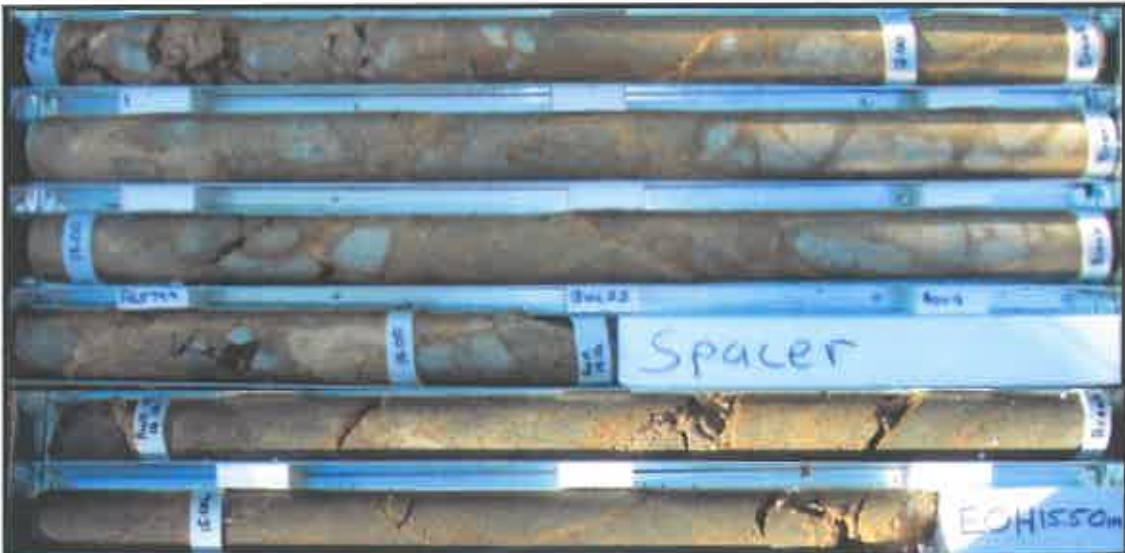
CORE PHOTO LOG - BH C22

Project Name:	BRUCE HIGHWAY UPGRADE - SECTION C		
Project No.:	FG5799	Date:	06/09/2011
Details:	Cut 7	Start Depth (m):	2.50
Reference No.:	H11115	Finish Depth (m):	15.50
