ENGINEERING BOREHOLE LOG

BOREHOLE No BH C19
SHEET 1 of 2
REFERENCE No H11112

PROJECT Bruce Highway Upgrade (Cooroy to Curra) Section C
LOCATION Cut 7 COORDINATES 472656.8 E; 7092308.6 N
PROJECT No FG5799 SURFACE R.L. 91.80m PLUNGE DATE STARTED 05/08/11 GRID DATUM MGA94
JOB No 232/10A/2 HEIGHT DATUM AHD BEARING DATE COMPLETED 05/08/11 DRILLER Cairns Drilling Contract

CORE PHOTO LOG - BH C19

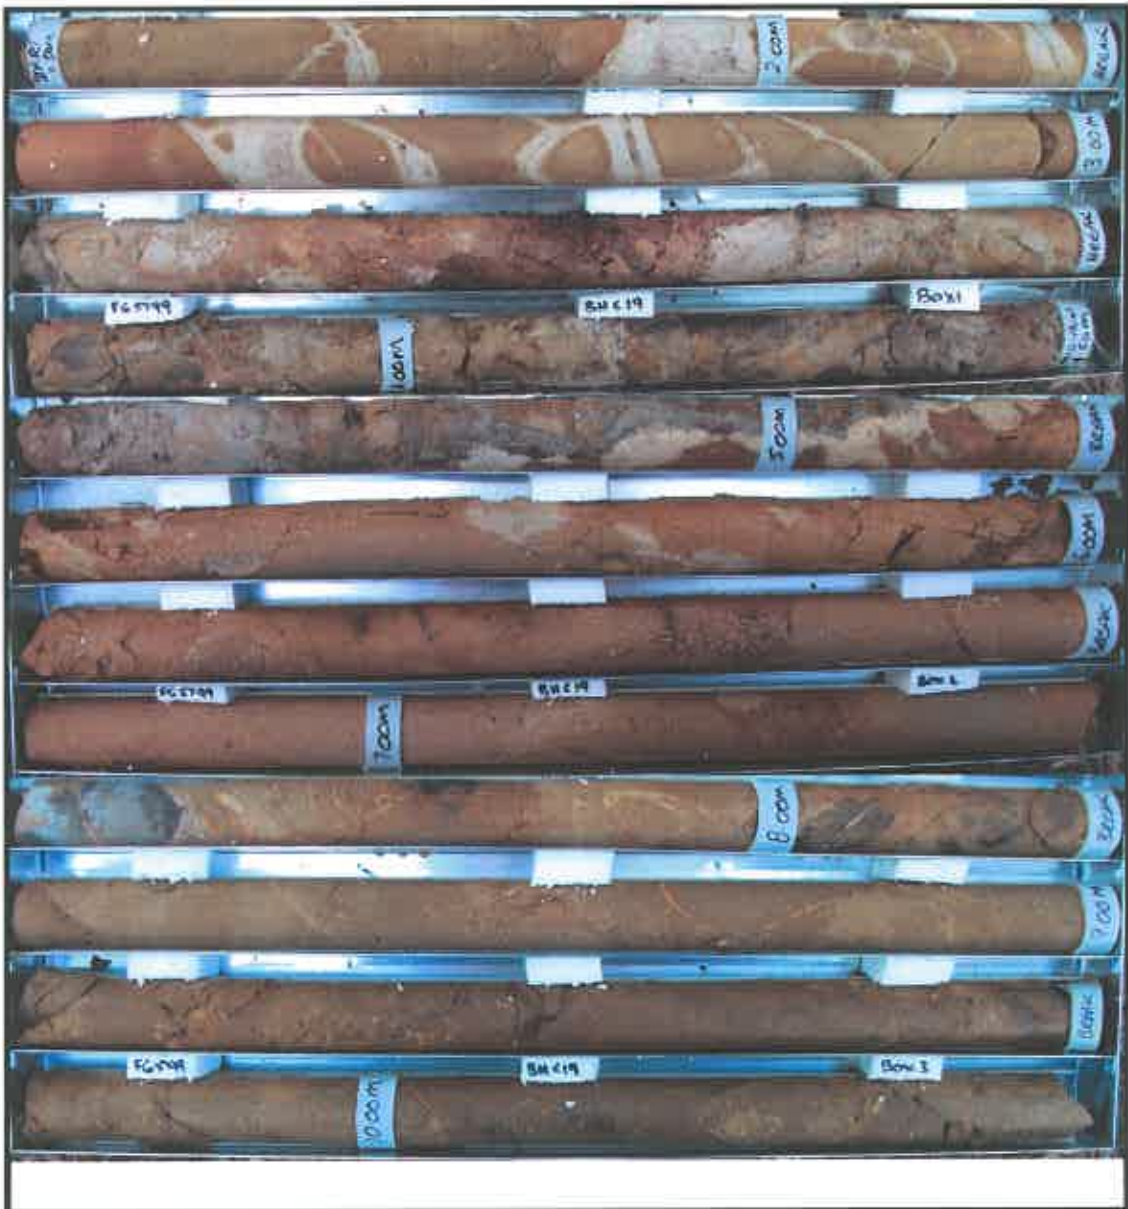
Project Name:	BRUCE HIGHWAY UPGRADE - SECTION C		
Project No.:	FG5799	Date:	06/09/2011
Details:	Cut 7	Start Depth (m):	1.50
Reference No.:	H11112	Finish Depth (m):	12.07

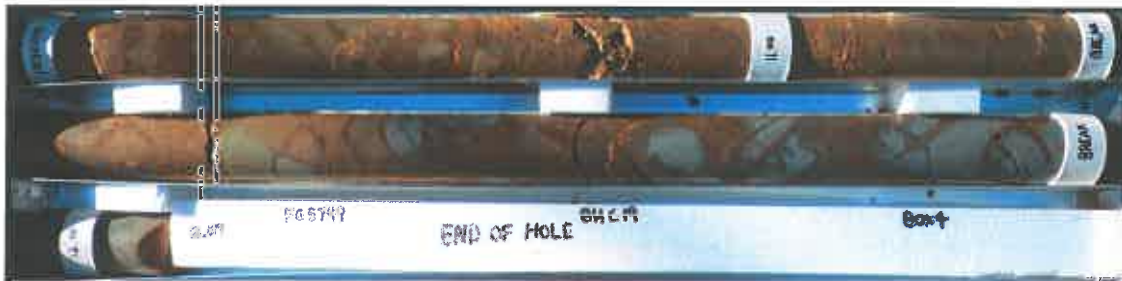
CORE PHOTO LOG - BH C19

Project Name:	BRUCE HIGHWAY UPGRADE - SECTION C		
Project No.:	FG5799	Date:	06/09/2011
Details:	Cut 7	Start Depth (m):	1.50
Reference No.:	H11112	Finish Depth (m):	12.07

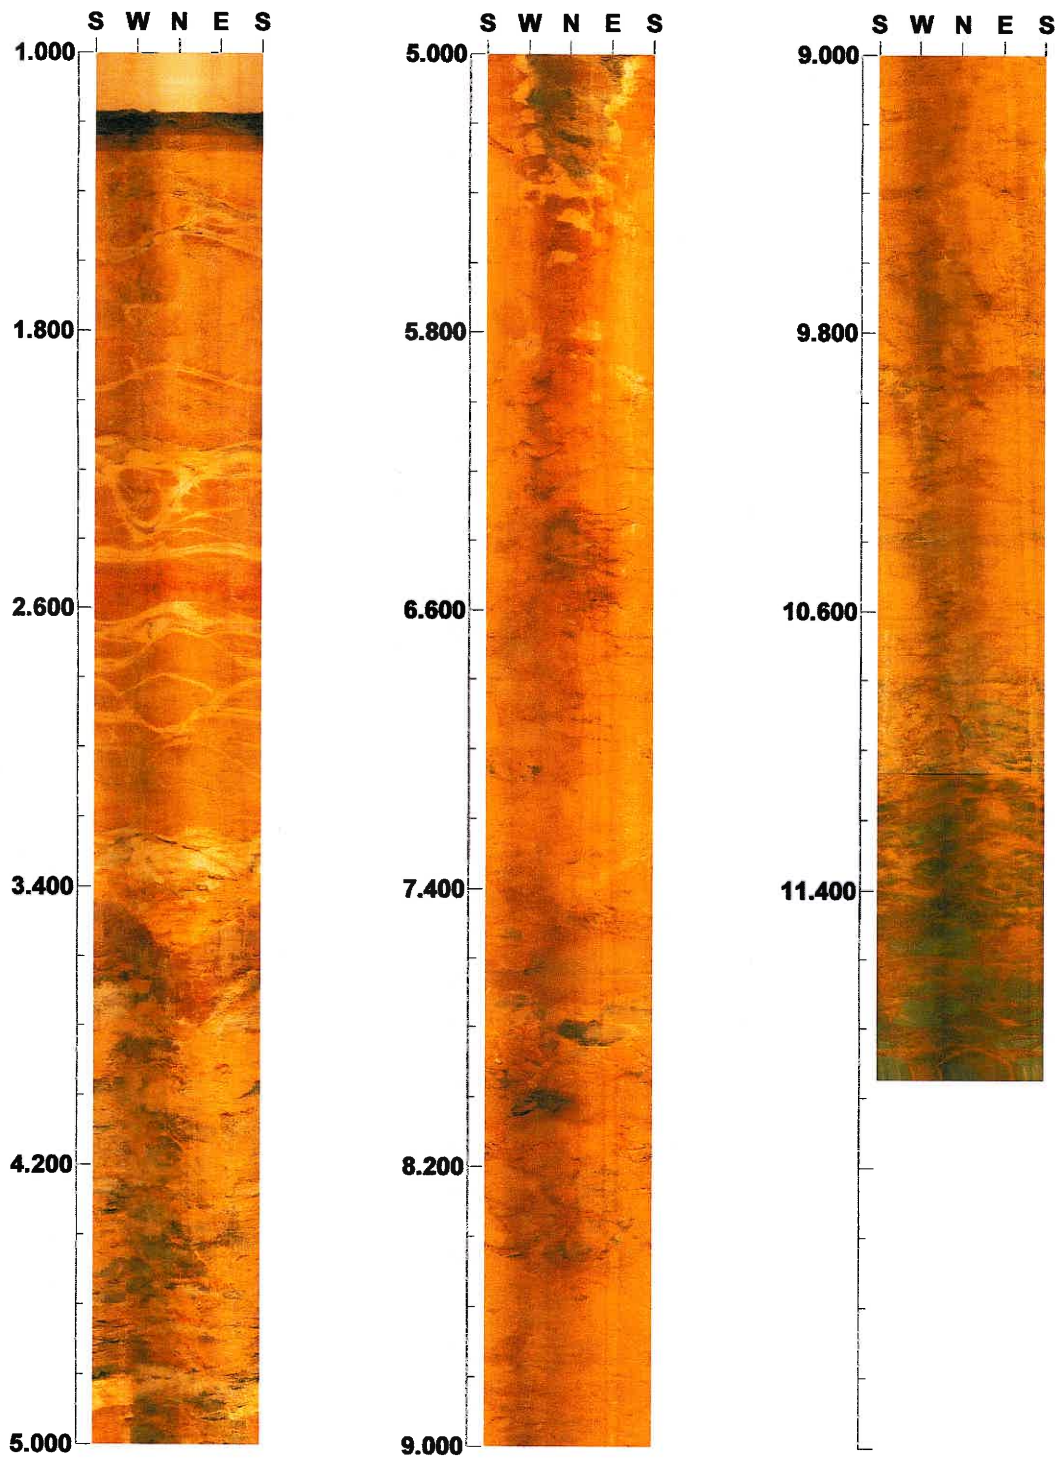
Bore hole No.: C-19

Depth range: 1.000 - 11.947 m

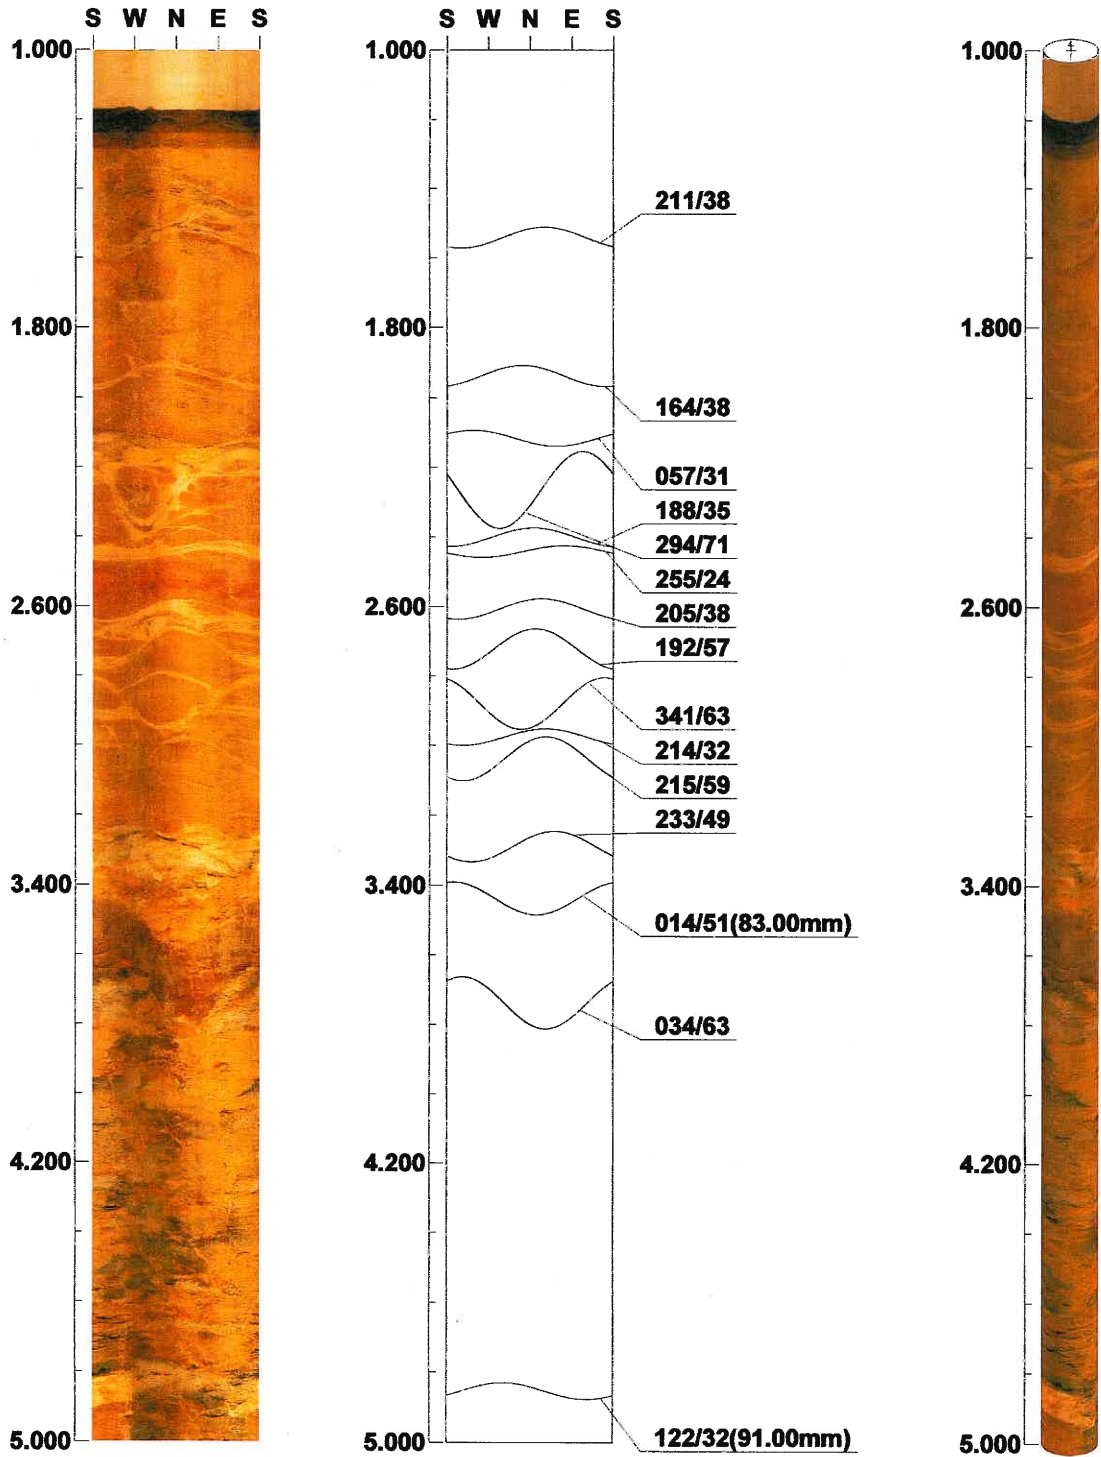
Project name: BRUCE HIGHWAY UPGRADE SECTION C
Bore hole No.: C-19

Depth range: 1.000 - 5.000 m

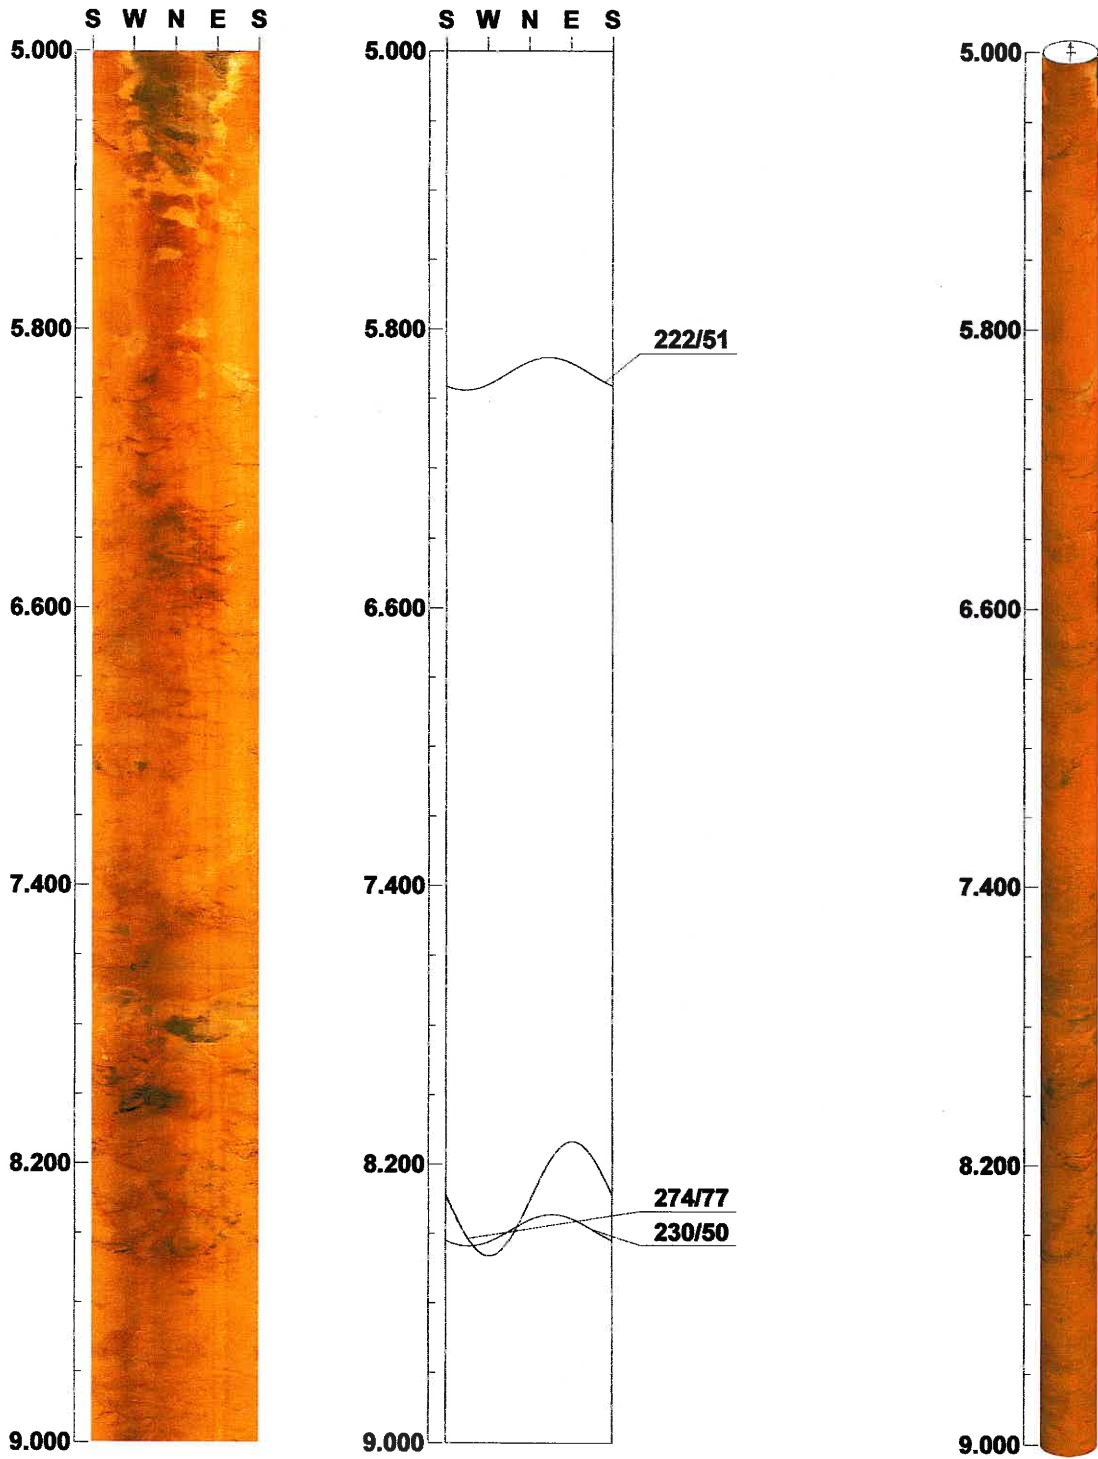
Bore hole No.: C-19

Depth range: 5.000 - 9.000 m

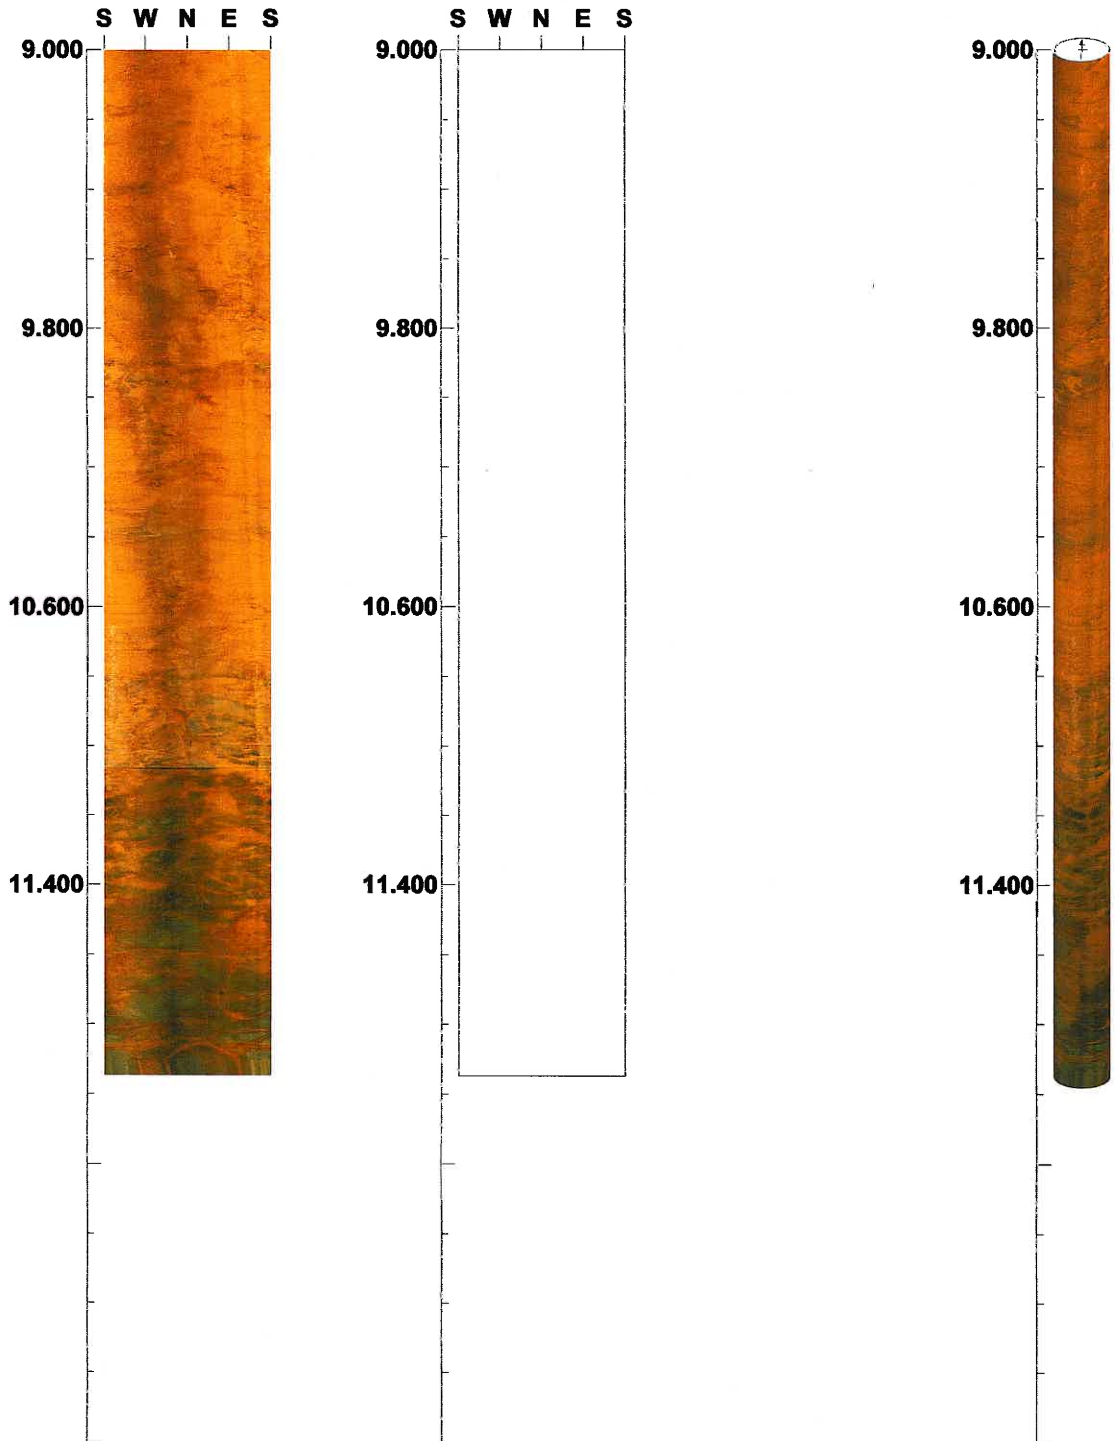
Bore hole No.: C-19

Depth range: 9.000 - 11.947 m

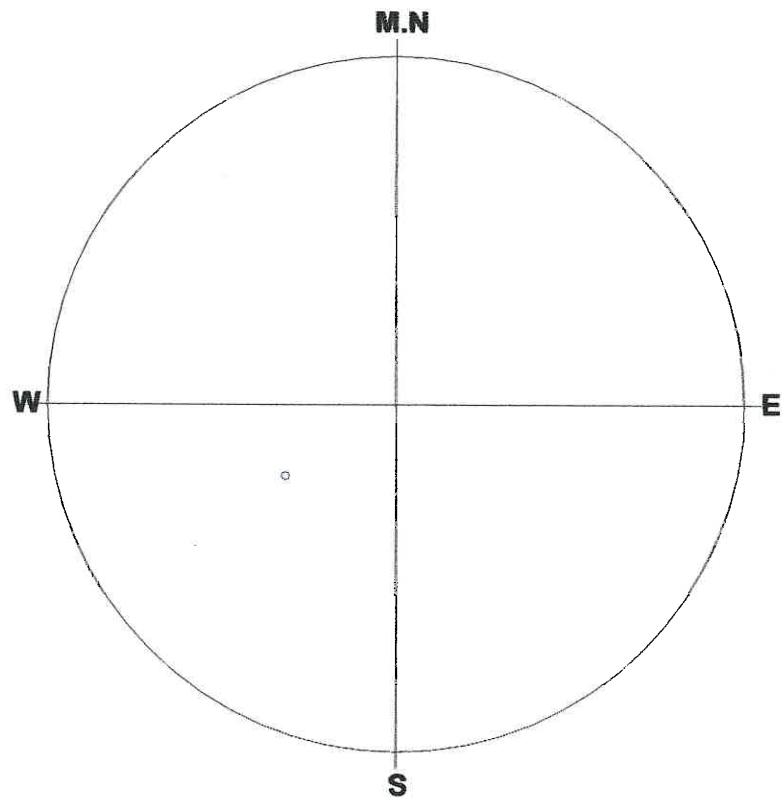
C-19.STR
<<FOLIATION>>

Number of Data : 1/18

Depth : 1.542 - 8.390 m

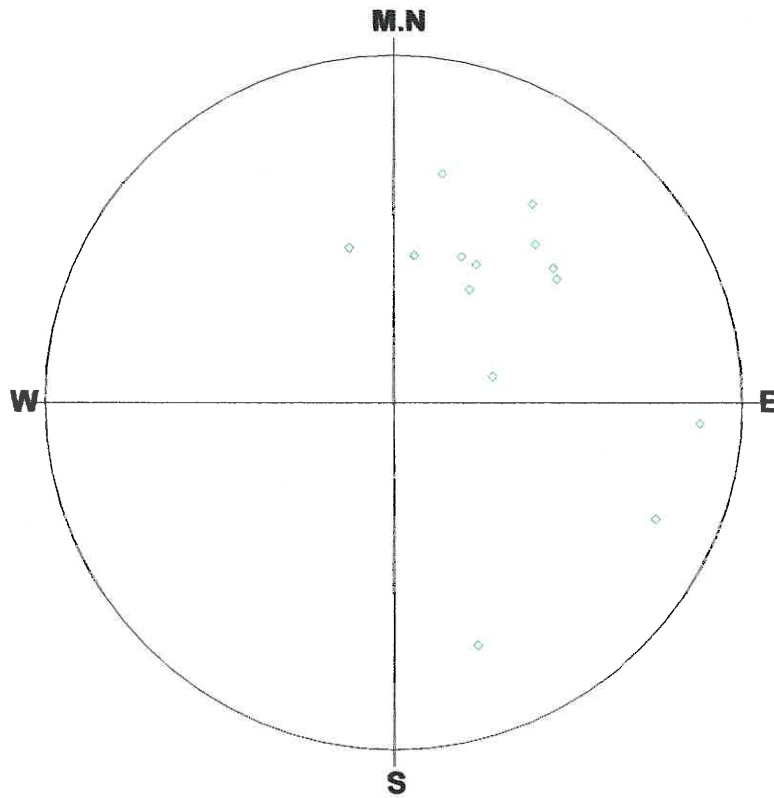
C-19.STR
<<JOINT>>

Number of Data : 14/18

Depth : 1.542 - 8.390 m

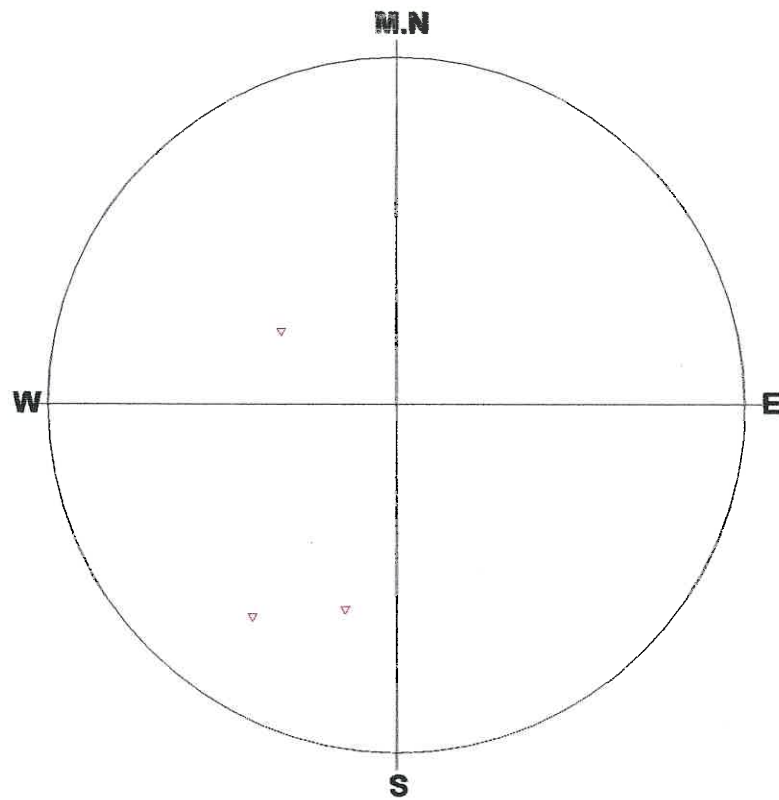
C-19.STR
<<SHEAR ZONE>>

Number of Data : 3/18

Depth : 1.542 - 8.390 m

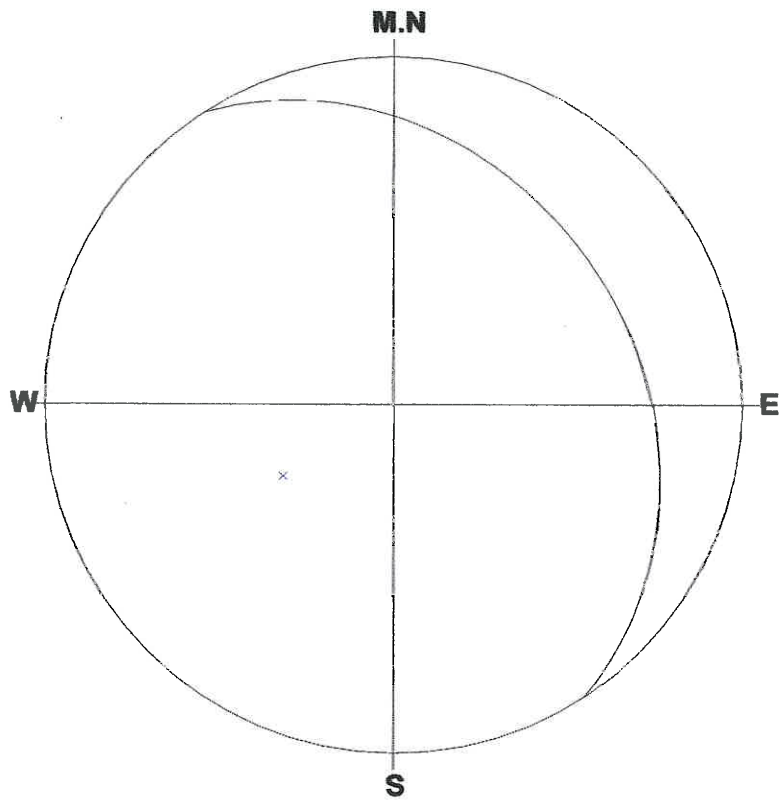
C-19.STR
<<FOLIATION>>

Number of Data:1/18

1 : 057/31(3)

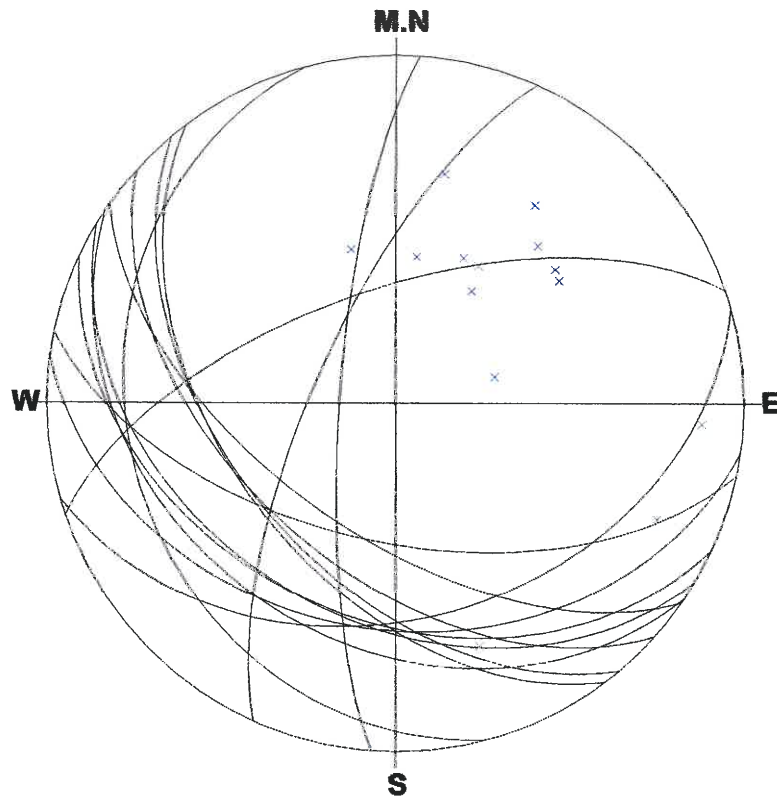
C-19.STR
<<JOINT>>

Number of Data:14/18

| 1 : 211/38(1) | 6 : 205/38(7) |
| 2 : 164/38(2) | 7 : 192/57(8) |
| 3 : 294/71(4) | 8 : 341/63(9) |
| 4 : 188/35(5) | 9 : 214/32(10) |
| 5 : 255/24(6) | 10 : 215/59(11) |

No.	Depth (m)	Dir/Dip	Sort	Aperture (mm)	Form	Condition	Remark
1	1.542	211/38	Joint	1.0	Planar	Brec/crus'd	Open/loose
2	1.938	164/38	Joint	0.5	Planar	Smooth	Open
3	2.116	057/31	Foliation	0.0	Planar	Smooth	Tight
4	2.264	294/71	Joint	1.0	Planar	Smooth	Open
5	2.400	188/35	Joint	0.3	Planar	Smooth	Open
6	2.441	255/24	Joint	0.5	Planar	Smooth	Open
7	2.606	205/38	Joint	0.3	Planar	Smooth	Tight
8	2.722	192/57	Joint	0.3	Planar	Smooth	Open
9	2.879	341/63	Joint	0.5	Planar	Smooth	Open
10	2.976	214/32	Joint	0.5	Planar	Smooth	Open
11	3.038	215/59	Joint	0.3	Planar	Smooth	Open
12	3.289	233/49	Joint	0.5	Planar	Smooth	Open
13	3.437	014/51	ShearZone	83.0	Planar	Weathered	Open/loose
14	3.737	034/63	ShearZone	28.0	Planar	Weathered	Open
15	4.853	122/32	ShearZone	91.0	Planar	Brec/crus'd	Open/loose
16	5.929	222/51	Joint	0.5	Planar	Rough	Open
17	8.299	274/77	Joint	0.5	Planar	Rough	Open
18	8.390	230/50	Joint	0.5	Planar	Smooth	Open

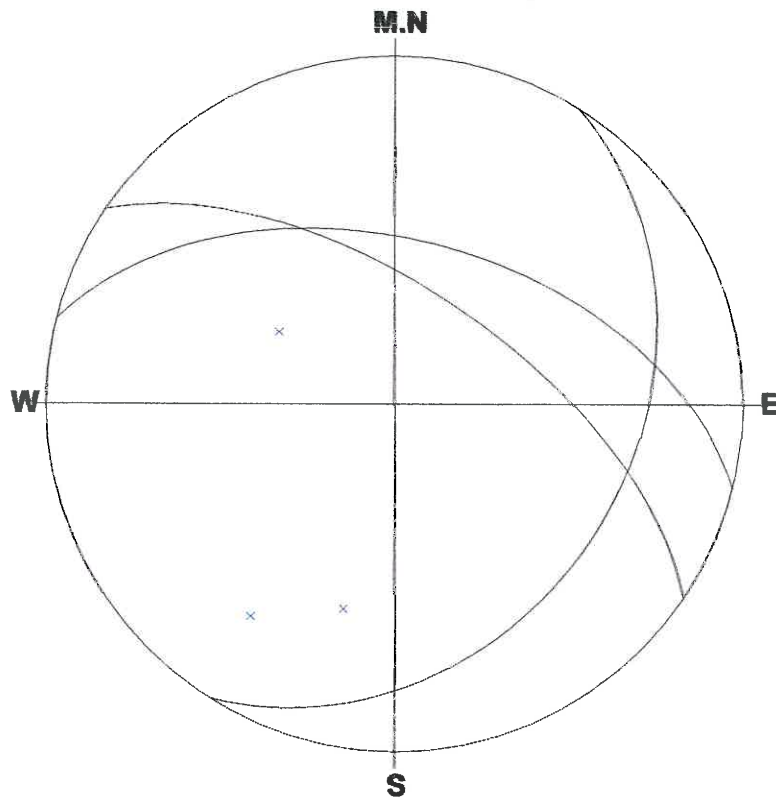
C-19.STR
<<SHEAR ZONE>>

Number of Data:3/18

1 : 014/51(13)

2 : 034/63(14)

3 : 122/32(15)

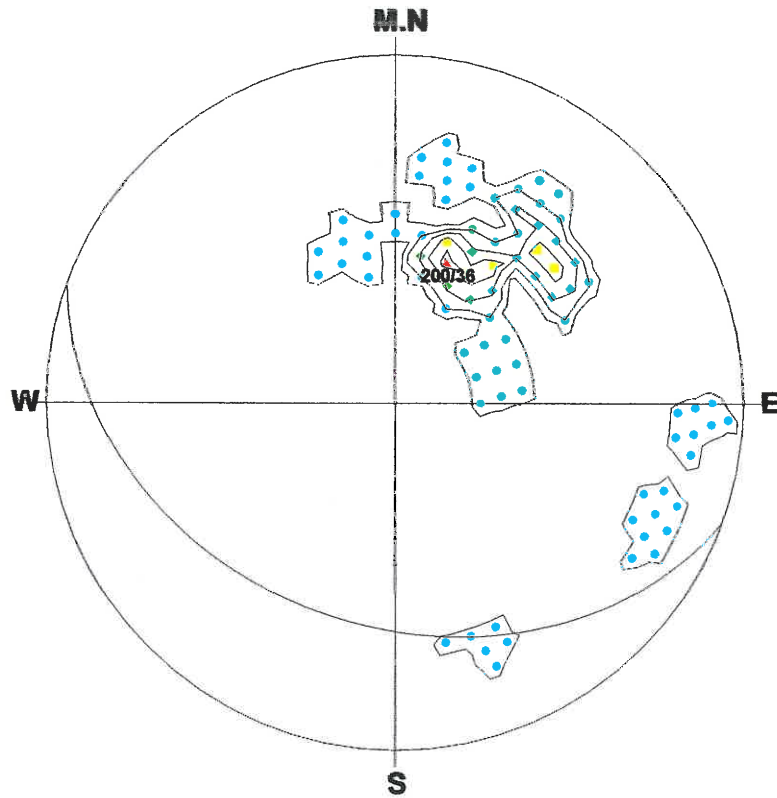
C-19.STR

***** % Diagram *****

Number of Data : 14

- ▲ : 28
- ▼ : 22 - 28
- : 17 - 22
- ◆ : 11 - 17
- : 5 - 11
- ⊕ : 0 - 5

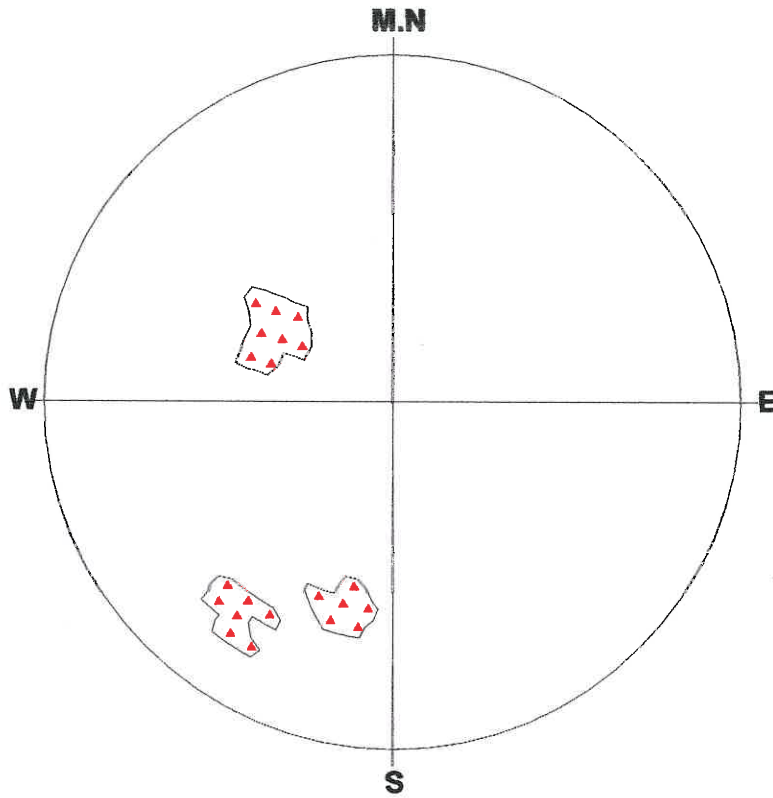
C-19.STR

******* % Diagram *******

Number of Data : 3

- ▲ : 33**
- ▼ : 26 - 33**
- : 20 - 26**
- ◆ : 13 - 20**
- : 6 - 13**
- ⊕ : 0 - 6**

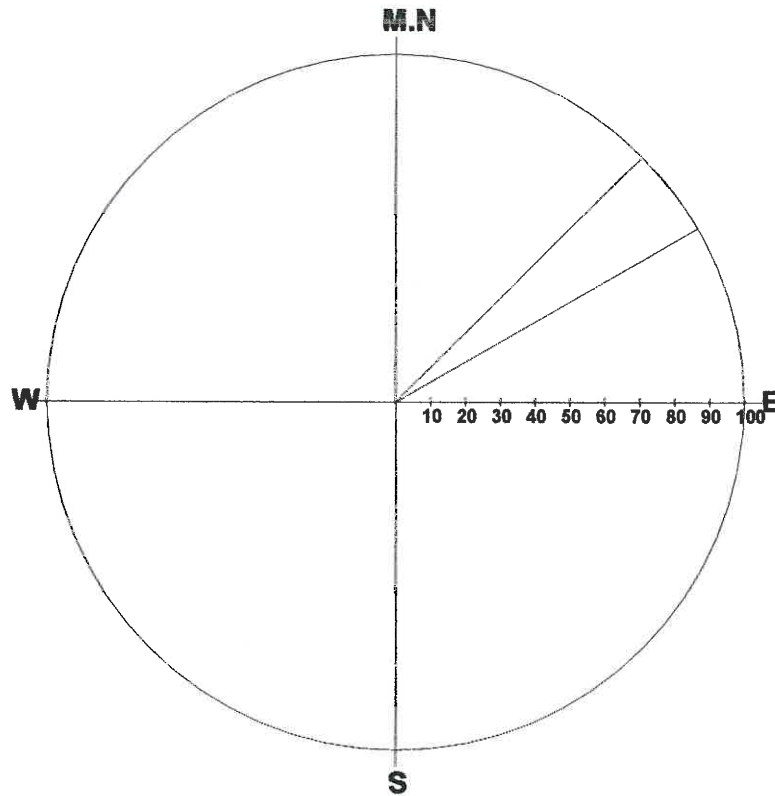
C-19.STR
<<FOLIATION>>

Number of Data : 1/18

Max : 100.0%

Dir	%	Dir	%	Dir	%
0-	0	135-	0	270-	0
15-	0	150-	0	285-	0
30-	0	165-	0	300-	0
45-	100	180-	0	315-	0
60-	0	195-	0	330-	0
75-	0	210-	0	345-	0
90-	0	225-	0		
105-	0	240-	0		
120-	0	255-	0

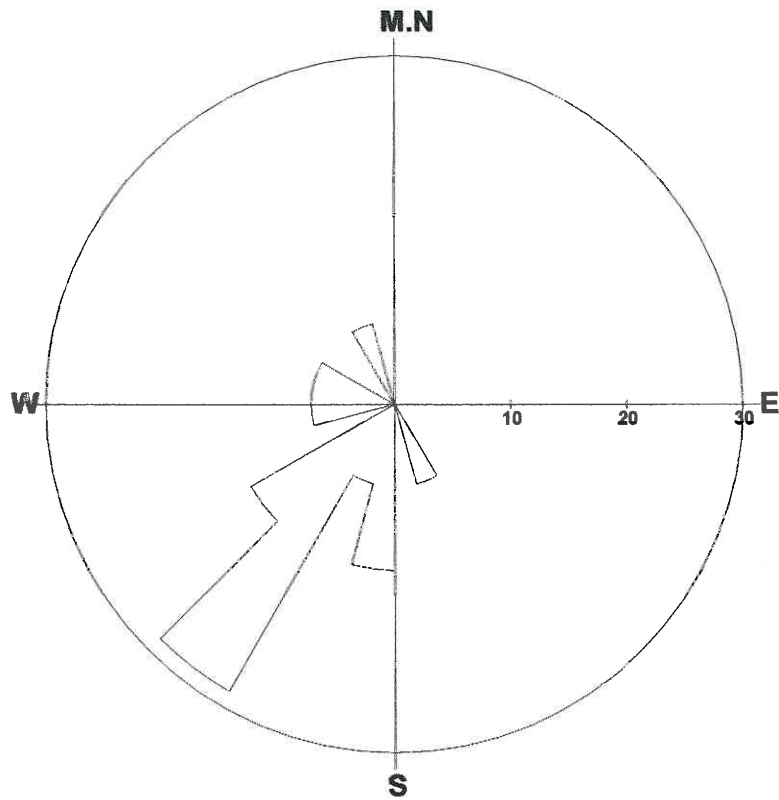
C-19.STR
<<JOINT>>

Number of Data : 14/18

Max : 28.6%

Dir	%	Dir	%	Dir	%
0-	0	135-	0	270-	7
15-	0	150-	7	285-	7
30-	0	165-	0	300-	0
45-	0	180-	14	315-	0
60-	0	195-	7	330-	7
75-	0	210-	29	345-	0
90-	0	225-	14		
105-	0	240-	0		
120-	0	255-	7

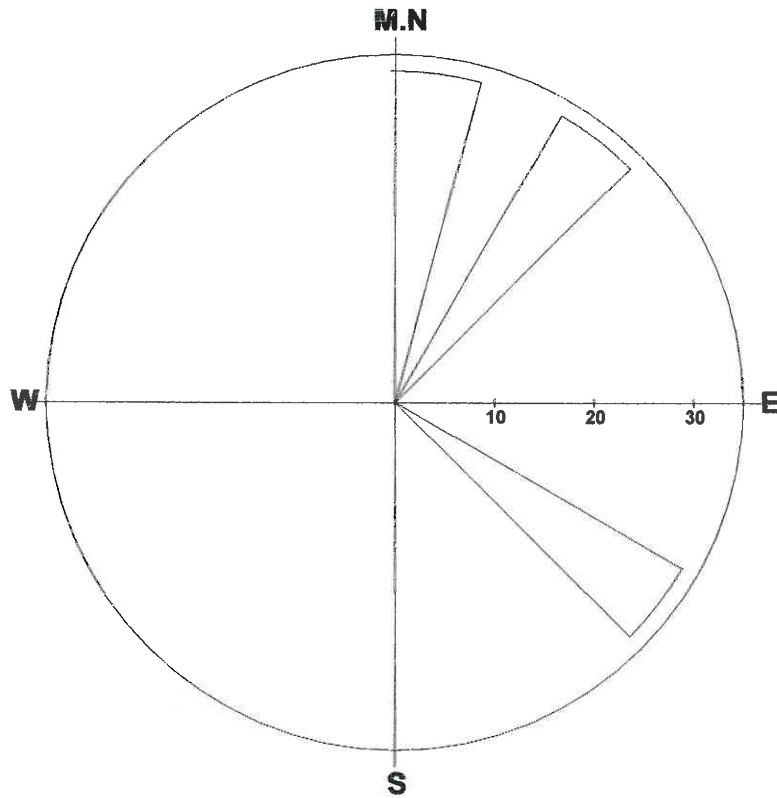
C-19.STR
<<SHEAR ZONE>>

Number of Data : 3/18

Max : 33.3%

Dir	%	Dir	%	Dir	%
0-	33	135-	0	270-	0
15-	0	150-	0	285-	0
30-	33	165-	0	300-	0
45-	0	180-	0	315-	0
60-	0	195-	0	330-	0
75-	0	210-	0	345-	0
90-	0	225-	0		
105-	0	240-	0		
120-	33	255-	0

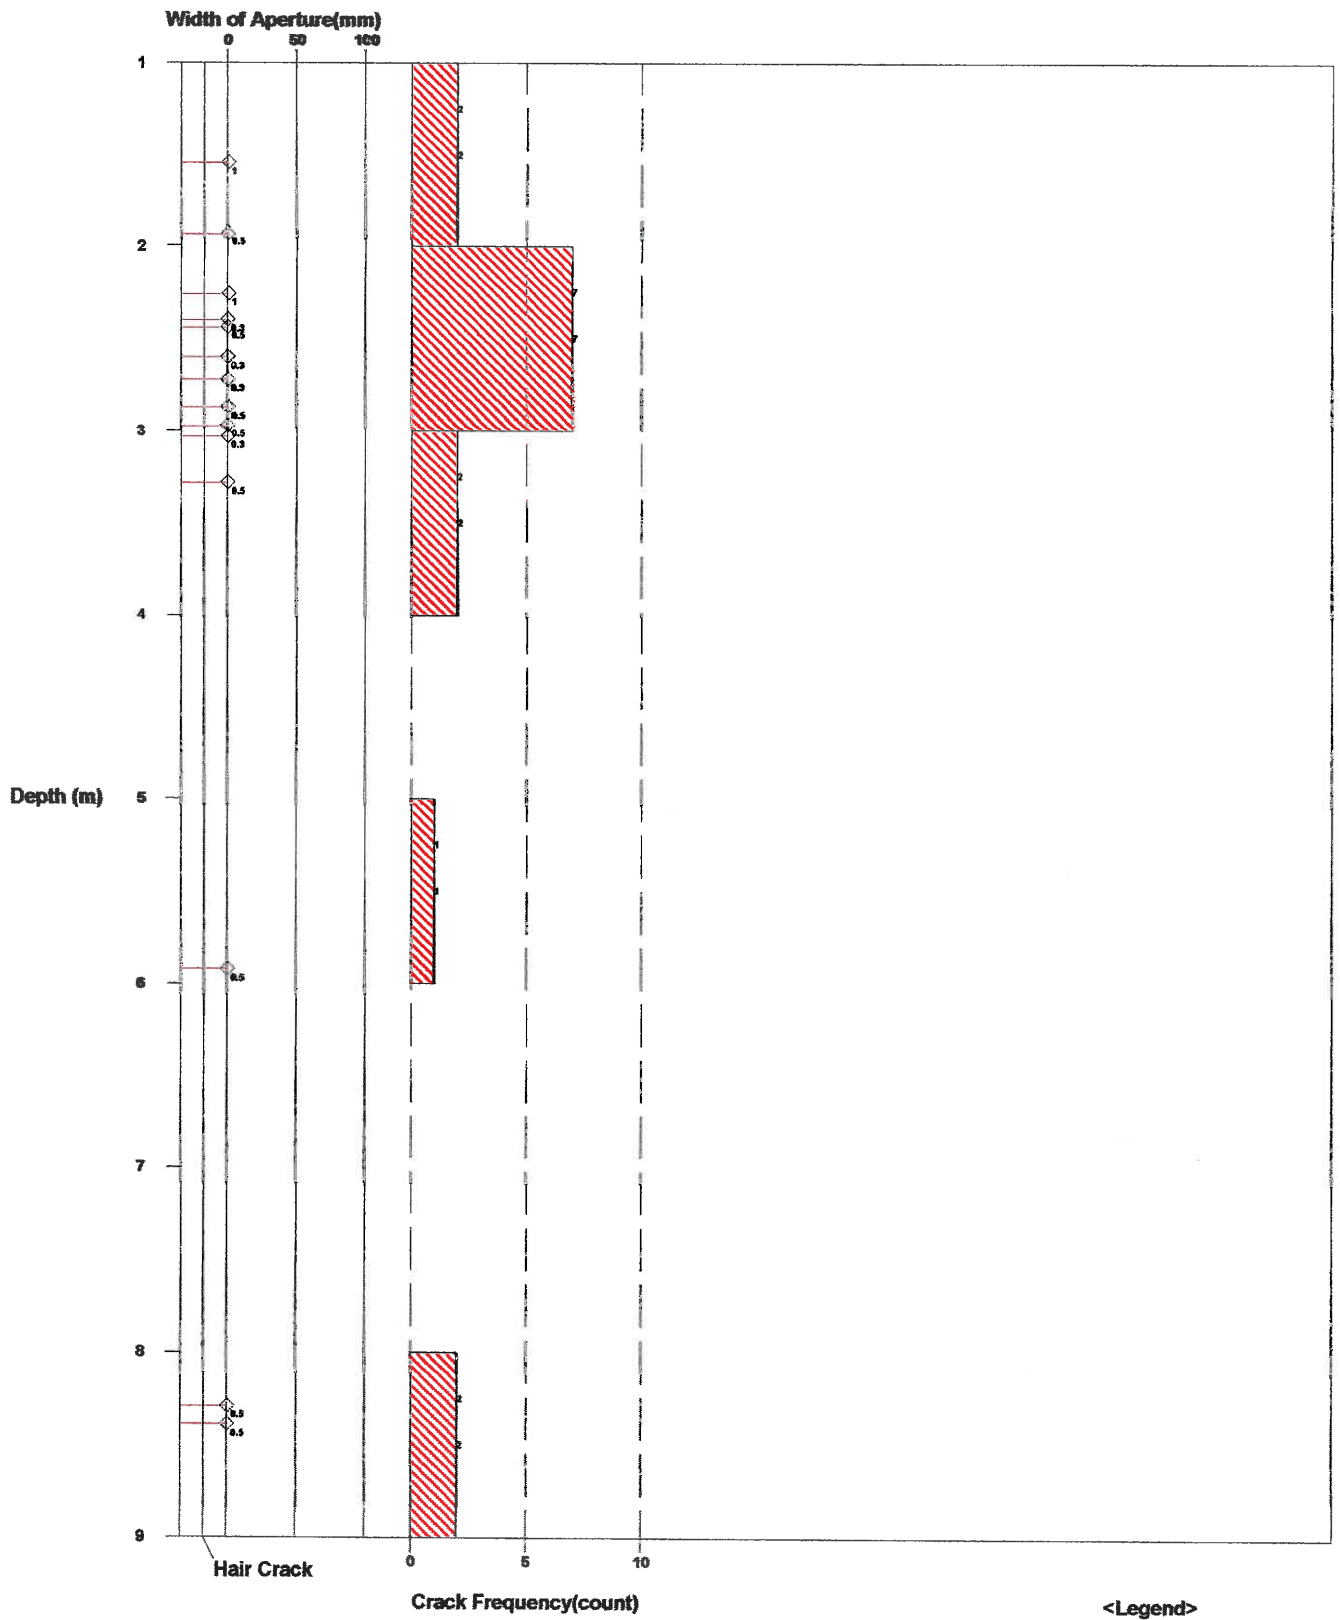
Fig. Rock Mass Condition Graph

Title: C-19.STR
 Comment: JOINT
 Depth: 1.542 - 8.390 m
 Aperture: 0.0 - 91.0 mm

2011/ 8/ 31
 Elevation: 0.000m
 Water Level: 11.060m

- All Crack Frequency
- Open Crack Frequency
- Water Level

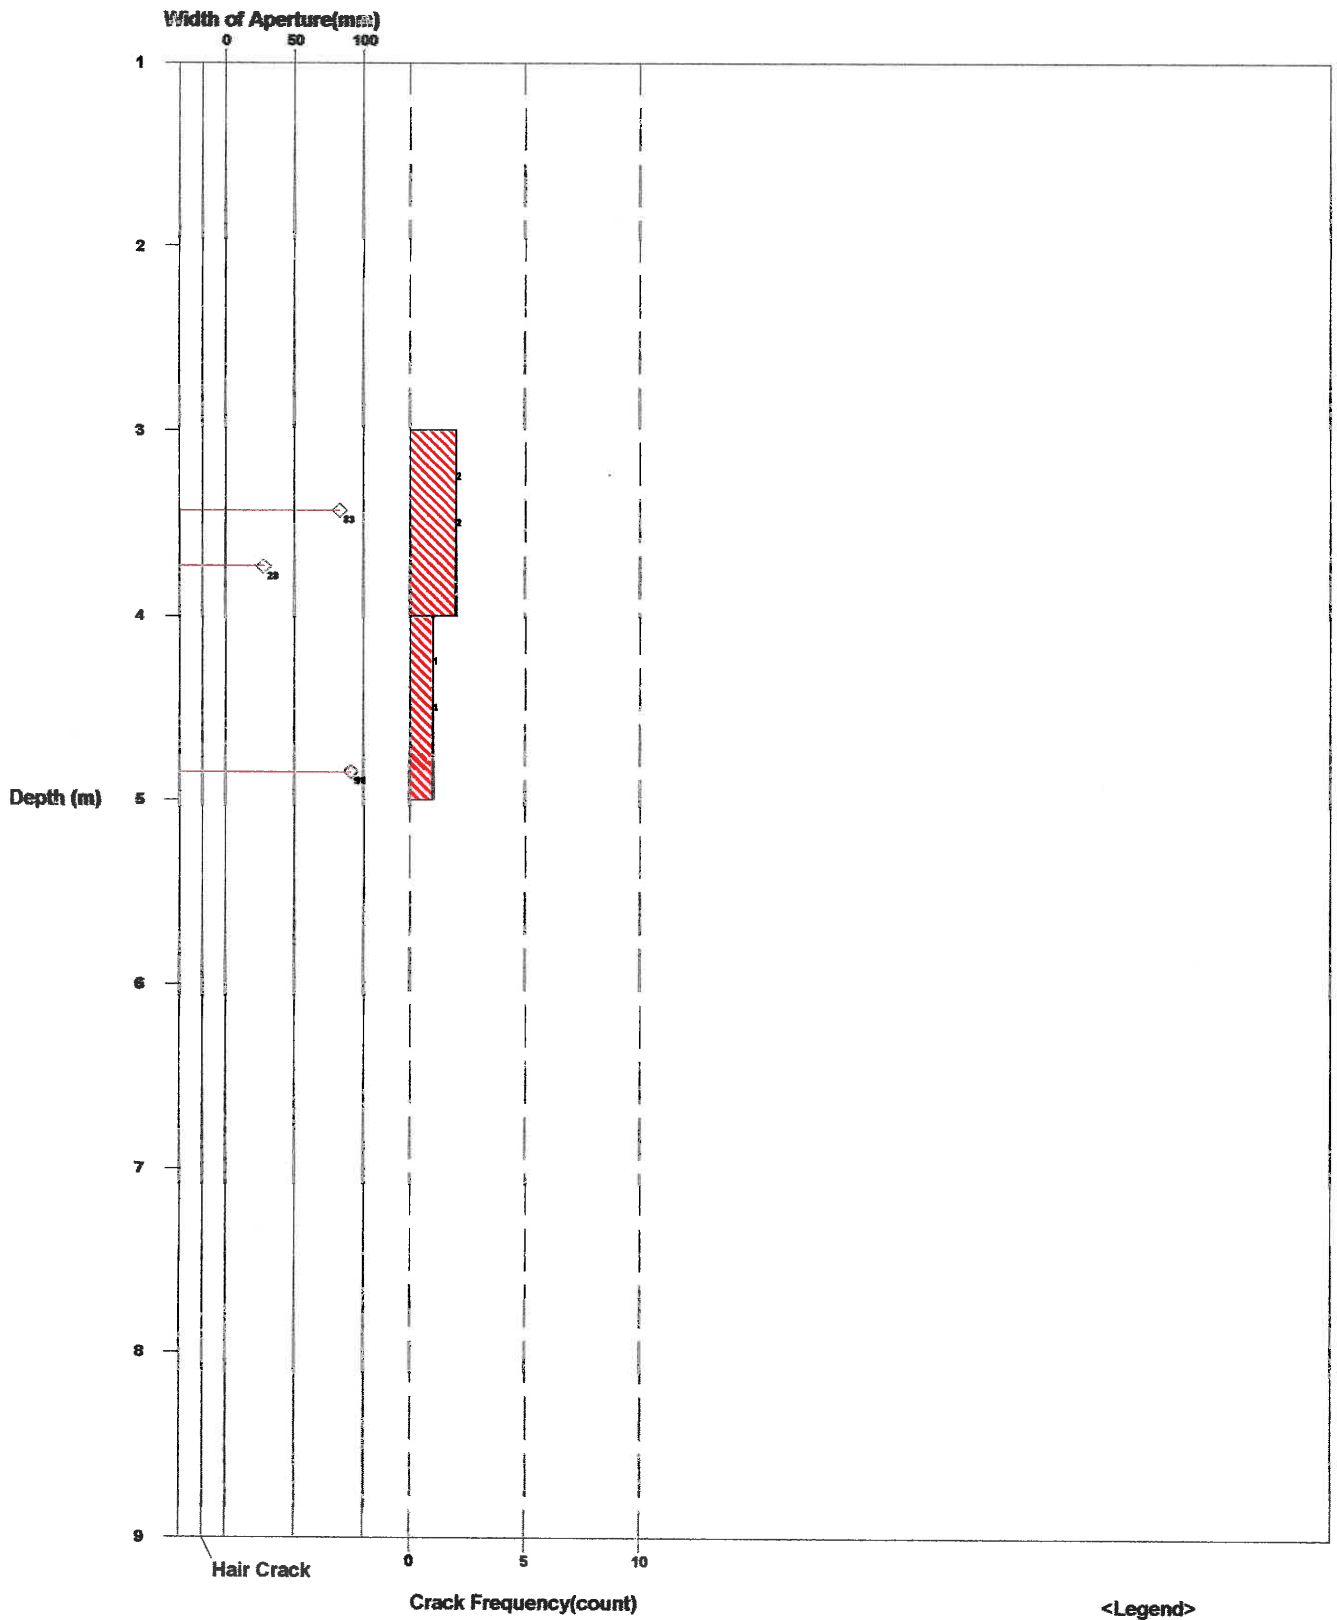
Fig. Rock Mass Condition Graph

Title: C-19.STR
 Comment: SHEAR ZONE
 Depth: 1.542 - 8.390 m
 Aperture: 0.0 - 91.0 mm

2011/ 8/ 31
 Elevation: 0.000m
 Water Level: 11.060m

- All Crack Frequency
- Open Crack Frequency
- Water Level

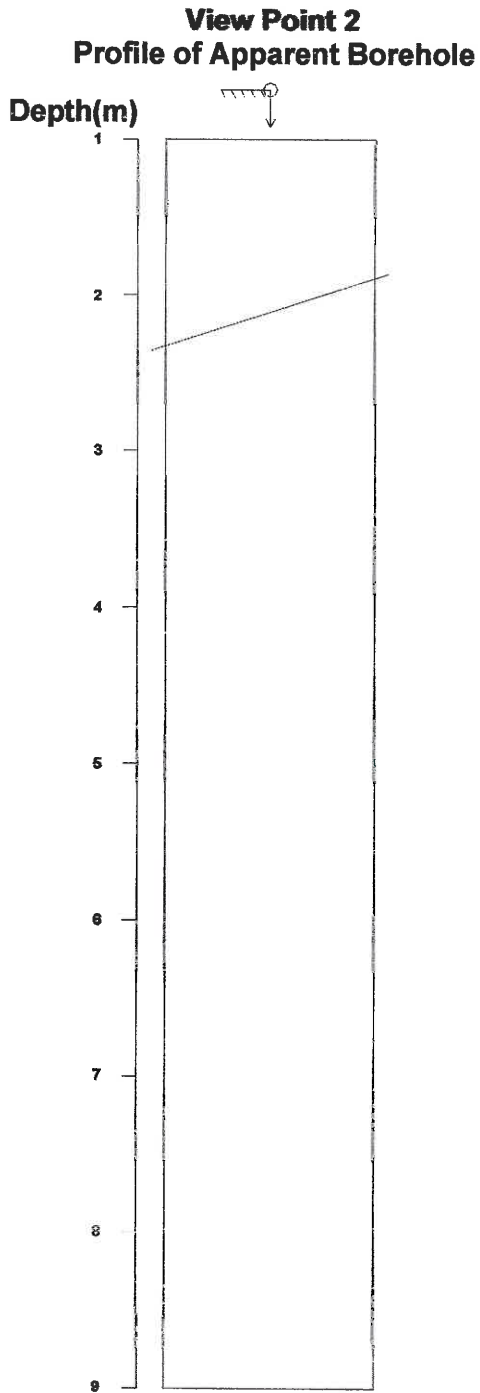
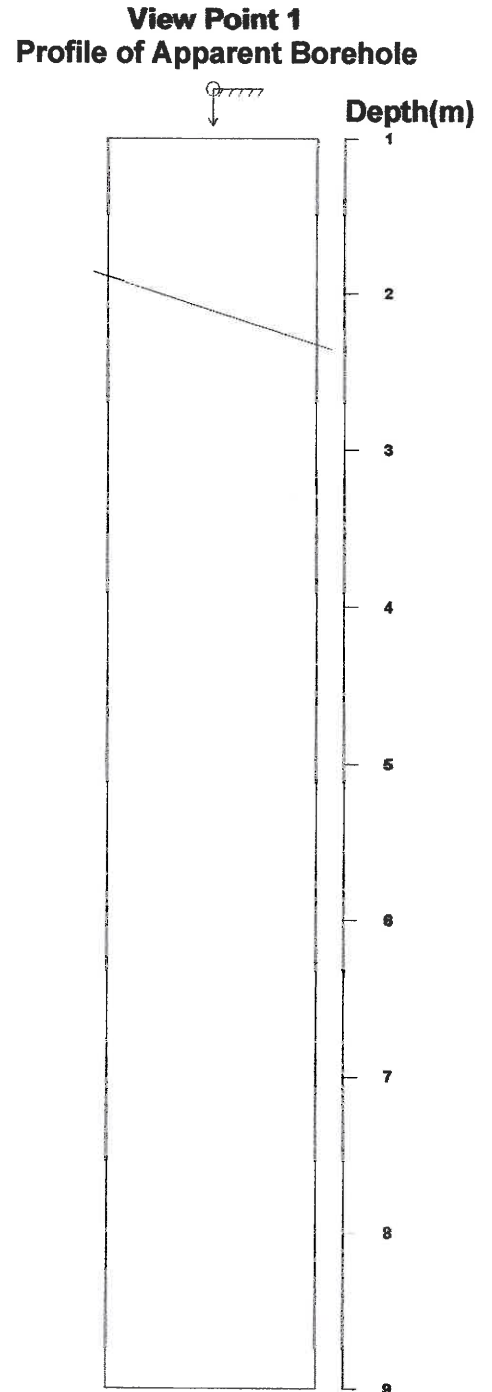
Fig. Apparent Dip

Title: C-19.STR
 Comment: FOLIATION
 Depth: 1.542 - 8.390 m
 Aperture: 0.0 - 91.0 mm

Direction: 0 deg
 Inclination: Vertical(Down)

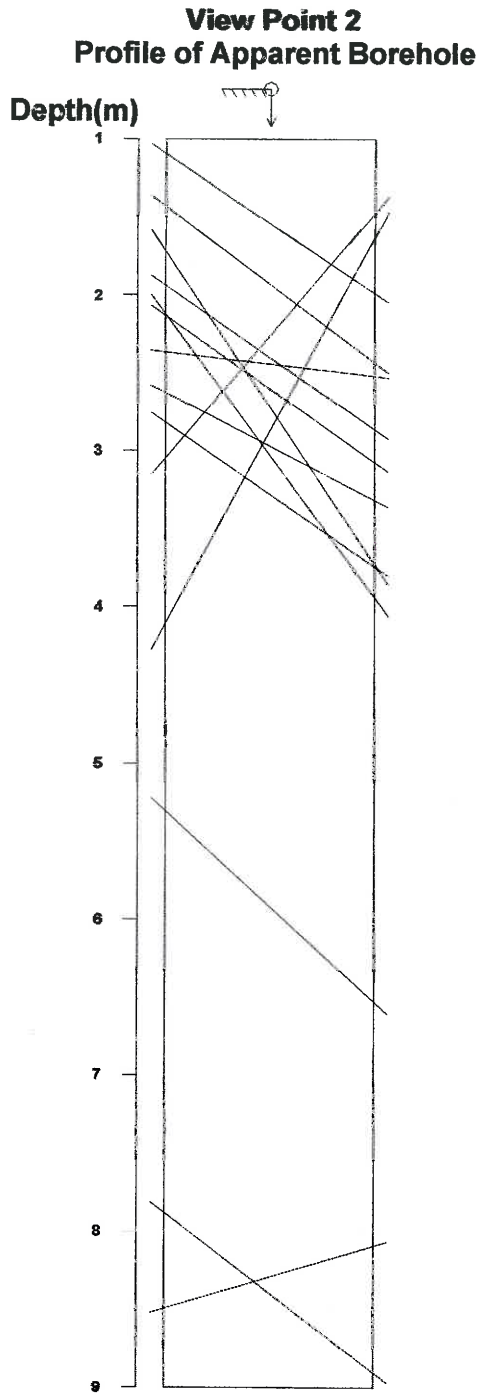
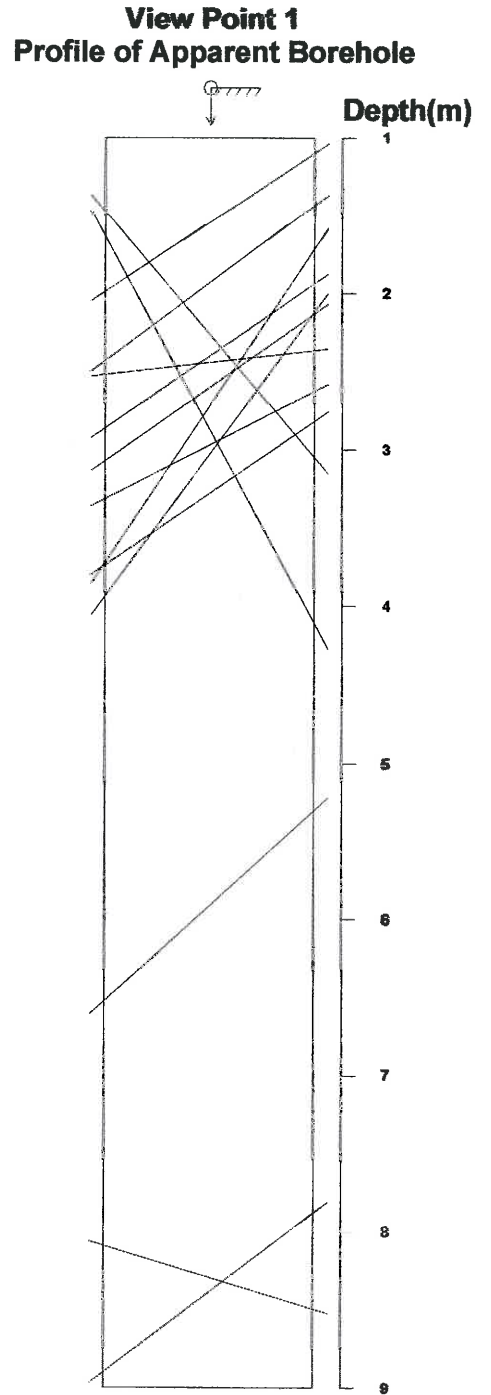
Fig. Apparent Dip

Title: C-19.STR
 Comment: JOINT
 Depth: 1.542 - 8.390 m
 Aperture: 0.0 - 91.0 mm

Direction: 0 deg
 Inclination: Vertical(Down)
