ENGINEERING BOREHOLE LOG

BOREHOLE No BH C19
SHEET 1 of 2
REFERENCE No H11112

PROJECT Bruce Highway Upgrade (Cooroy to Curra) Section C
LOCATION Cut 7 COORDINATES 472656.8 E; 7092308.6 N
PROJECT No FG5799 SURFACE R.L. 91.80m PLUNGE DATE STARTED 05/08/11 GRID DATUM MGA94
JOB No 232/10A/2 HEIGHT DATUM AHD BEARING DATE COMPLETED 05/08/11 DRILLER Cairns Drilling Contract

CORE PHOTO LOG - BH C19

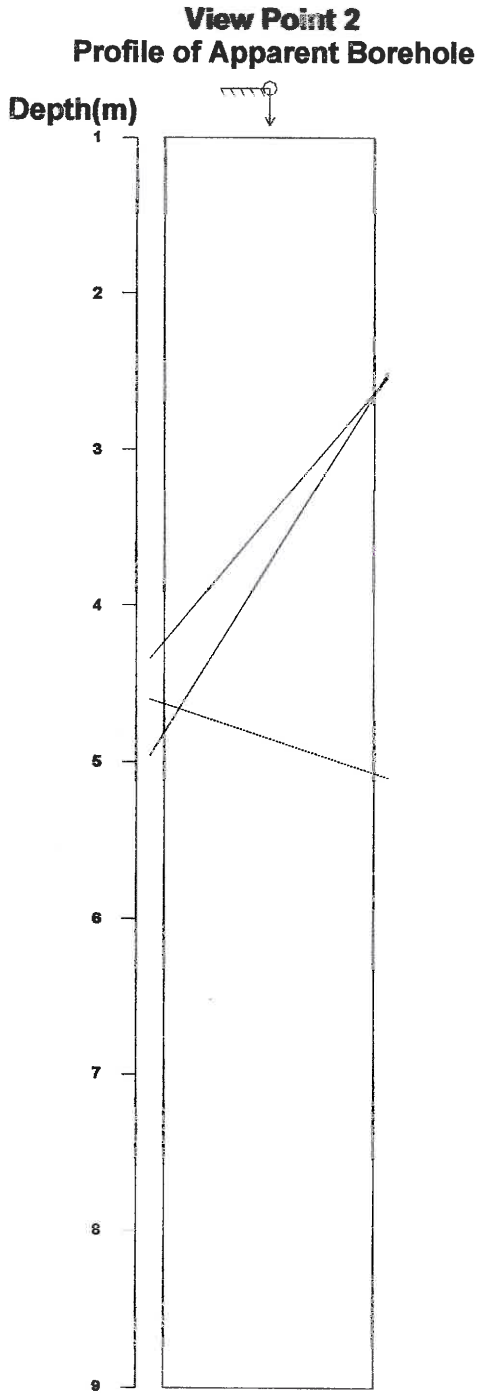
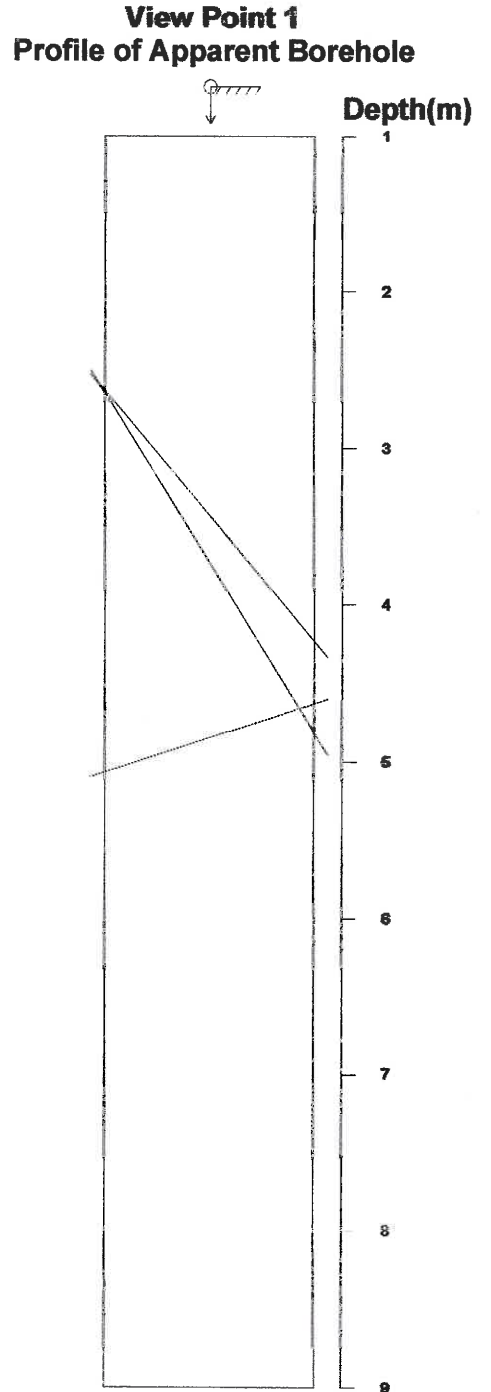
Fig. Apparent Dip

Title: C-19.STR
 Comment: SHEAR ZONE
 Depth: 1.542 - 8.390 m
 Aperture: 0.0 - 91.0 mm

Direction: 0 deg
 Inclination: Vertical(Down)
