TRANSPORT TECHNOLOGY DIVISION

GEOTECHNICAL LOG OF EXCAVATION											HOLE NO.: TP101			
CLIENT: METRO DISTRICT PROJECT: BRISBANE PORT ROAD – STAGE 3 LOCATION: NEAR GAS LINE EAST											SHEET: 1 OF 1			
											JOB NO: C60323			
											Co-ords: 46544E 34120N			
											RL: 6.337			
EXCAVATION					SUBSTANCE					TEST RESULTS And ADDITIONAL OBSERVATIONS				
DEPTH	METHOD	SUPPORT	FAST	MEDIUM	SLOW	WATER	LOGGRAPHIC	USC	DESCRIPTION Soil Type: grain size, plasticity, colour structure, minor components.	MOISTURE	CONSISTENCY	DENSITY	SAMPLES	Eg: Structure / Origin Test Results

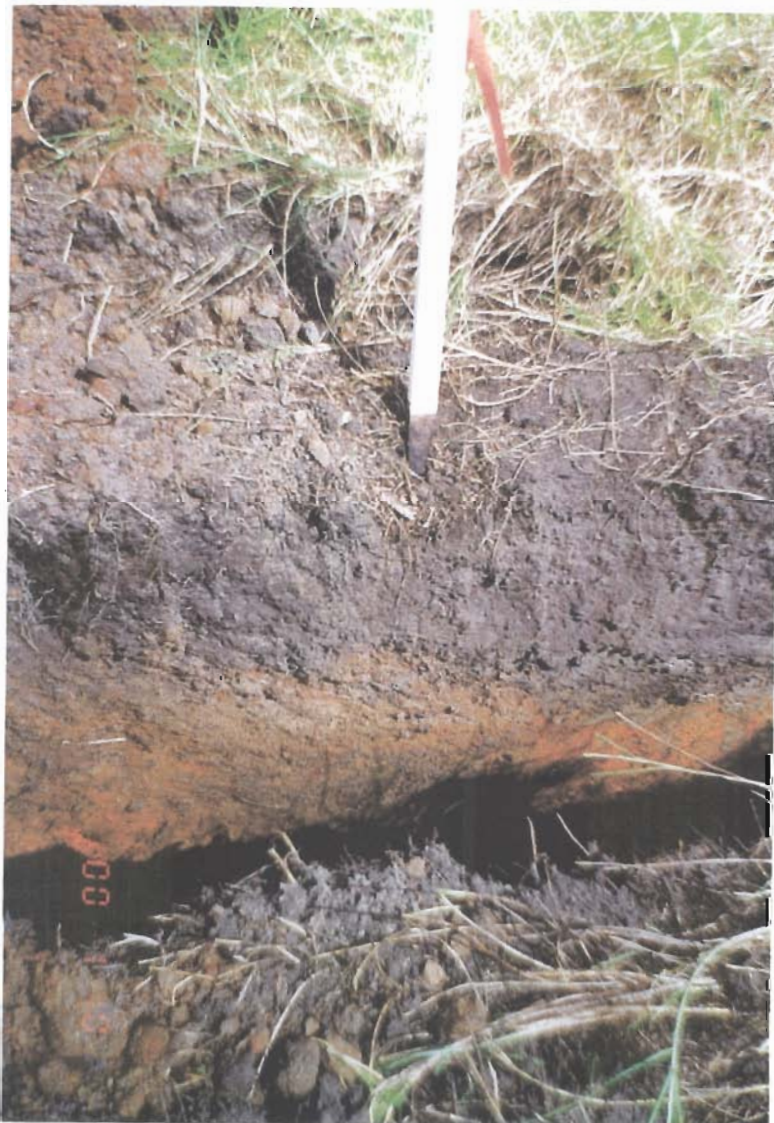
**Material Profile of Test Pit 101**

0.1									<b>TOP SOIL/ PROBABLE SLOPE WASH</b>					
0.2								OL	Dark grey to black moist, soft to firm	M				@ 0.2m PP Su= 50kPa
0.3									sandy silty clay. Loamy structure, high					@ 0.4m PP Su=40kPa

0.4									content of organic and tree roots.					
0.5									Medium plasticity					
0.6														
0.7									<b>RESIDUAL SILTY CLAY</b>					@ 0.7m PP Su=250kPa

0.8								RS	Pale grey, red brown mottled, moist,	M				
0.9									very stiff to hard.					
1.0									Low plasticity; lateritic and concreted					@ 1.1m PP Su=100kPa

1.1									zones; gradual increase in texture down					
1.2									the profile from sandy silty clay to silty					
1.3									Clay.					@1.5m PP Su=100kPa

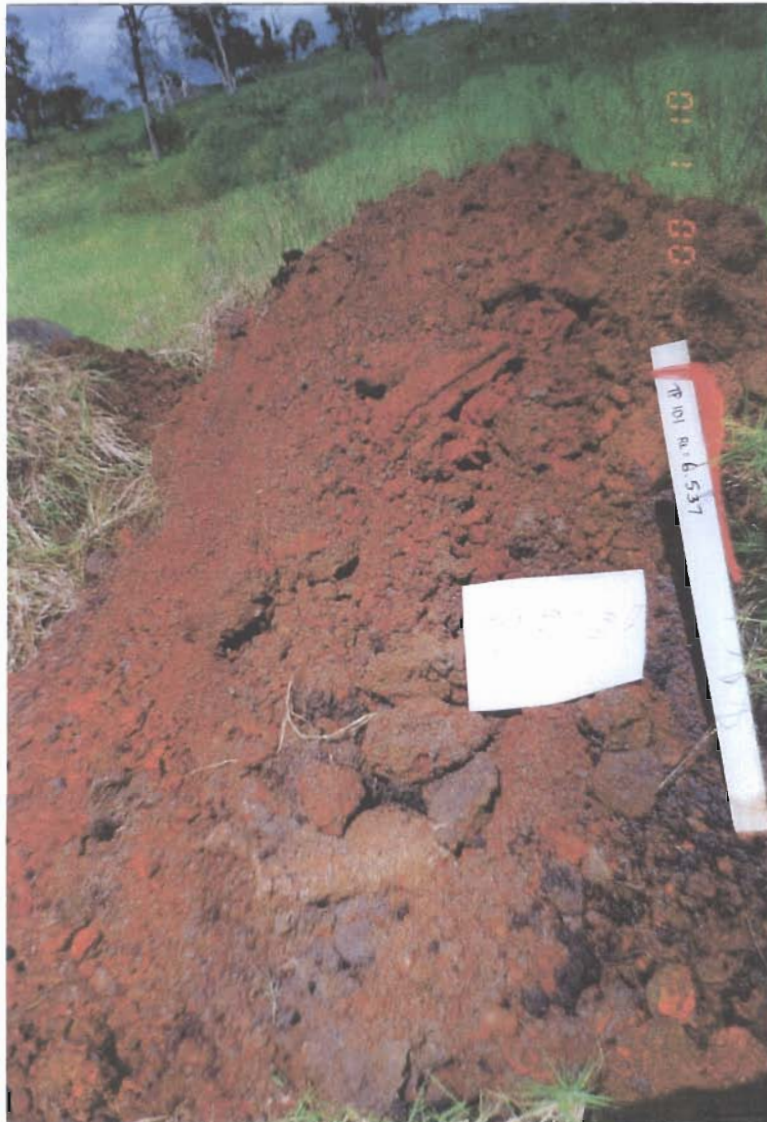
**Encountered Material in Test Pit 101**
