# ENGINEERING BORELOG

PROJECT : PEDESTRIAN OVERPASS OVER GATWAY ARTERIAL AT DEAGON  
 LOCATION : PIER 9 -38116E 47661N  
 PROJECT No : 1-694 SURFACE R.L. : 5.72 DRILLER : DALY BROS  
 JOB No : 140/U13C/41 DATUM : AHD DATE DRILLED : 2/3/93

# PEDESTRIAN FOOTBRIDGE AT DEAGON

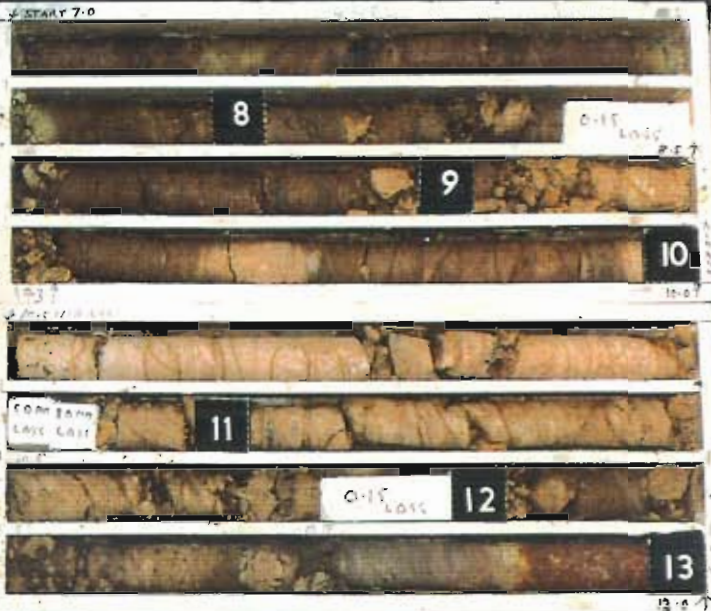
HOLE 6  
H 7168

START  
7.0 M

1 OF 1

MARCH 93
