REPORT OF BOREHOLE: CRR 214

PROJECT: Cross River Rail

LOCATION: Christensen St Park and Ride

JOB NO: 107632034

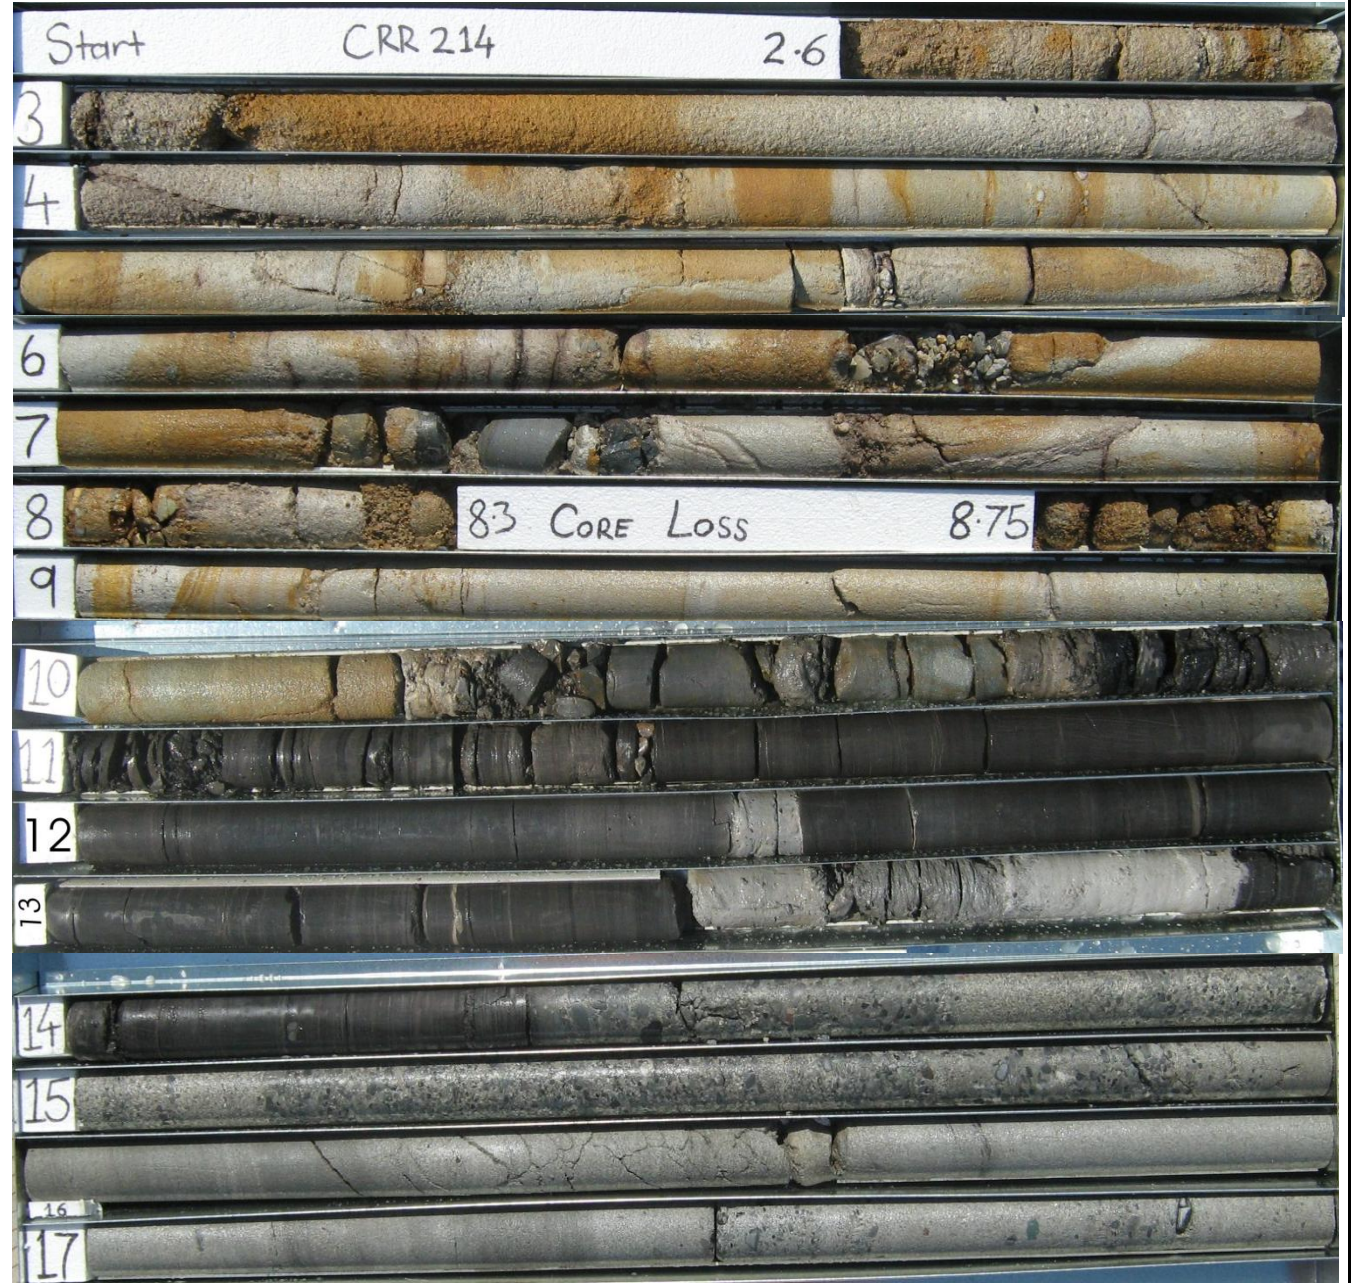
REPORT OF CORE PHOTOGRAPHS: CRR 214

DEPTH RANGE: 2.6-18.0 m
DRILL RIG: Fox B40
DRILLER: Schneider Drilling Pty Ltd
LOGGED: RCD DATE: 30/08/10
CHECKED: NK DATE: 4/10/10

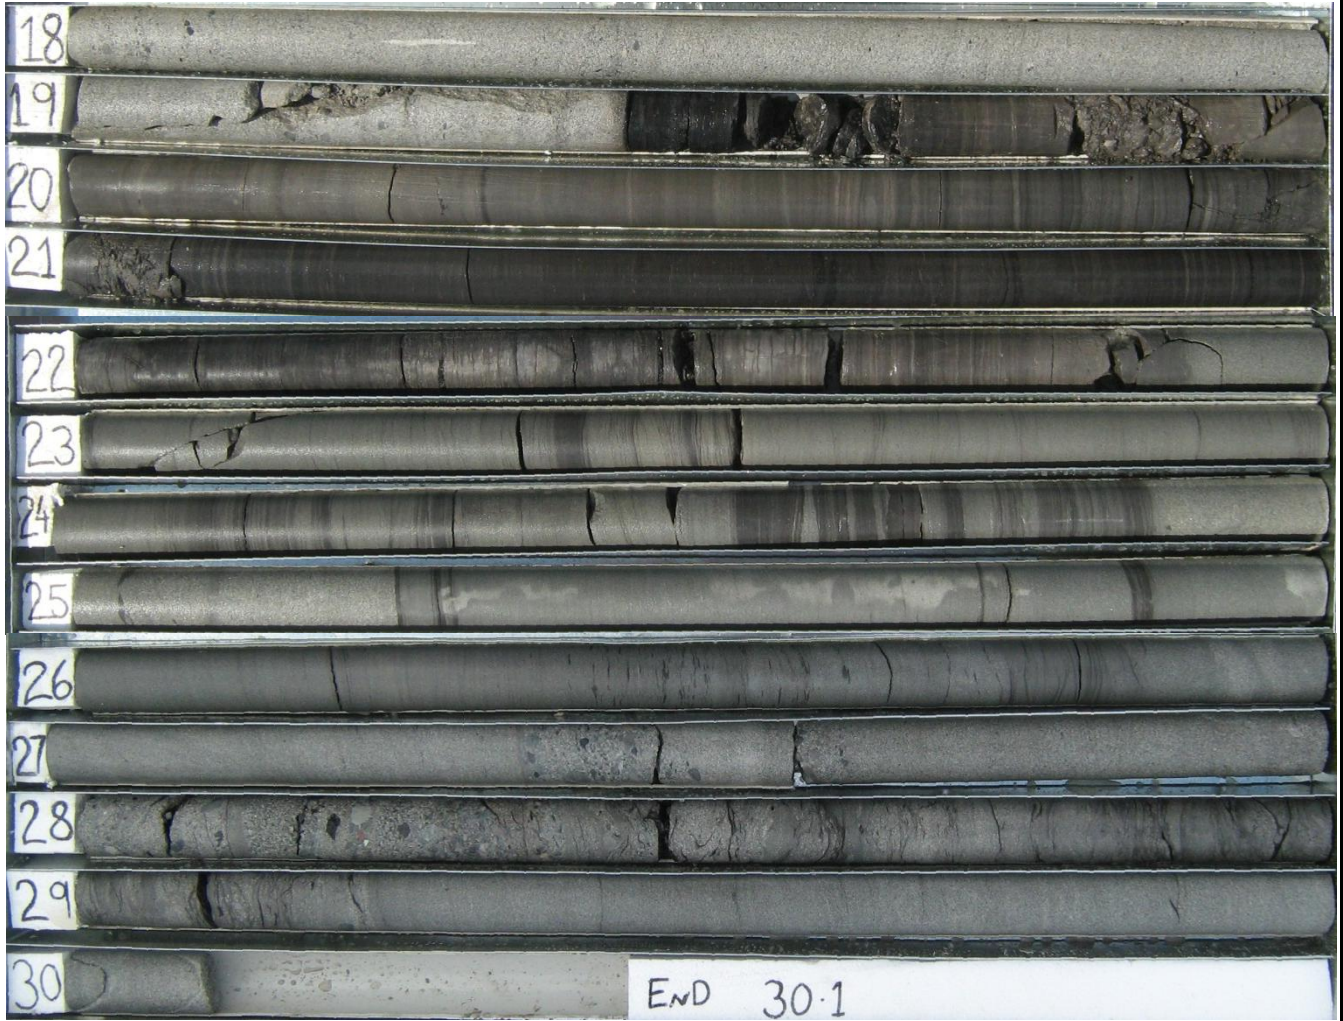
REPORT OF CORE PHOTOGRAPHS: CRR 214

DEPTH RANGE: 18.0-30.1 m
DRILL RIG: Fox B40
DRILLER: Schneider Drilling Pty Ltd
LOGGED: RCD DATE: 30/08/10
CHECKED: NK DATE: 4/10/10

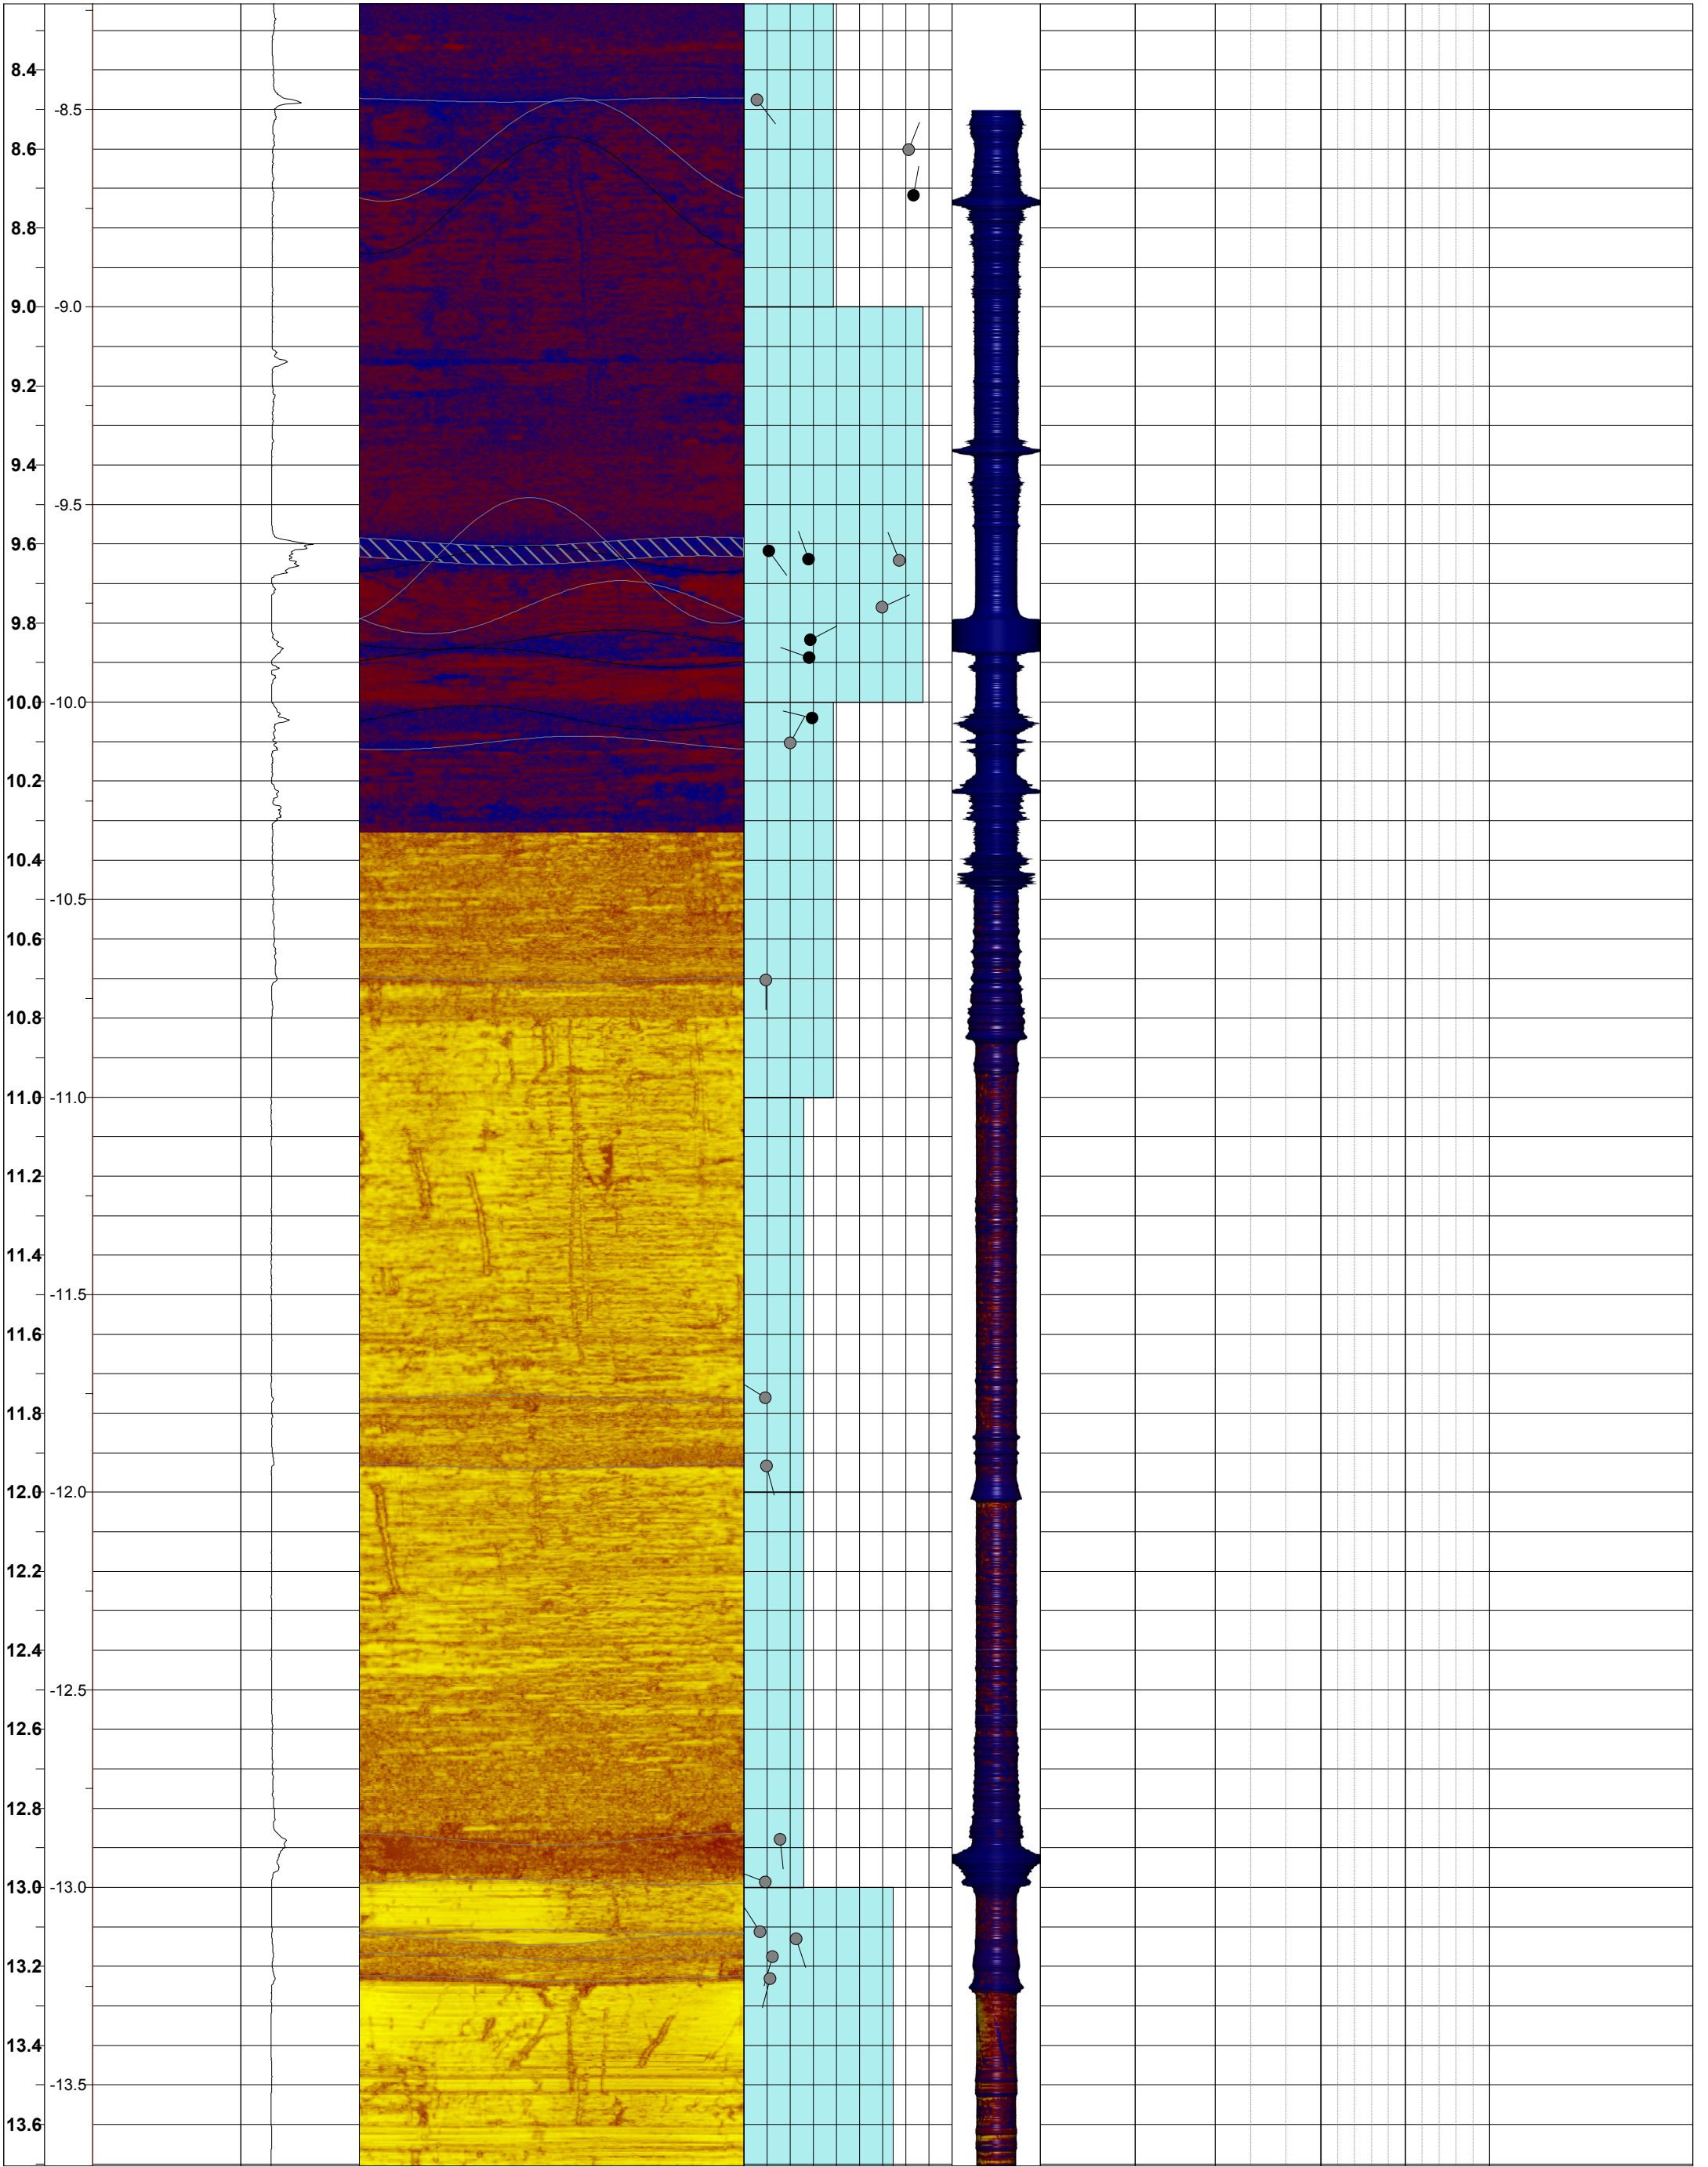
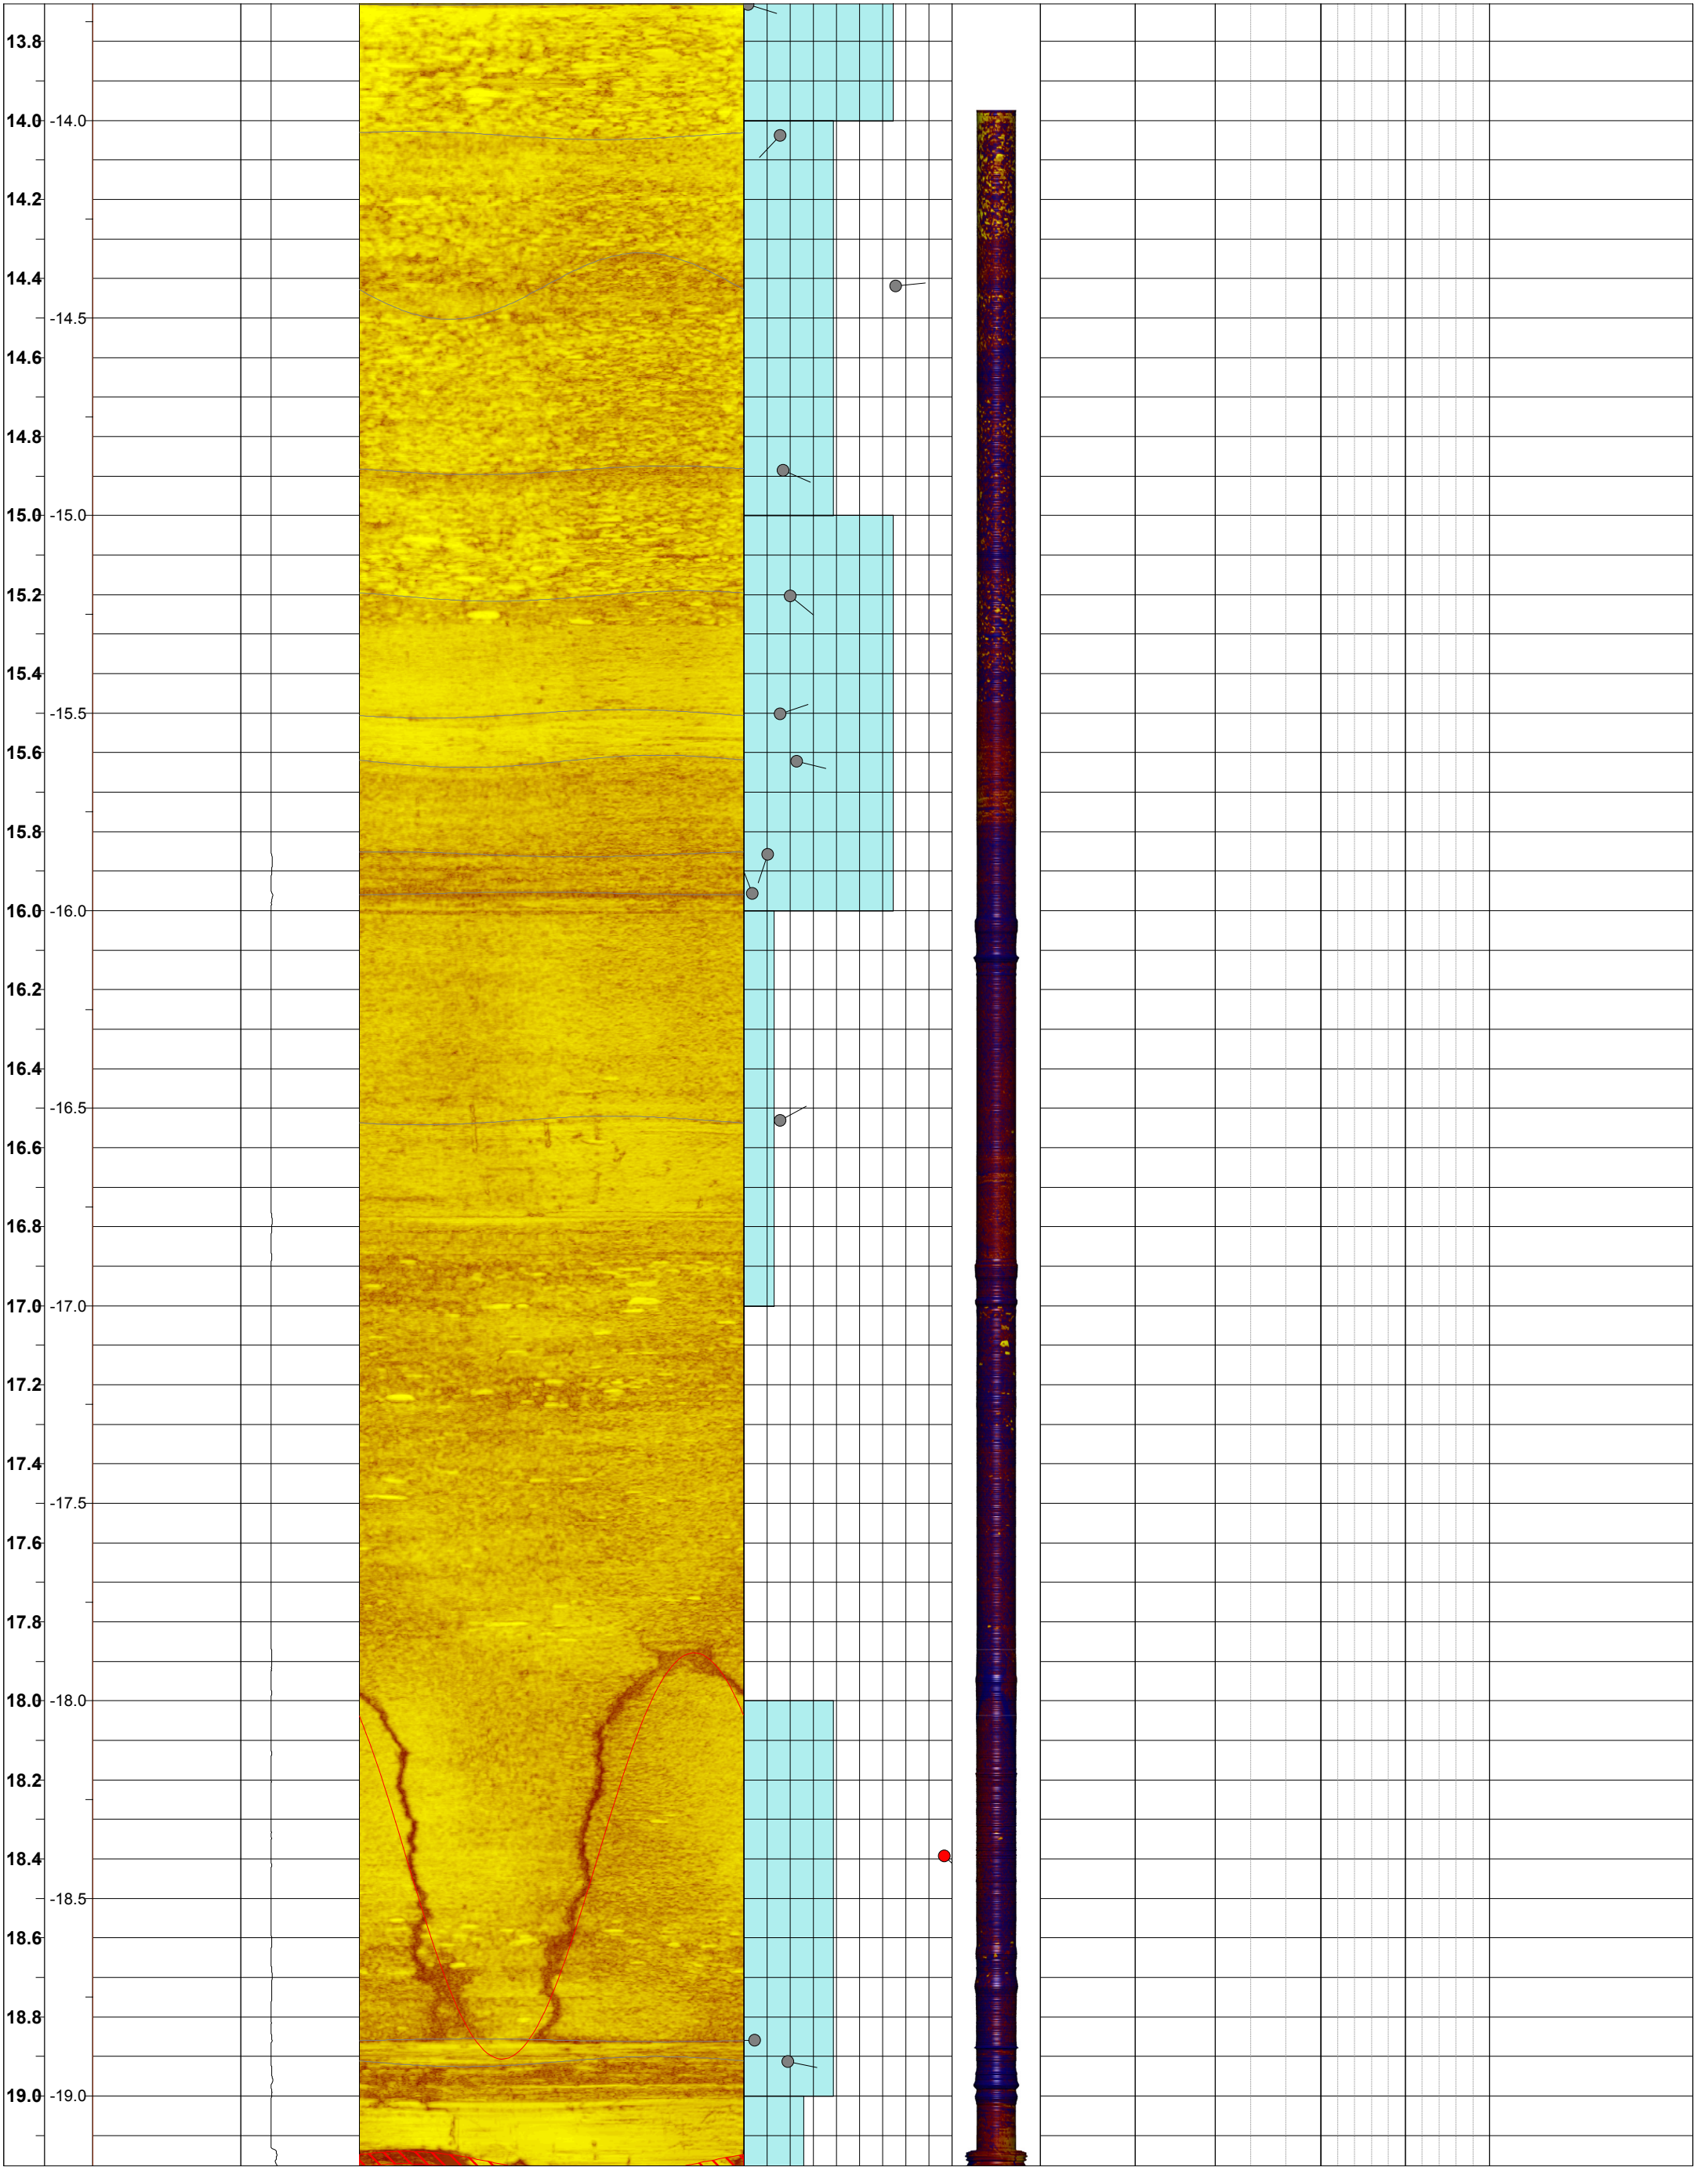
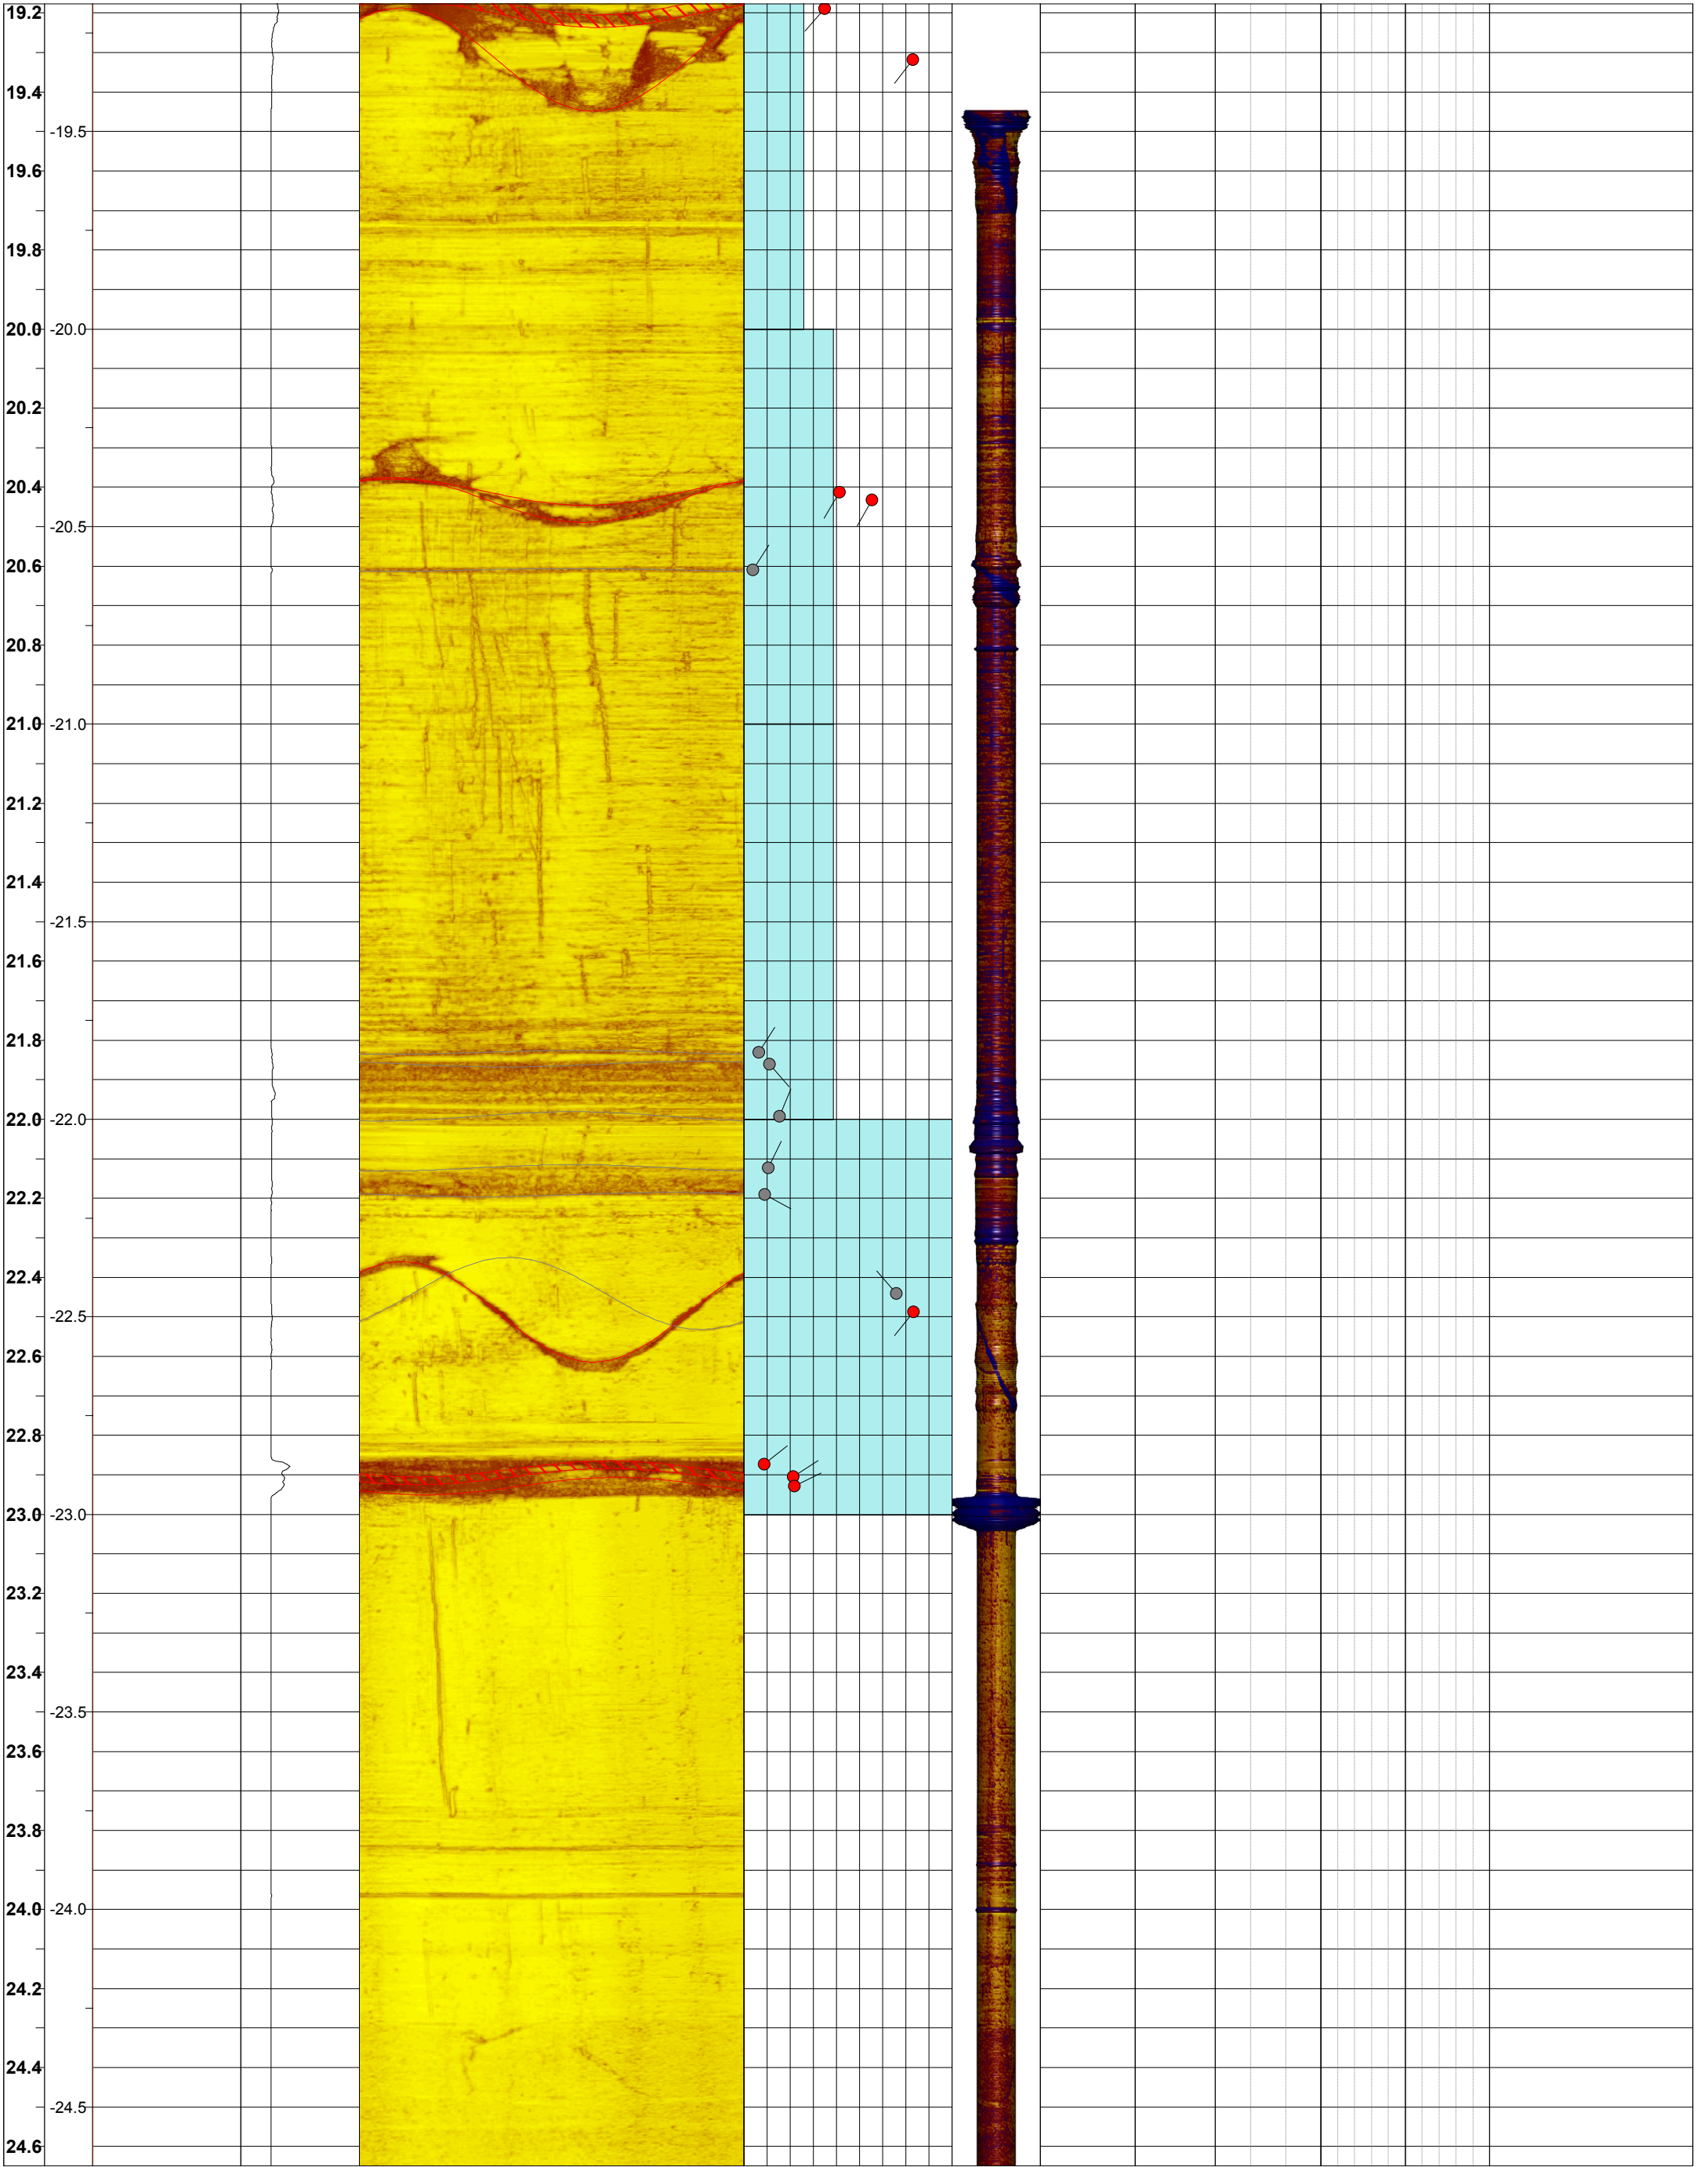
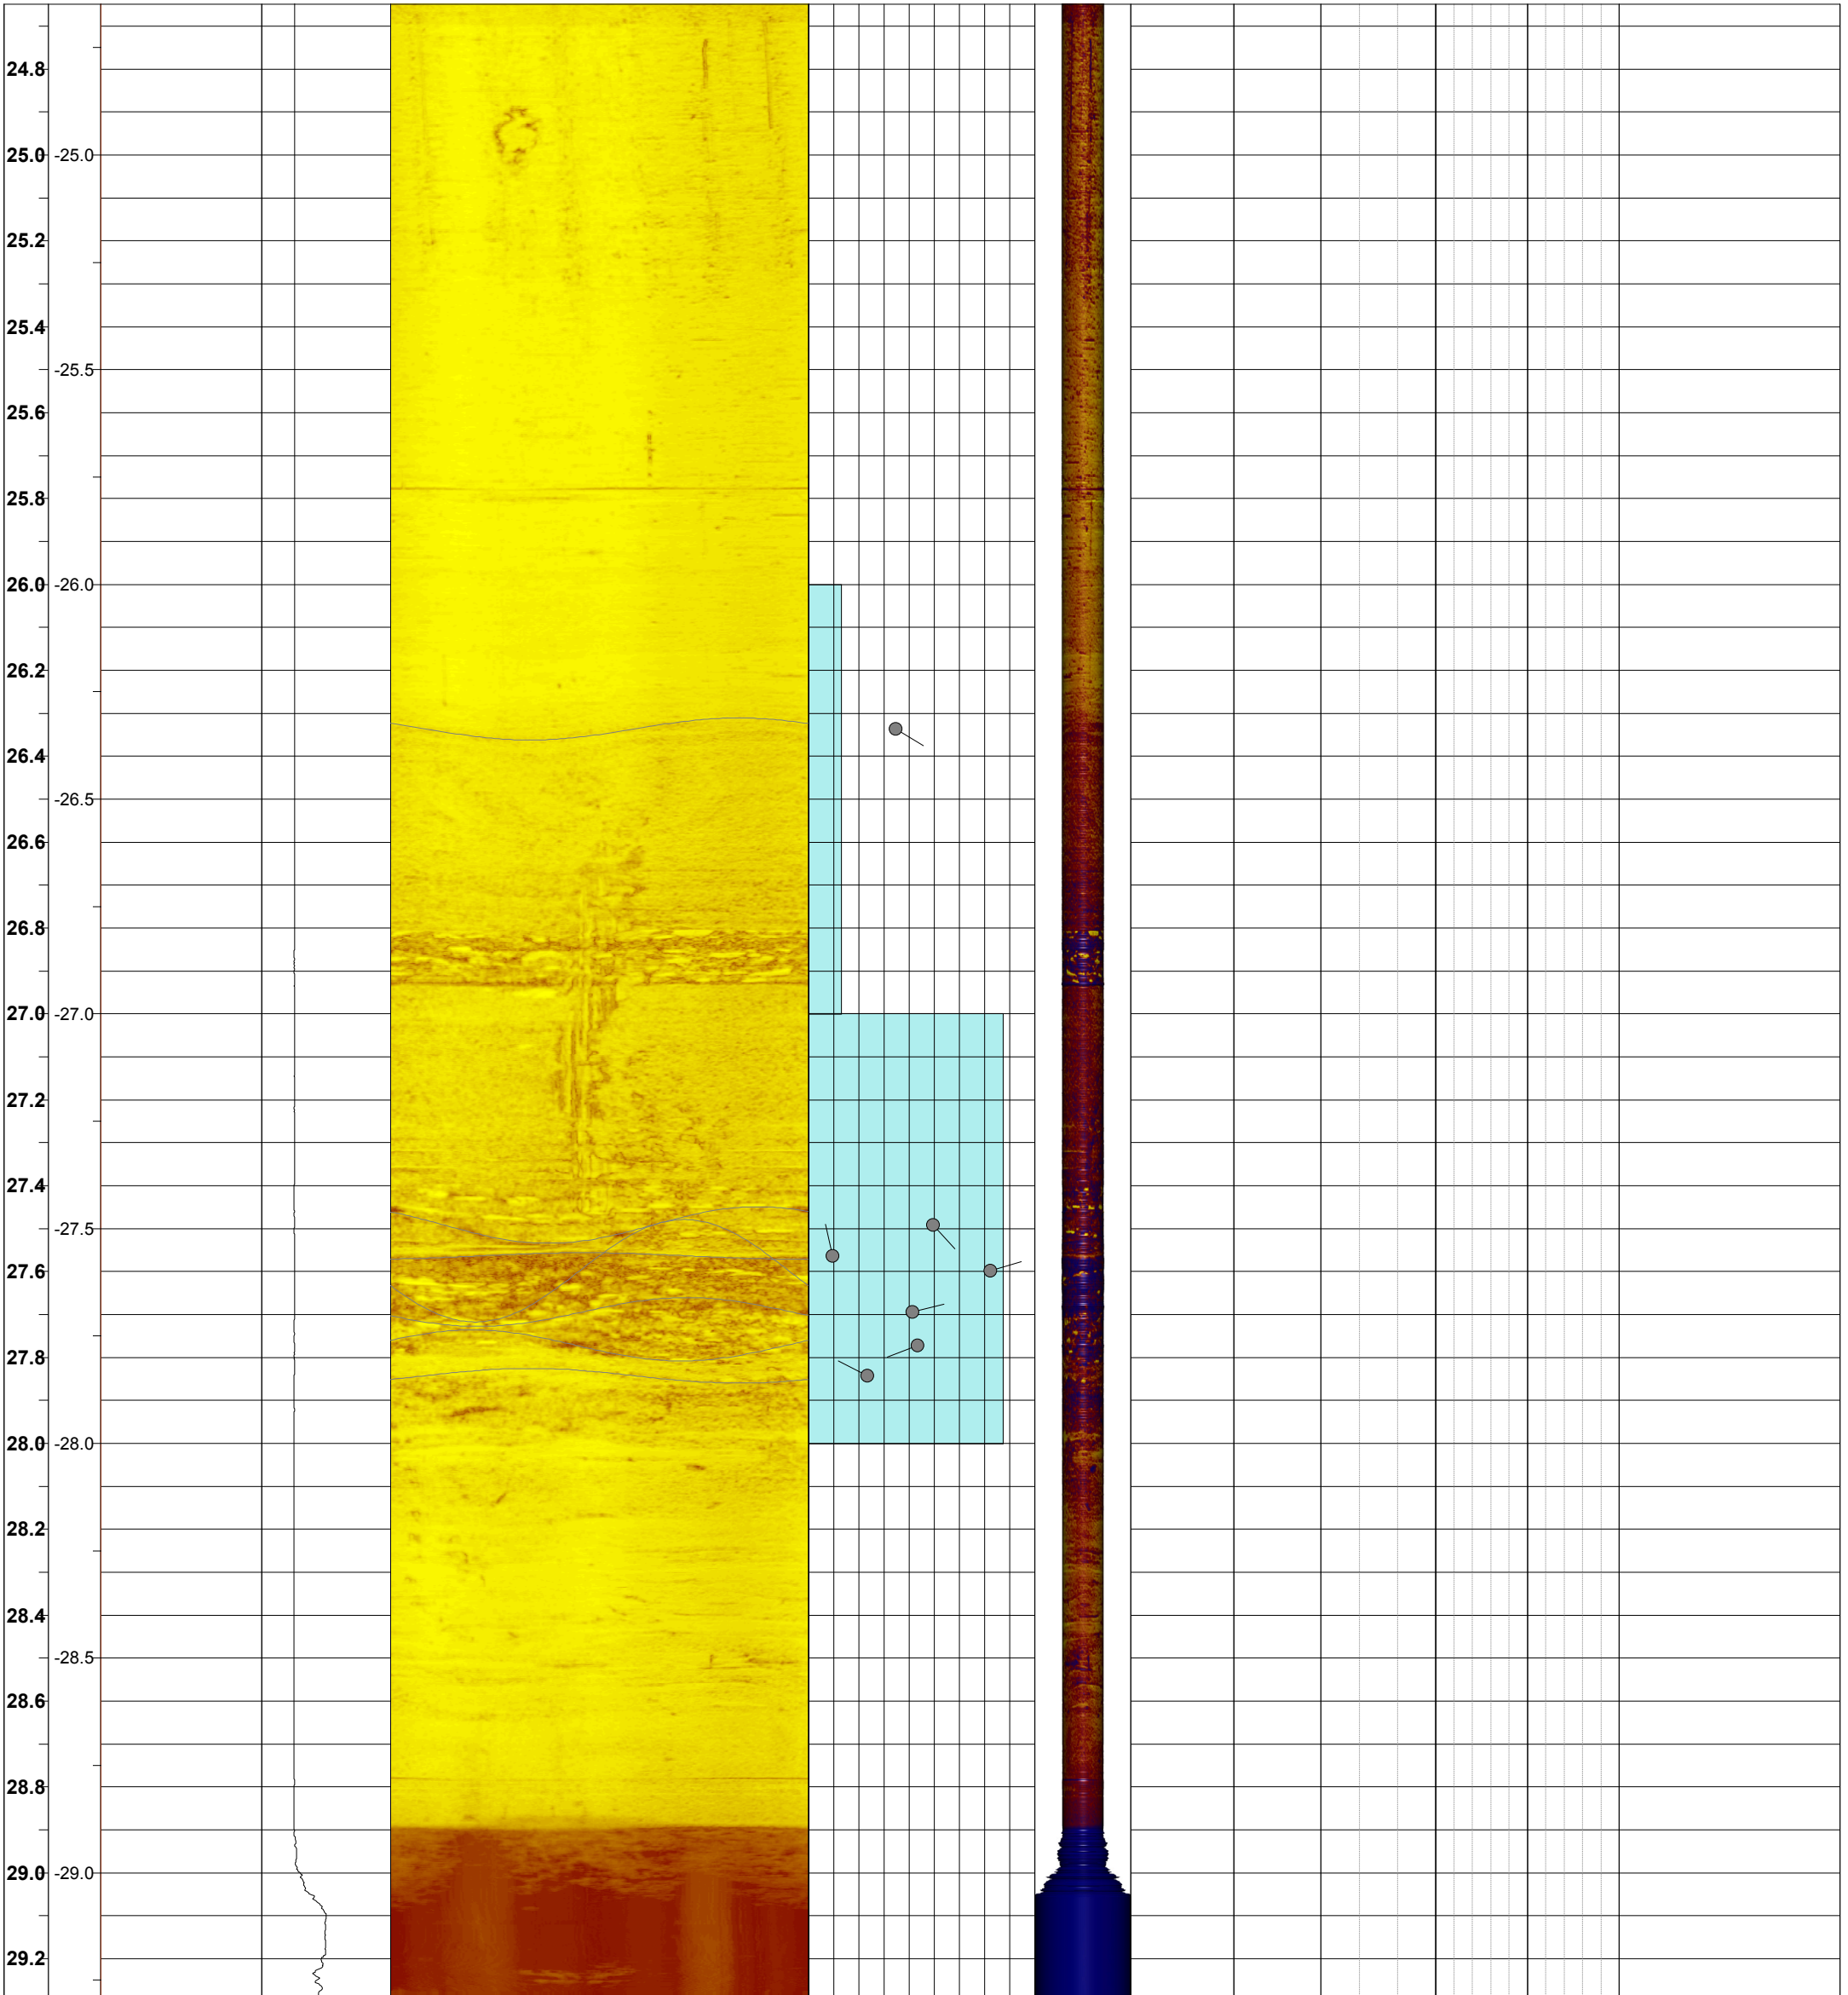
GEOPHYSICAL RECORD OF BOREHOLE: CRR 214

- Joint - Medium Confidence
- Decomposed Seam - Low Confidence
- Joint - High Confidence
- Decomposed Seam - High Confidence
- ◆ Crushed Seam - High Confidence
- Joint - Low Confidence

Depth 1:15	RL	TELEVIEWER DATA				CORE DATA						
		NATURAL GAMMA 0 cps 300	ATV - Caliper 0 mm 300	Amplitude 0° 90° 180° 270° 0°	Structure Orientations 0 90	3D log 293°	Core Photo	Lithology	Logged FF 0 30	RQD 0 100	TCR 0 100	Defect Description
				Interpreted Structures 0° 90° 180° 270° 0°	ATV FF 0 counts/m 7	(Refer to detailed core log, provided separately)						
4.5												
4.6												
4.8												
5.0	-5.0											
5.2												
5.4												
5.5												
5.6												
5.8												
6.0	-6.0											
6.2												
6.4												
6.5												
6.6												
6.8												
7.0	-7.0											
7.2												
7.4												
7.5												
7.6												
7.8												
8.0	-8.0											
8.2

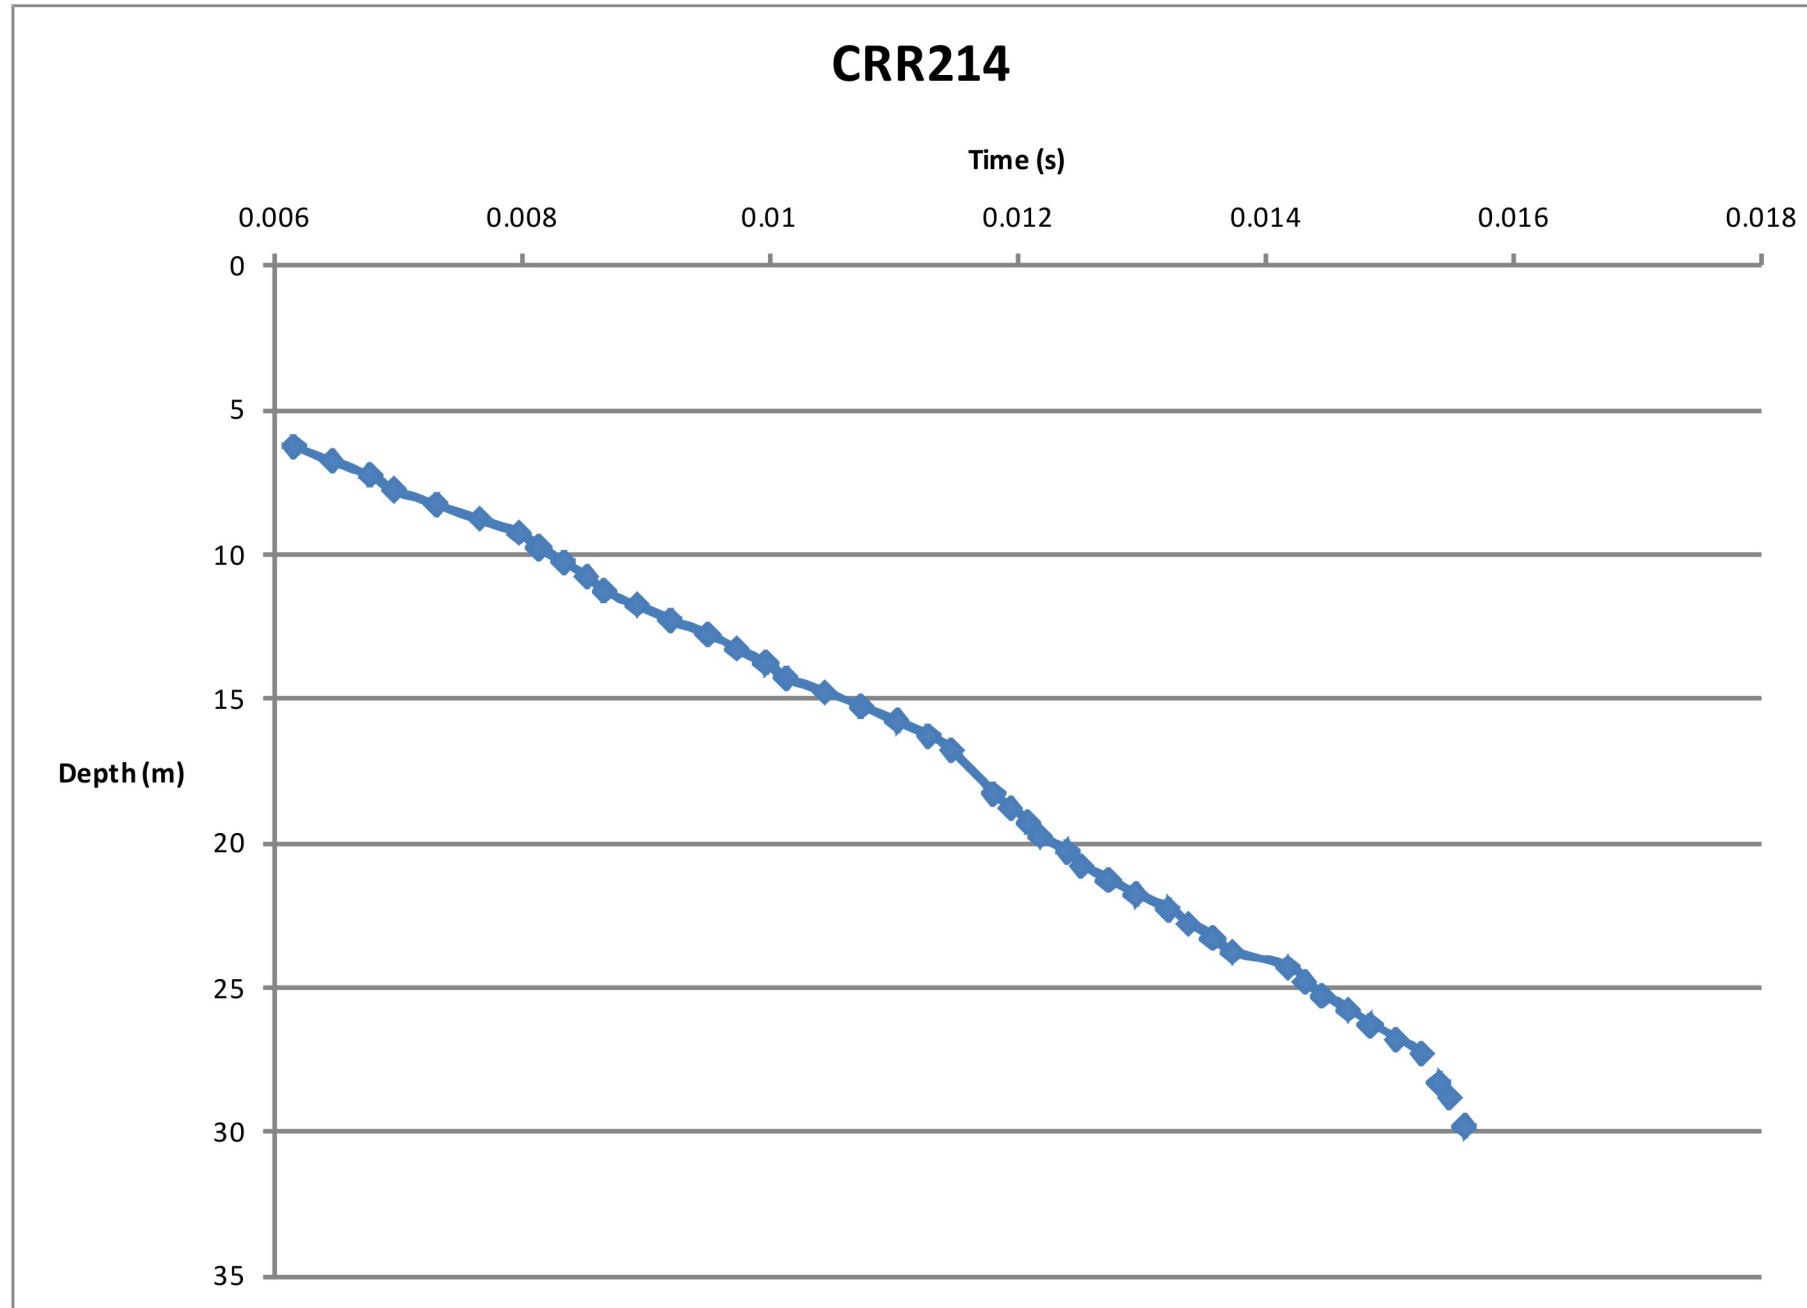
CLIENT Department of Transport and Main Roads		PROJECT Cross River Rail	
	DRAWN GDK	DATE OCT 4	TITLE CRR214 VSP	
	CHECKED TR	DATE		
	SCALE NTS	PROJECT No 000-107632034	FIGURE No	REV No A3

Geophone Depth (m)		Interval velocity (P wave m/s)
from	to	
6.3	6.8	1614
6.8	7.3	1621
7.3	7.8	2656
7.8	8.3	1443
8.3	8.8	1446
8.8	9.3	1577
9.3	9.8	3102
9.8	10.3	2483
10.3	10.8	2641
10.8	11.3	3662
11.3	11.8	1873
11.8	12.3	1875
12.3	12.8	1648
12.8	13.3	2142
13.3	13.8	2143
13.8	14.3	3002
14.3	14.8	1605
14.8	15.3	1710
15.3	15.8	1719
15.8	16.3	1974
16.3	16.8	2706
16.8	18.3	4483
18.3	18.8	3533
18.8	19.3	3534
19.3	19.8	5042
19.8	20.3	2291
20.3	20.8	4592
20.8	21.3	2243
21.3	21.8	2244
21.8	22.3	1923
22.3	22.8	3057
22.8	23.3	2573
23.3	23.8	3147
23.8	24.3	1113
24.3	24.8	3624
24.8	25.3	3625
25.3	25.8	2362
25.8	26.3	2848
26.3	26.8	2397
26.8	27.3	2397
27.3	27.8	*
27.8	28.3	*
28.3	28.8	6431
28.8	29.3	*
29.3	29.8	*

* - 1st arrival not clear due to noise

Calculations done without accounting for borehole deviation
