# REPORT OF TEST PIT: TP413

CLIENT: McConnell Dowell Constructors (Aust) P/L COORDS: 85959.6 m E 59305.6 m N GCCC

PROJECT: Gold Coast Rapid Transit

LOCATION: Zone 4

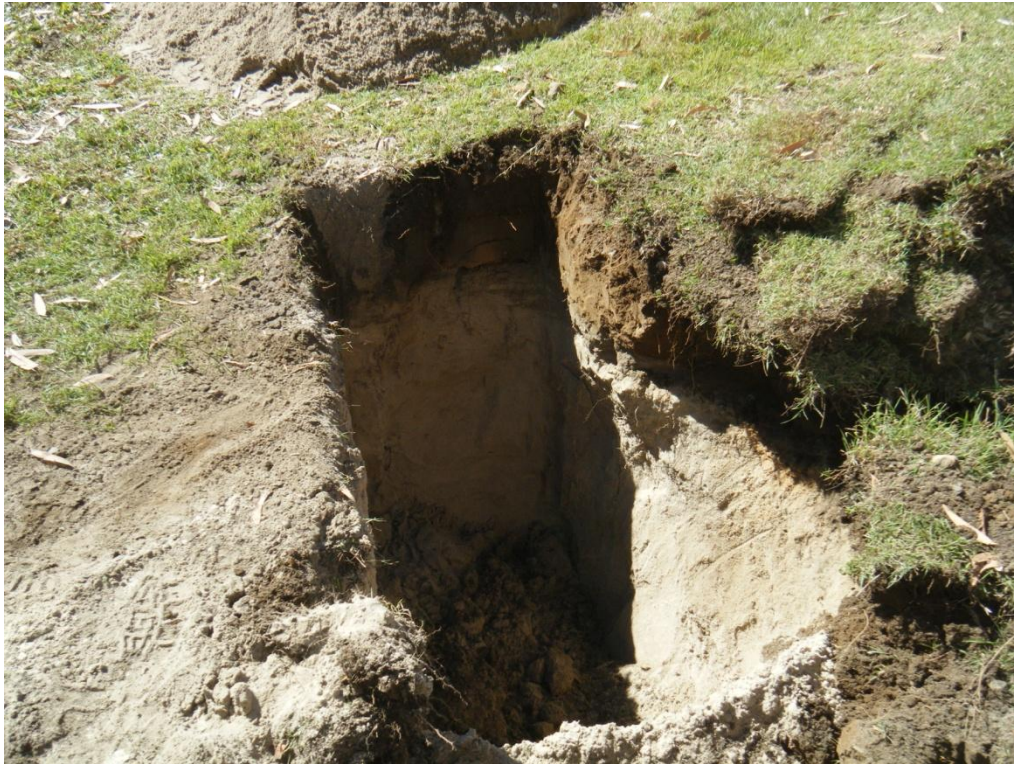
Photo 1 : Side Wall

| Excavation | | | | Sampling | | Field Material Description | | | | | | |
|---|---|---|---|---|---|---|---|---|---|---|---|---|
| EX | L | Groundwater not encountered | 0.0 | 2.98 | | | CL-CI | TOPSOIL: Sandy CLAY low to medium plasticity, dark brown, rootlets and grass covering noted | M (<PL) | F | | |
| | | | 0.30 | 2.68 | | | SM | SAND fine to medium grained, pale grey | D - M | | | |
| | | | | 1.38 | | | | TEST PIT DISCONTINUED @ 1.60 m COLLAPSE GROUNDWATER NOT ENCOUNTERED | | | | |
