# REPORT OF TEST PIT: TP417

PROJECT: Gold Coast Rapid Transit SURFACE RL: 2.25 m DATUM: AHD

LOCATION: Zone 4 PIT DEPTH: 2.30 m

## REPORT OF TEST PIT PHOTOGRAPHS: TP417

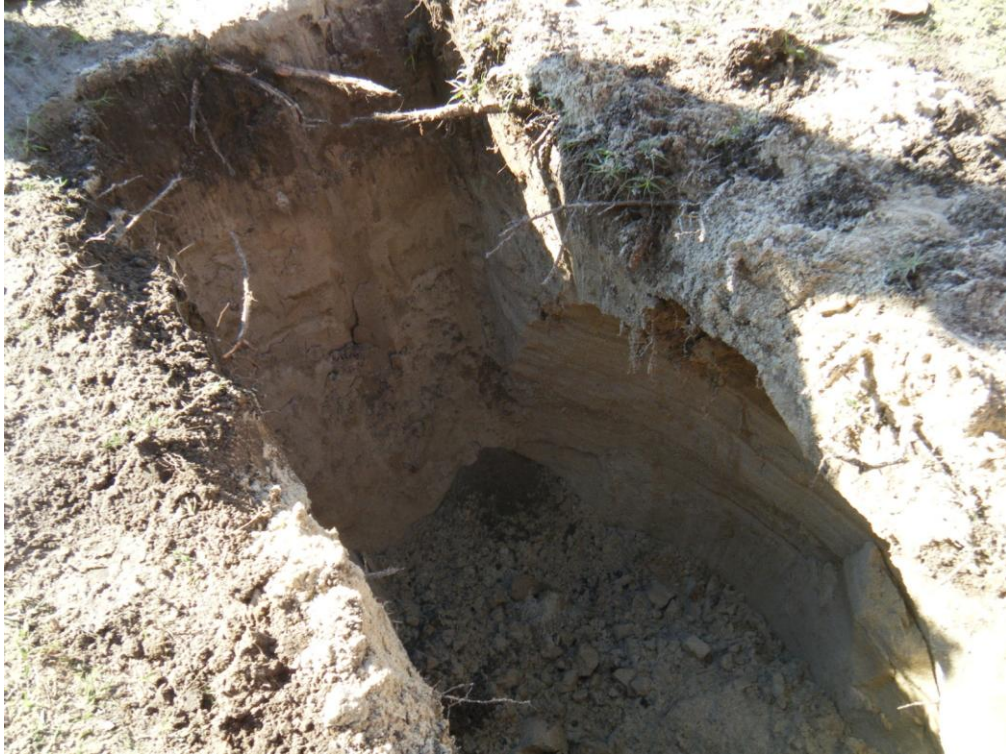
Photo 1 : Test Pit

| Excavation | | | | Sampling | | Field Material Description | | | | | | |
|---|---|---|---|---|---|---|---|---|---|---|---|---|
| EX | L | Groundwater not encountered | 0.0 | 2.25 | BDS 0.60-1.00 m | | SP-SC | TOPSOIL: SAND fine to medium grained, dark brown, with some low to medium plasticity clay, roots and grass covering noted | M | L | | |
| | | | 0.20 | 2.05 | | | SP | SAND fine to coarse grained, pale brown, with some pockets of dark brown clayey sand noted, layering clearly visible | | | | |
