TEST PIT LOG

FEATURE No TP123

PROJECT Bruce Highway Cooroy to Curra Section A Geotechnical Investigation

LOCATION Embankment 9 COORDINATES 486980.4 E; 7080818.6 N

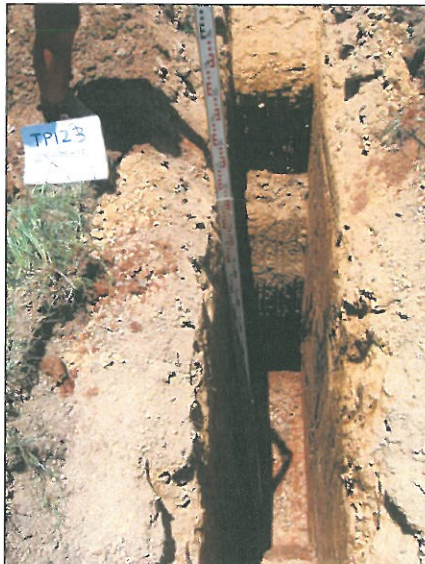
Testpit Profile

119.09	118.99	ML		SILT with Gravel (Topsoil) Pale brown, dry, firm. Low plasticity; trace sand; rootlets; gravel fraction is fine to medium grained, sub-angular to round, mixed origin.		LL = 56; PI = 23; LS = 11; MC = 20.9%; WPI=1550	A	D,Bulk
		CI		Sandy SILT (Colluvium) Pale brown, dry, stiff. Trace fine to medium gravel; sand fraction is fine to medium grained; trace rootlets.

118.39		MH		SILT with clay and gravel (Colluvium) Pale yellow brown to orange brown, dry, very stiff. High plasticity; trace fine to coarse sand; gravel fraction comprises fine to coarse grained, angular to sub-angular, phyllite and quartz; phyllite gravels are tabular; trace cobble sized quartz; trace rootlets.		FSU(Su) unable to push Shear vane LL = 52; PI = 23; LS = 9.4; MC = 20.8%; WPI=2087	B	D,Bulk
		CH		Silty CLAY (Colluvium) Pale grey, pale brown and mottled pale orange, dry, stiff to very stiff. High plasticity; trace fine to coarse quartz and phyllite gravel; iron nodules; phyllite is sub-angular to sub-rounded; quartz is sub-angular to angular.

117.39		CI		Gravelly CLAY (Colluvium) Pale to dark grey, dark brown with red brown mottling, dry, stiff to very stiff. Gravel fraction is comprised of fine to medium grained quartz and phyllite; trace clay; possible organic material within matrix.

116.59		MH		SILT (Colluvium) Red to orange brown with pale grey mottling, dry, very stiff. Low plasticity; trace gravel; gravel is fine to medium grained, sub-angular to sub-rounded, comprised of quartz and iron nodules; occasional dark grey flecks. Below 3.3m: Becoming slightly moist.	LL = 37; PI = 14; LS = 8.4; MC = 17.9%; WPI=1049	C	D,Bulk

115.74				Excavation terminated at 3.55m		LL = 53; PI = 25; LS = 13.6; MC = 18.5%; WPI=2102	D	D,Bulk
115.29

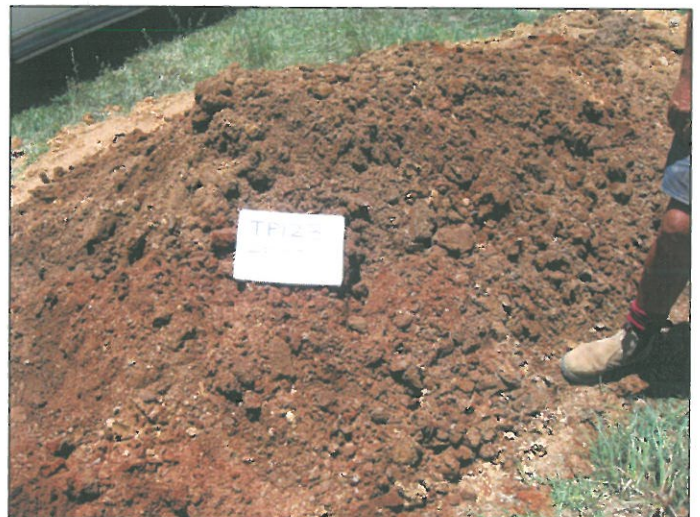
Excavated Material

REMARKS NOTE: Query origin of material. Possible slope debris / colluvium due to disturbed structure and heterogeneous matrix;
FSV= Field shear vane (Peak/residual);
