Sheet 1 of 1

Date: 5/12/2023
Logged: AV

Queensland Hydro
Netherdale
Pioneer-Burdekin Pumped Hydro Energy
Storage
TPL-11

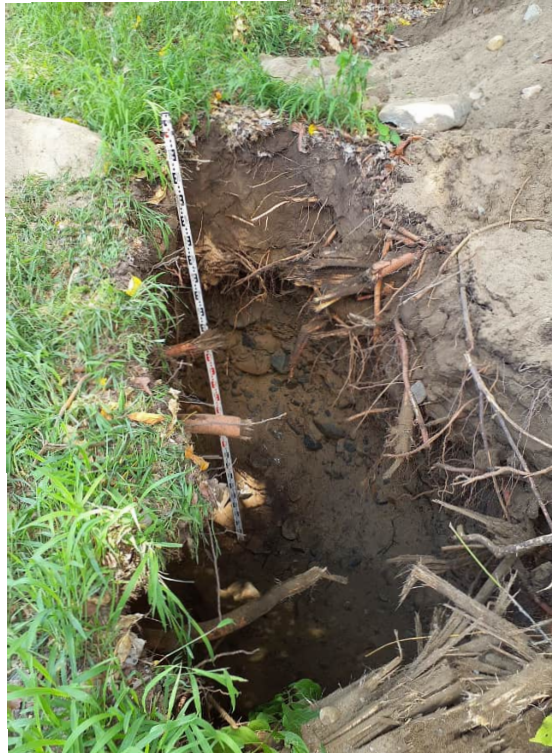
TPL-11-1 Test pit excavation - sidewall collapse occurring below 3.0 m below ground level

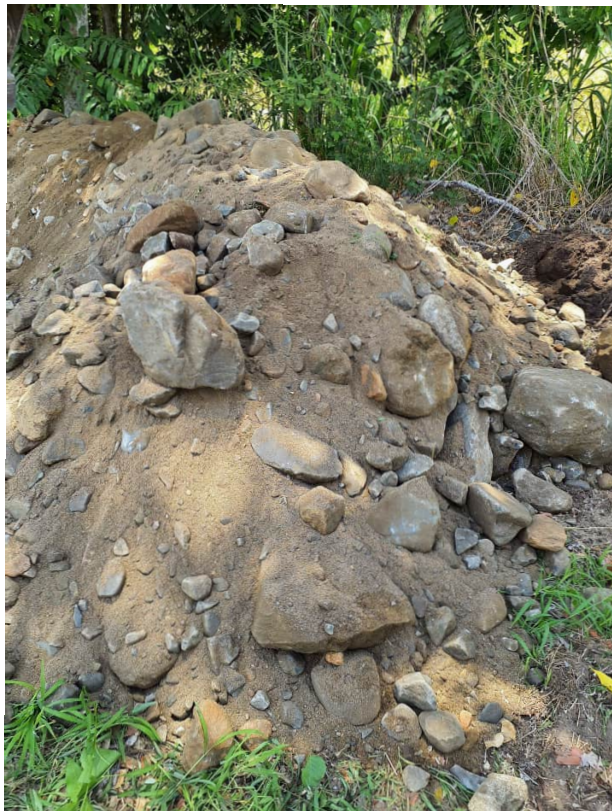
TPL-11-2 Test pit excavated spoil
