CORED BOREHOLE RECORD

BH9

PROJECT LANG PARK STADIUM REDEVELOPMENT

JOB

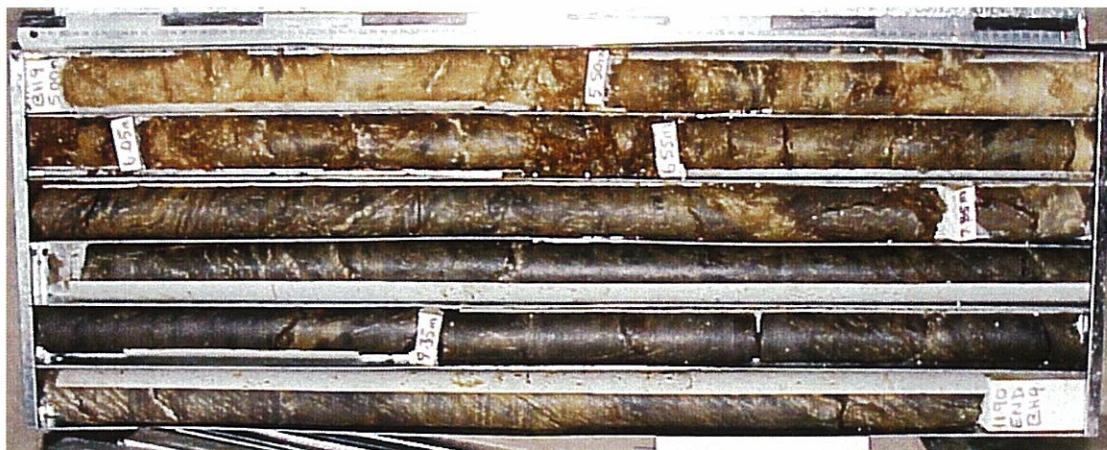
Borehole 9

5m - 11.9m

Box 1 of 1
