# REPORT OF TEST PIT: TP412

CLIENT: McConnell Dowell Constructors (Aust) P/L COORDS: 85935.9 m E 59350.8 m N GCCC  
PROJECT: Gold Coast Rapid Transit SURFACE RL: 3.23 m DATUM: AHD  
LOCATION: Zone 4 PIT DEPTH: 1.60 m  
JOB NO: 117632047 BUCKET TYPE: 600 mm Scraper

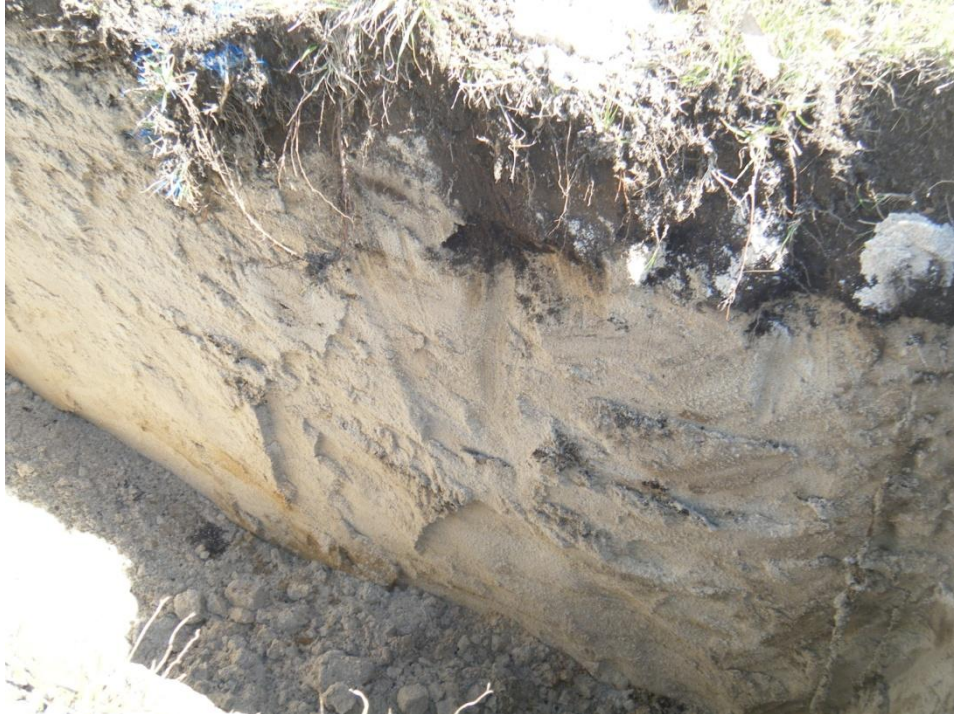
Photo 1 : Side Wall

| Excavation | | | | Sampling | | Field Material Description | | | | | |
|---|---|---|---|---|---|---|---|---|---|---|---|
| | | | 0.15 | 3.08 | | | SP-SC | SAND fine to medium grained, pale brown, orange colouring noted at depth of test pit, trace clay at depth | | | |
