ENGINEERING BOREHOLE

BOREHOLE No BH22

PROJECT IPSWICH MOTORWAY / LOGAN MOTORWAY GEOTECHNICAL INVESTIGATION

LOCATION Near Abutment A, Approximate Chainage 67m, 7m right of control MC81. COORDINATES 29686.6 E; 147202.8 N

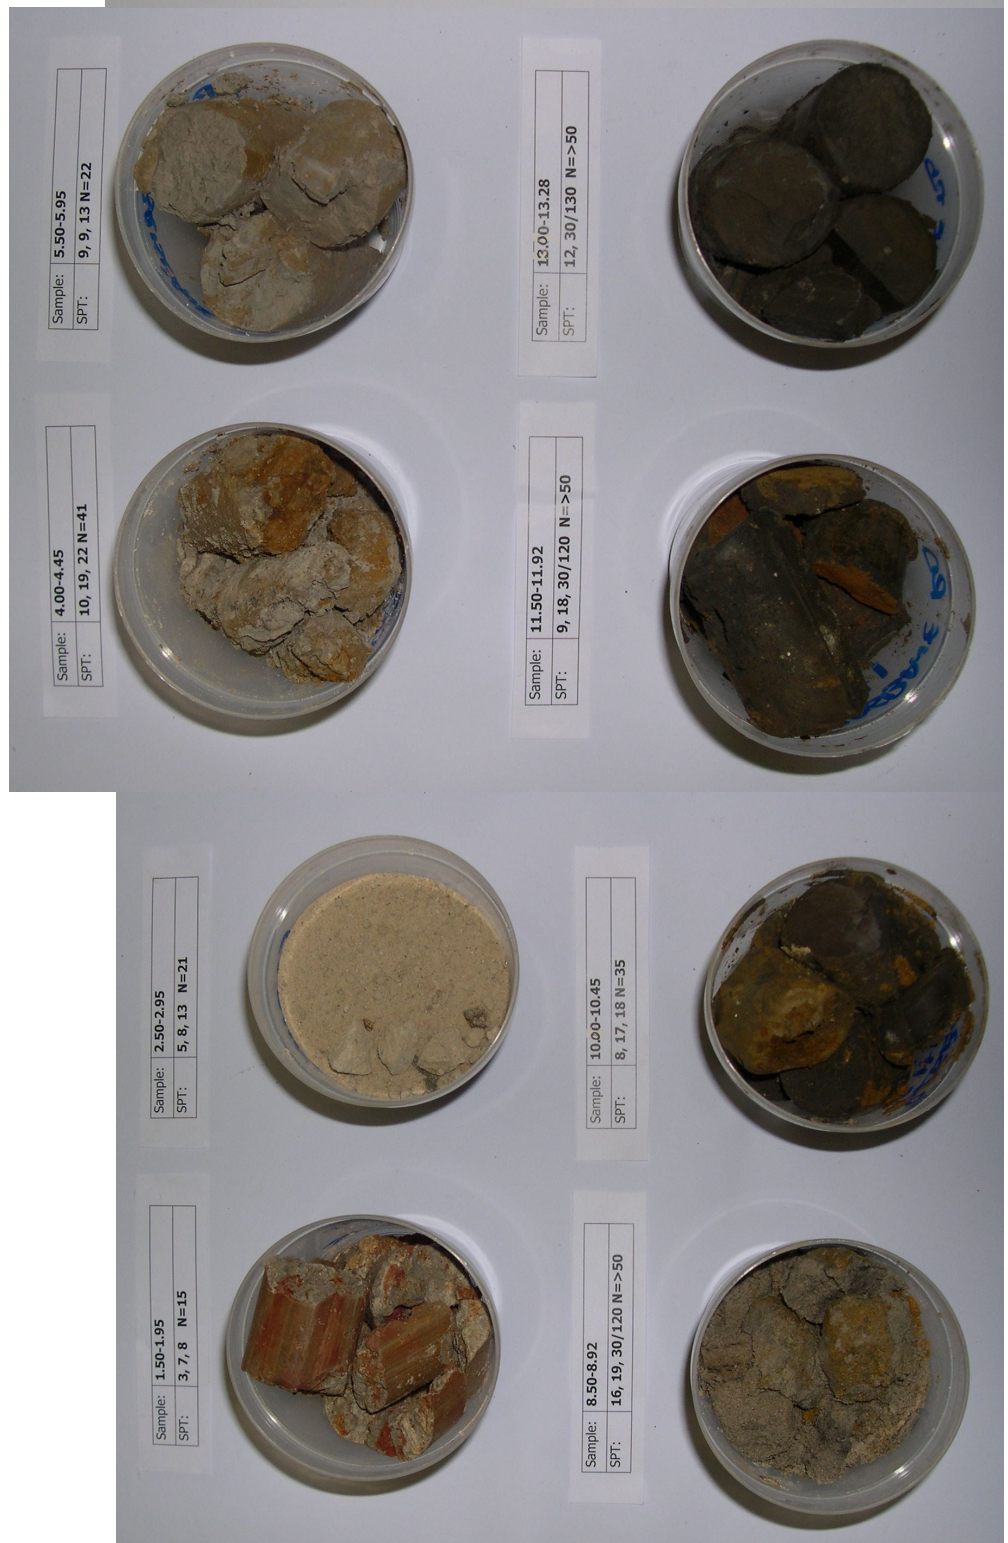
Borehole No: **BH22**

Project: Ipswich Motorway / Logan Motorway Interchange

Start Depth: 1.50m

Finish Depth: 14.78m

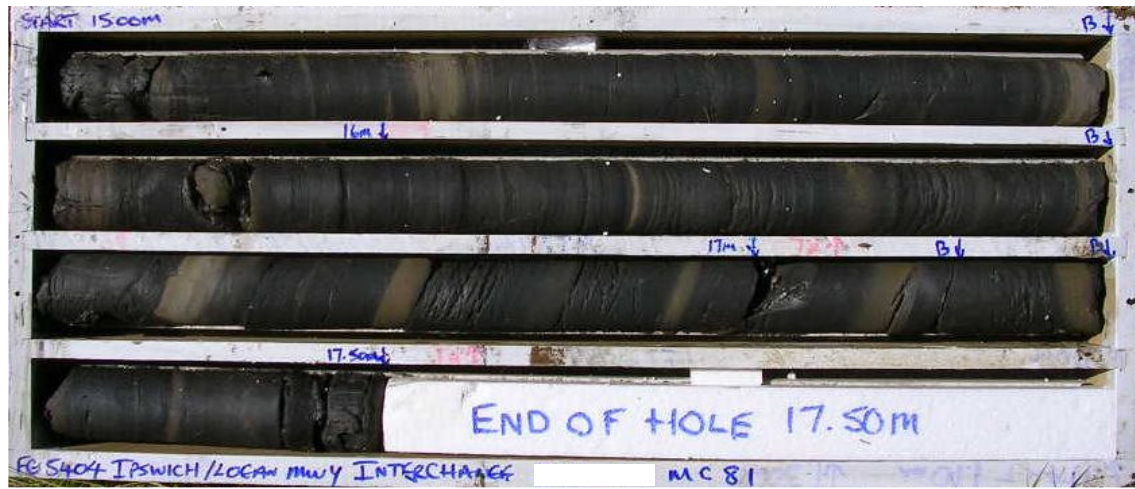
Project: **Ipswich Motorway / Logan Motorway Interchange**
Borehole No: **BH22**
Start Depth: 15.00m
Finish Depth: 17.50m
Project No: FG5404
H No: 9722
