# CONE PENETROMETER TEST RESULT

Client : McConnell Consulting  
Project : Stockland Residential  
Location : Bermuda St, Robina

Test No : **MC-R26-W**

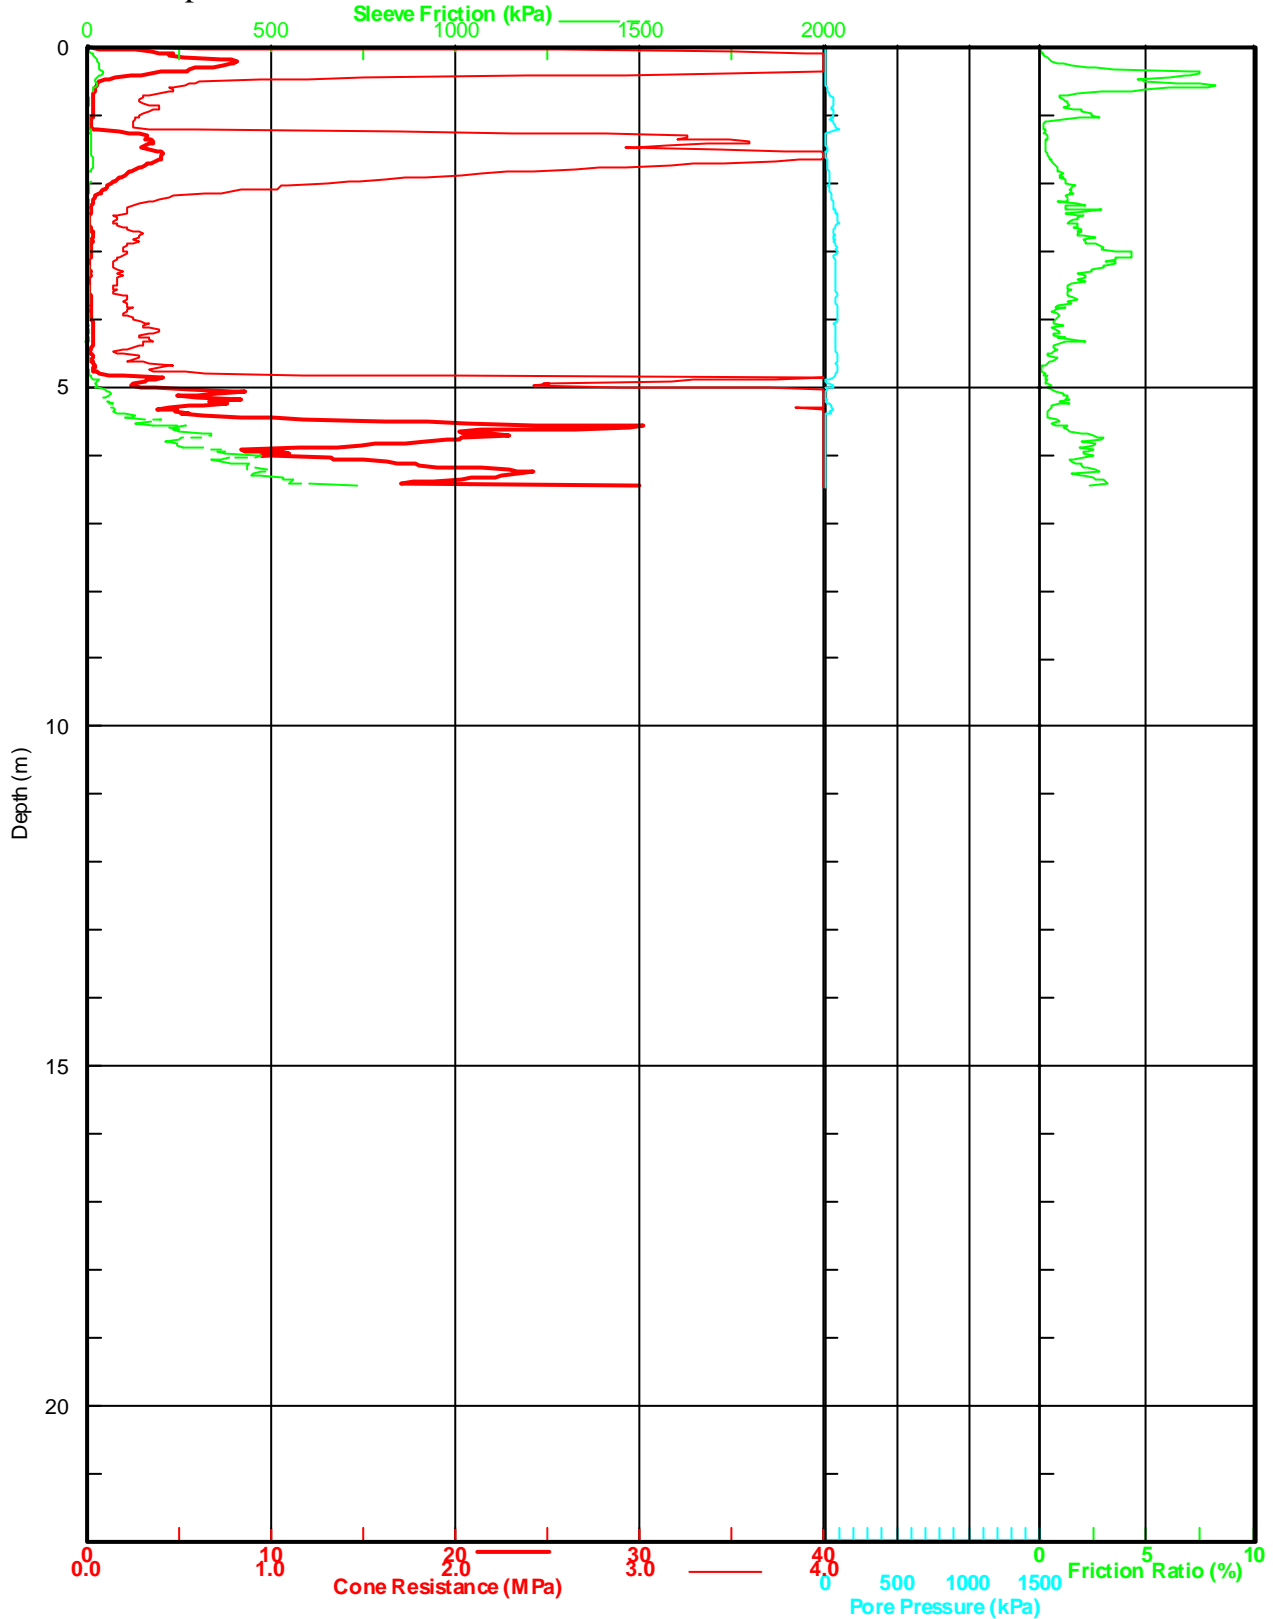
DGPS Position : 56J 0541532, 6894340  
Predrill Depth : 0.00m

Tested in accordance with AS 1289.6.5.1-1999.
