BOREHOLE No	<u>BH121</u>
SHEET	<u>1</u> of <u>4</u>
REFERENCE No	<u>H10884</u>

PROJECT WALKERSTON BYPASS PROJECT GEOTECHNICAL INVESTIGATION - COWLEYS ROAD OVERPASS BRIDGE
 LOCATION PIER 1 - (Ch. 84514.6 22.0m LHS) COORDINATES 721511.3 E; 7654843.2 N
 PROJECT No FG5635 SURFACE R.L. 9.29m PLUNGE _____ DATE STARTED 31/10/10 GRID DATUM MGA 94
 JOB No 242/33B/6 HEIGHT DATUM AHD BEARING _____ DATE COMPLETED 31/10/10 DRILLER Drillsure Pty Ltd

Project: **Walkerston Bypass Geotechnical Investigation**
Borehole No: BH121 (Cowleys Rd Bridge Ch. 84514.6 22.0m left)
Start Depth: 29.60m
Finish Depth: 32.95 m
Project No: FG5635
H No: 10890

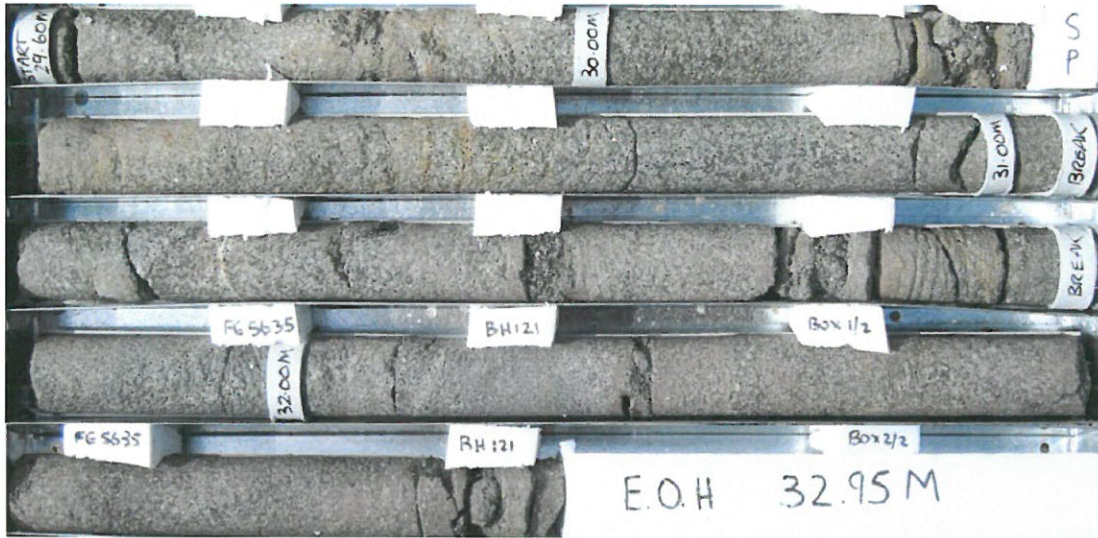
DEPTH (m)	R.L. (m)	AUGER CASING WASH BORING CORE DRILLING	RQD (%)	SAMPLE	MATERIAL DESCRIPTION	LITHOLOGY	USC WEATHERING	INTACT STRENGTH	DEFECT SPACING (mm)	GRAPHIC LOG	ADDITIONAL DATA AND TEST RESULTS	SAMPLES TESTS
30	-20.71				GRANODIORITE HW: (Cont'd)		HW					
	-21.11		100 (32)		MW: Grey brown to pink and speckled light grey, generally low to medium strength. Defects: - Joints @ 10-30° (7/m) Defects are generally planar, rough and open.		MW				Is(50) = 0.21MPa; * Is(50) = 0.32MPa; * Is(50) = 0.20MPa; *	x o x
	-23.66		100 (35)								Is(50) = 0.04MPa; * Is(50) = 0.06MPa; *	x o
33					Borehole terminated at 32.95m							
34												
35												
36												
37												
38												
39												
40
