REPORT ON CONE PENETROMETER TEST

Client **MAIN ROADS - GATEWAY UPGRADE PROJECT TEAM**
 Project **GATEWAY UPGRADE**
 Job Ref.
 Location **E 9492.12 N 172666.55 SET DATUM**
 Chainage
 Sounding **CPTU129**
 Test Date **10/06/2004**
 Remarks **Dissipation Tests @ 3.0, 7.0, 10.0 & 14.0m**

REPORT ON CPT_u DISSIPATION TEST

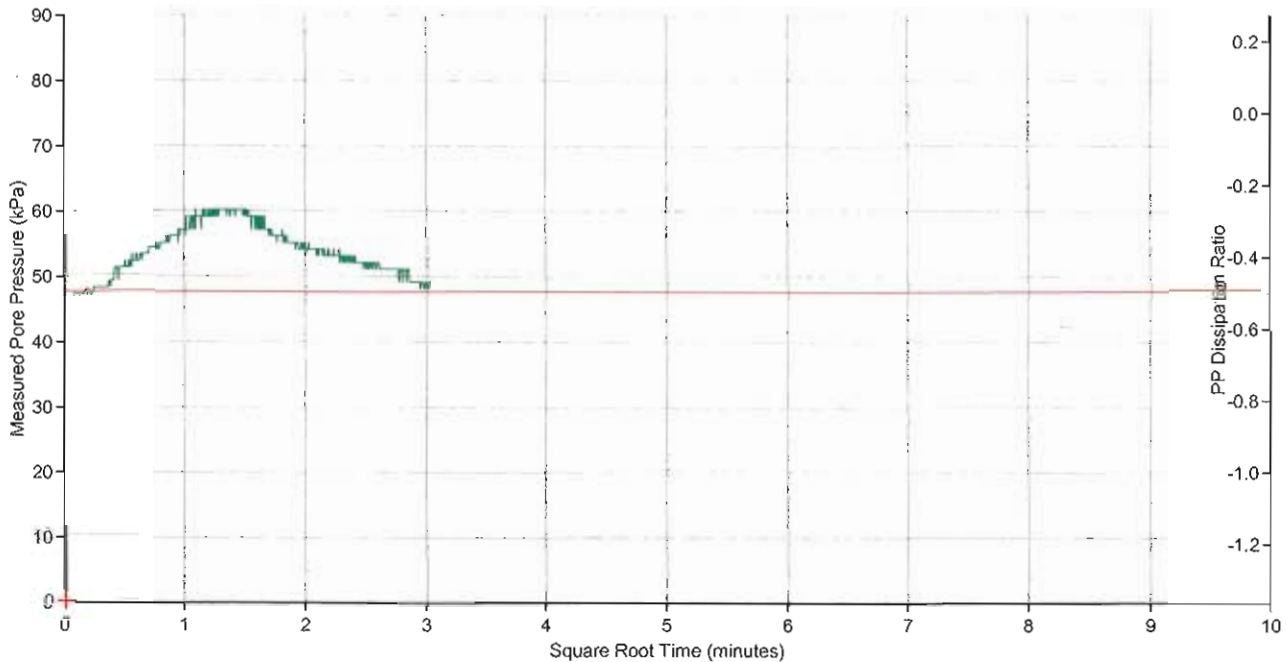
Depth (m) **3.04**
 Start Pressure (kPa) **75**
 Dissipation (%) **50**
 Dissipation Pressure (kPa) **48**
 Time for Dissipation (min) **9.0**

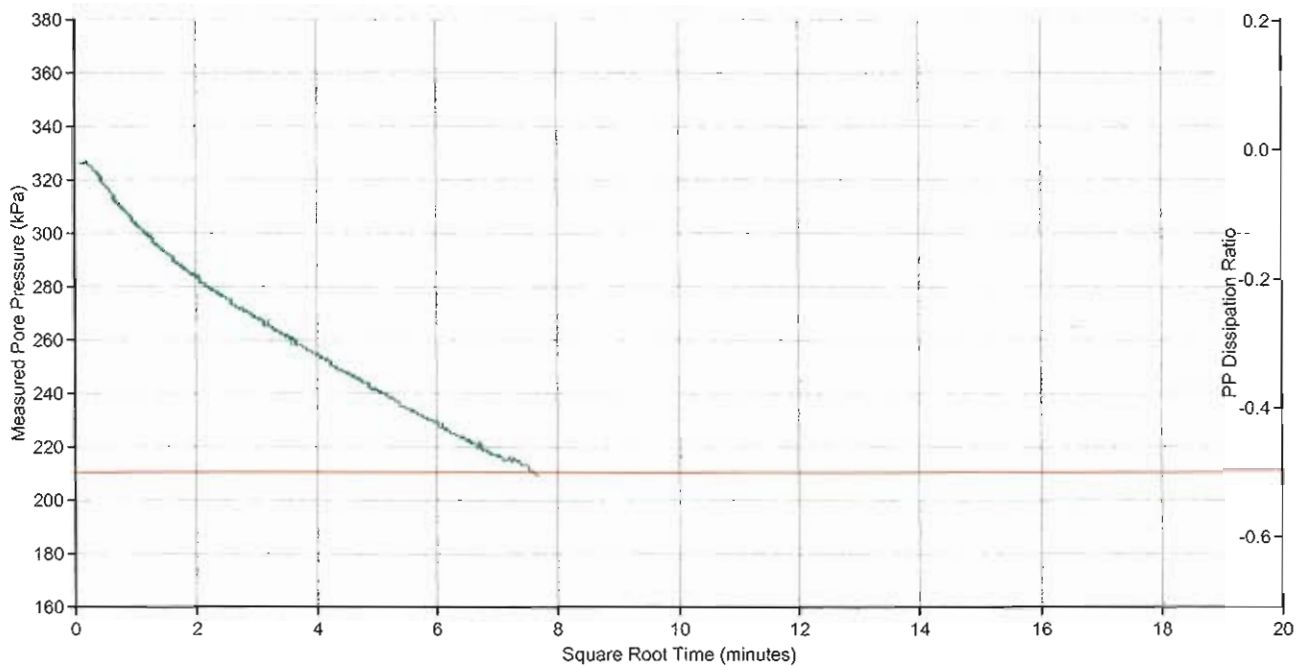
REPORT ON CPT_u DISSIPATION TEST

Depth (m) **10.15**
 Start Pressure (kPa) **331**
 Dissipation (%) **50**
 Dissipation Pressure (kPa) **210**
 Time for Dissipation (min) **56.3**
