ENGINEERING BOREHOLE

BOREHOLE No BH11

PROJECT GATEWAY UPGRADE PROJECT - GATEWAY BRIDGE DUPLICATION FOUNDATION INVESTIGATION

LOCATION PIER 6 - SOUTHERN FACE OF THE PILE CAP COORDINATES 10316.4 E; 167691.5 N

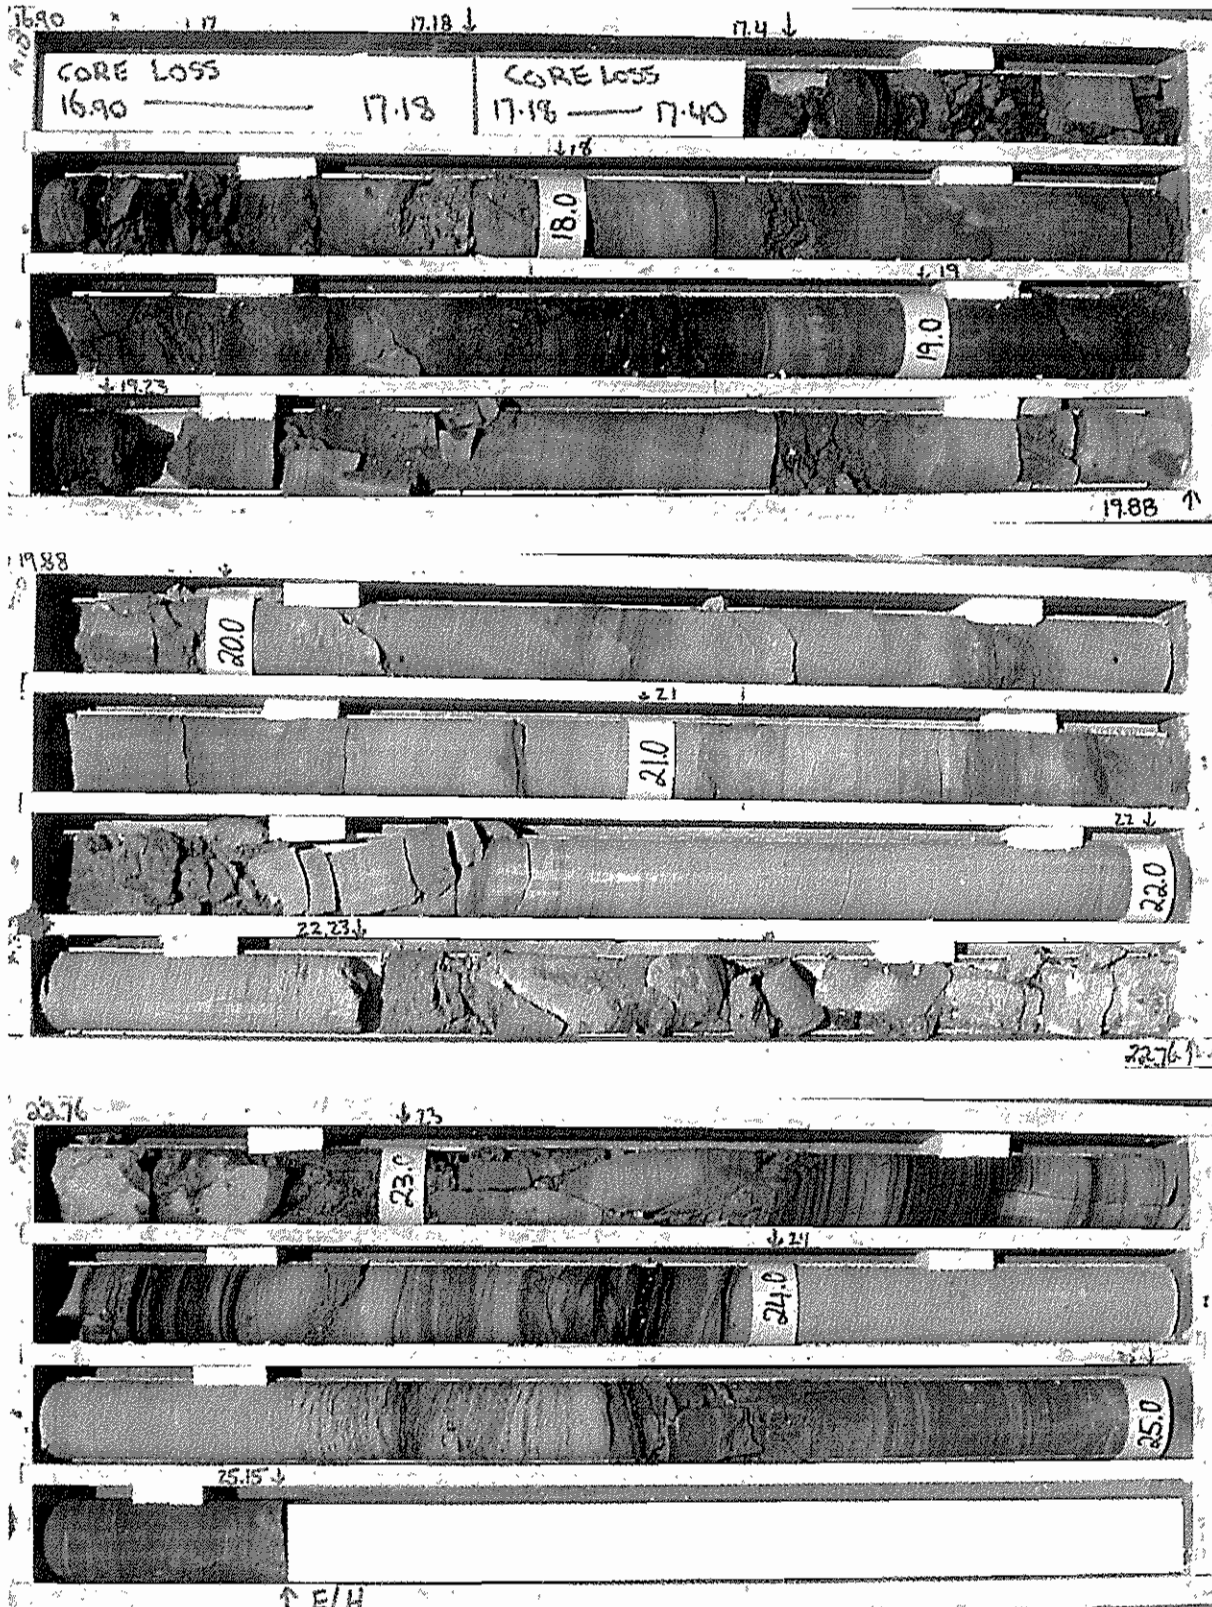
Project: **Gateway Upgrade Project - Gateway Bridge**

Borehole No: **BH 11**

Project No: FG 5388
