| BOREHOLE No | BH17 |

| | DJECT | | | | RADE PROJECT - GATEWAY BRIDGE DU | | | | A <u>TION IN/</u> | / <u>ES]</u> | TIGATION | |
| | CATION | | | | E OF PILE CAP | | | | | | OORD(NATES 10209.3 E; 167940.6 N | <u> </u> |

Borehole No: BH 17
Start Depth: 28.50m
Finish Depth: 67.90m
Project No: FG 5388

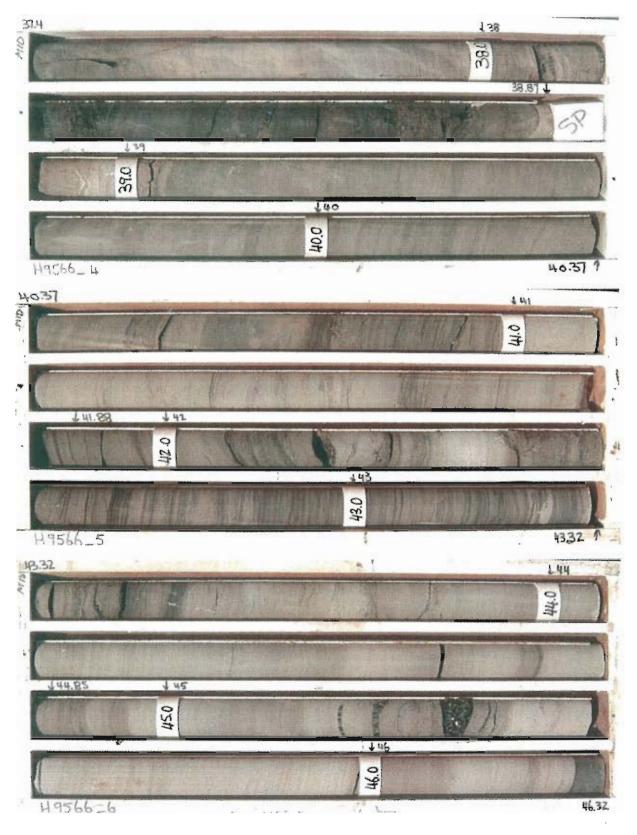
Borehole No: BH 17

Project: Gateway Upgrade Project - Gateway Bridge

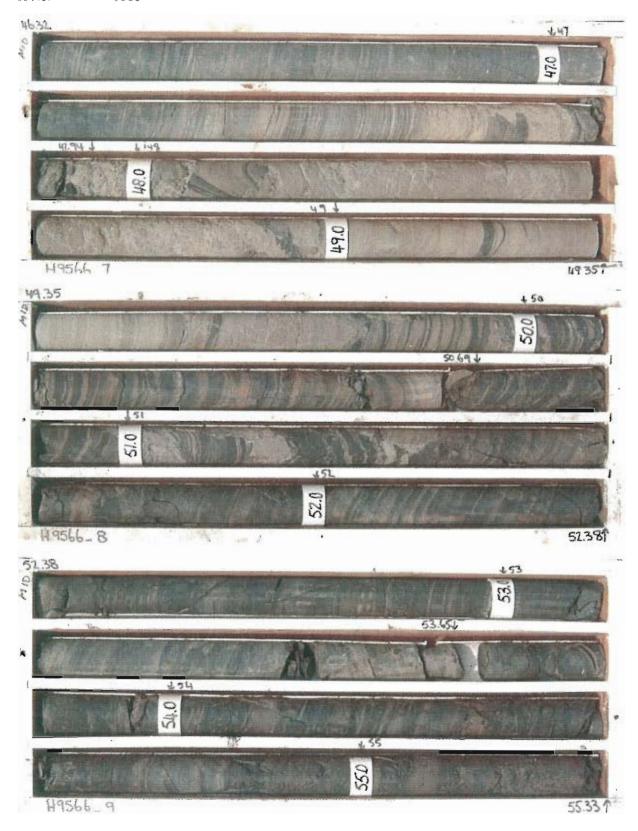
Borehole No: BH 17
Start Depth: 28.50m
Finish Depth: 67.90m

Project: Gateway Upgrade Project - Gateway Bridge

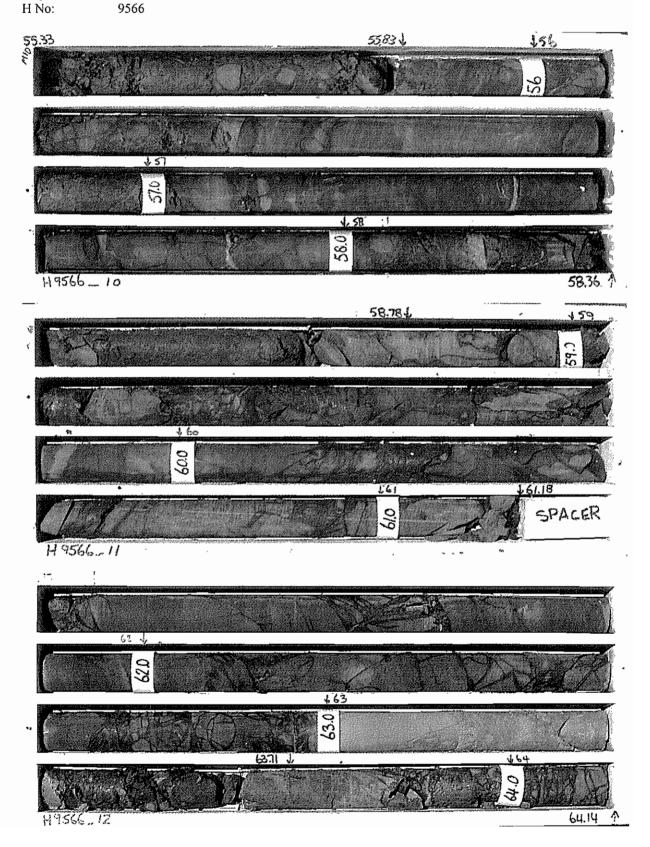
Borehole No: BH 17
Start Depth: 28.50m
Finish Depth: 67.90m
Project No: FG 5388

Project: Gateway Upgrade Project - Gateway Bridge
