## GEOTECHNICAL BOREHOLE LOG

BOREHOLE No **BH01**

PROJECT Centenary Bridge Upgrade

LOCATION 27 Vidgen Lane, Kenmore, M5 Centenary Motorway, Jindalee to Kenmore

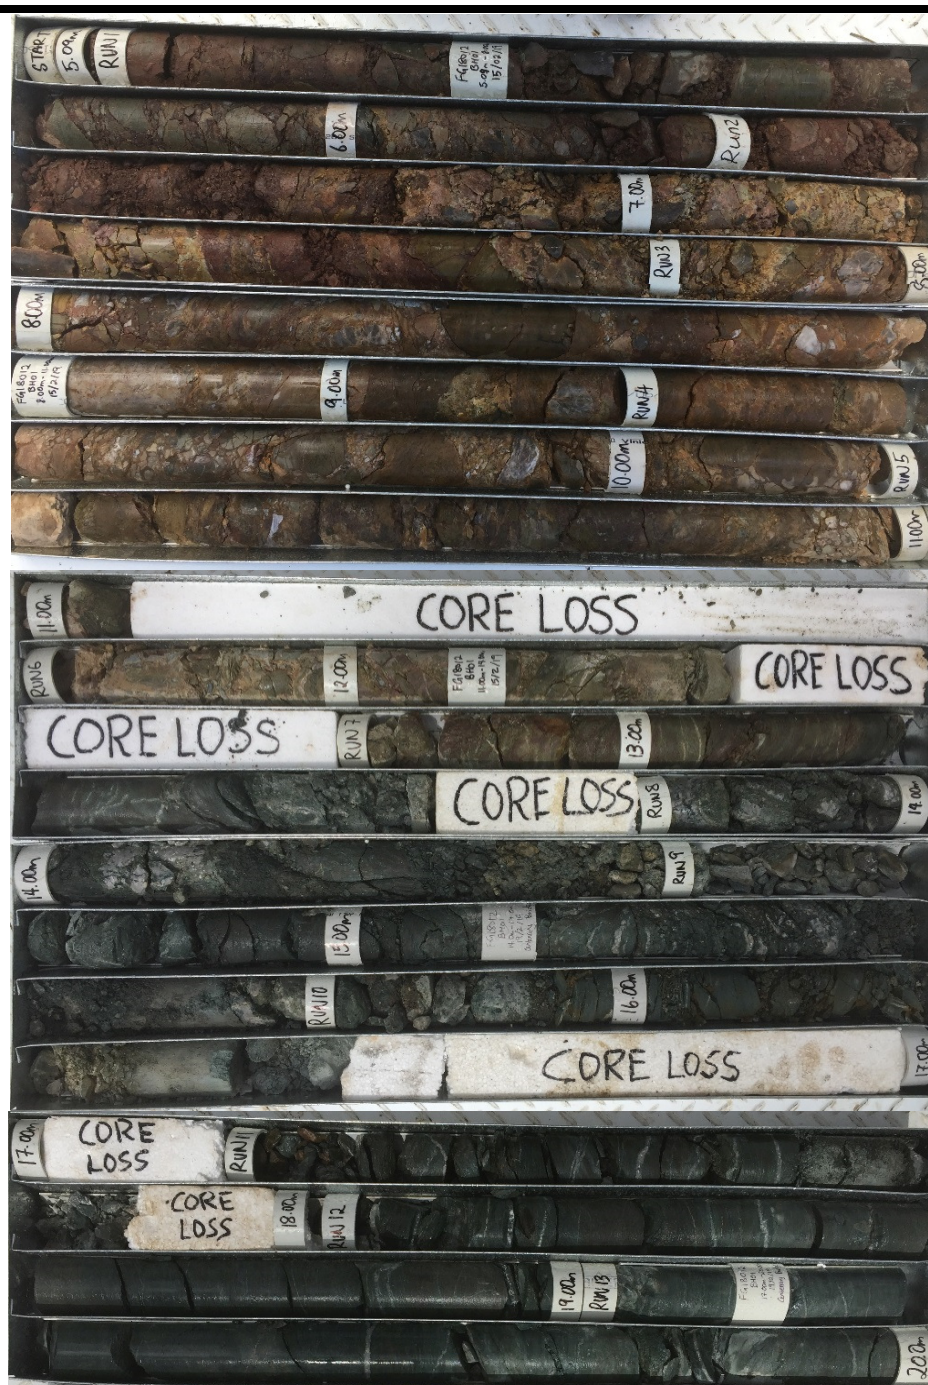
| Location | 27 Vidgen Lane, Kenmore | Start Depth (m) | 5.09 |
| Submitted By | M. Hayes | Finish Depth (m) | 30.90 |

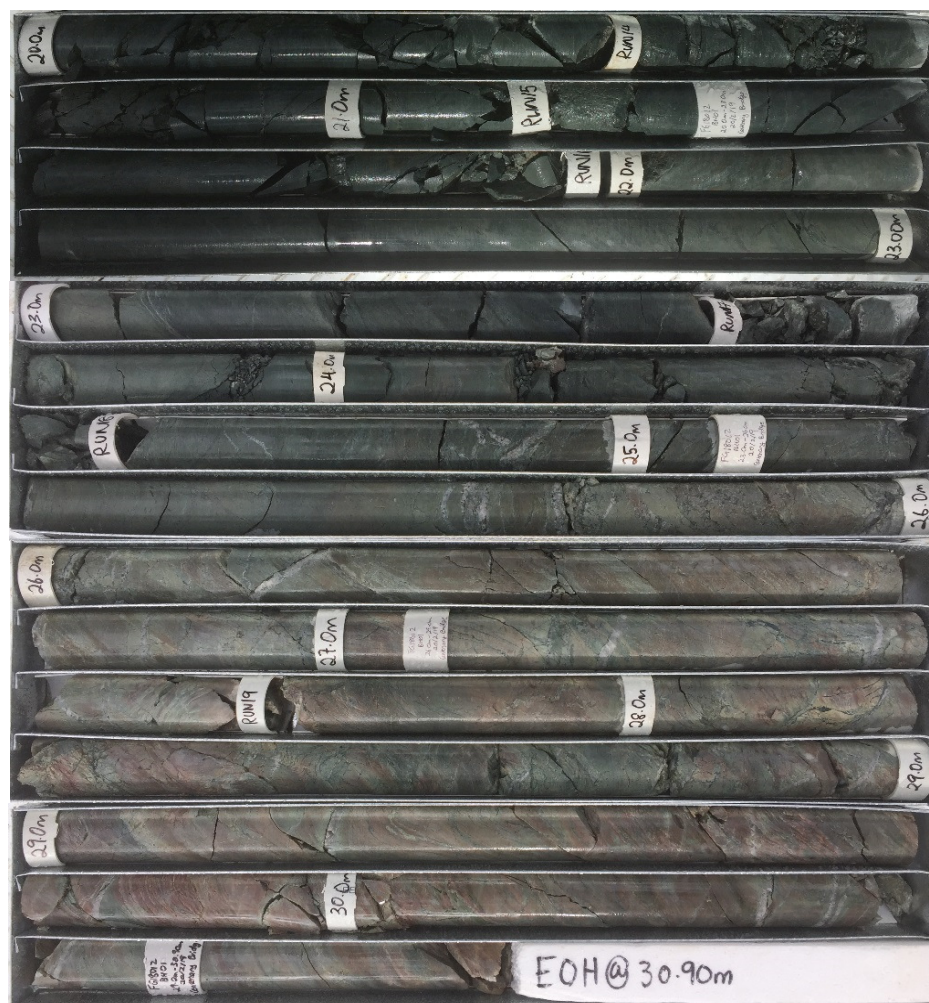
**CORE PHOTO LOG**

| Project Name | <b>Centenary Bridge Upgrade - Geotechnical Investigation</b> | | |
| Borehole No. | BH01 | Reference No. | H13321 |
| Location | 27 Vidgen Lane, Kenmore | Start Depth (m) | 5.09 |
| Submitted By | M. Hayes | Finish Depth (m) | 30.90 |
