ENGINEERING BOREHOLE LOG

BOREHOLE No BH042
SHEET 1 of 2
REFERENCE No H10587

PROJECT BRUCE HIGHWAY (COOROY - CURRA) SECTION A GEOTECHNICAL INVESTIGATION
LOCATION Cut 14 COORDINATES 484413.5 E; 7081296.2 N
PROJECT No FG5825 SURFACE R.L. 147.20m PLUNGE DATE STARTED 29/7/09 GRID DATUM MGA94
JOB No 128/10A/901 HEIGHT DATUM AHD BEARING DATE COMPLETED 29/7/09 DRILLER R & D Drilling

Project: **Bruce Highway Upgrade (Cooroy – Curra) Section A**
Borehole No: **BH42 Cut 14**
Start Depth: 5.00m
Finish Depth: 18.65m
Project No: FG5825
H No: 10587

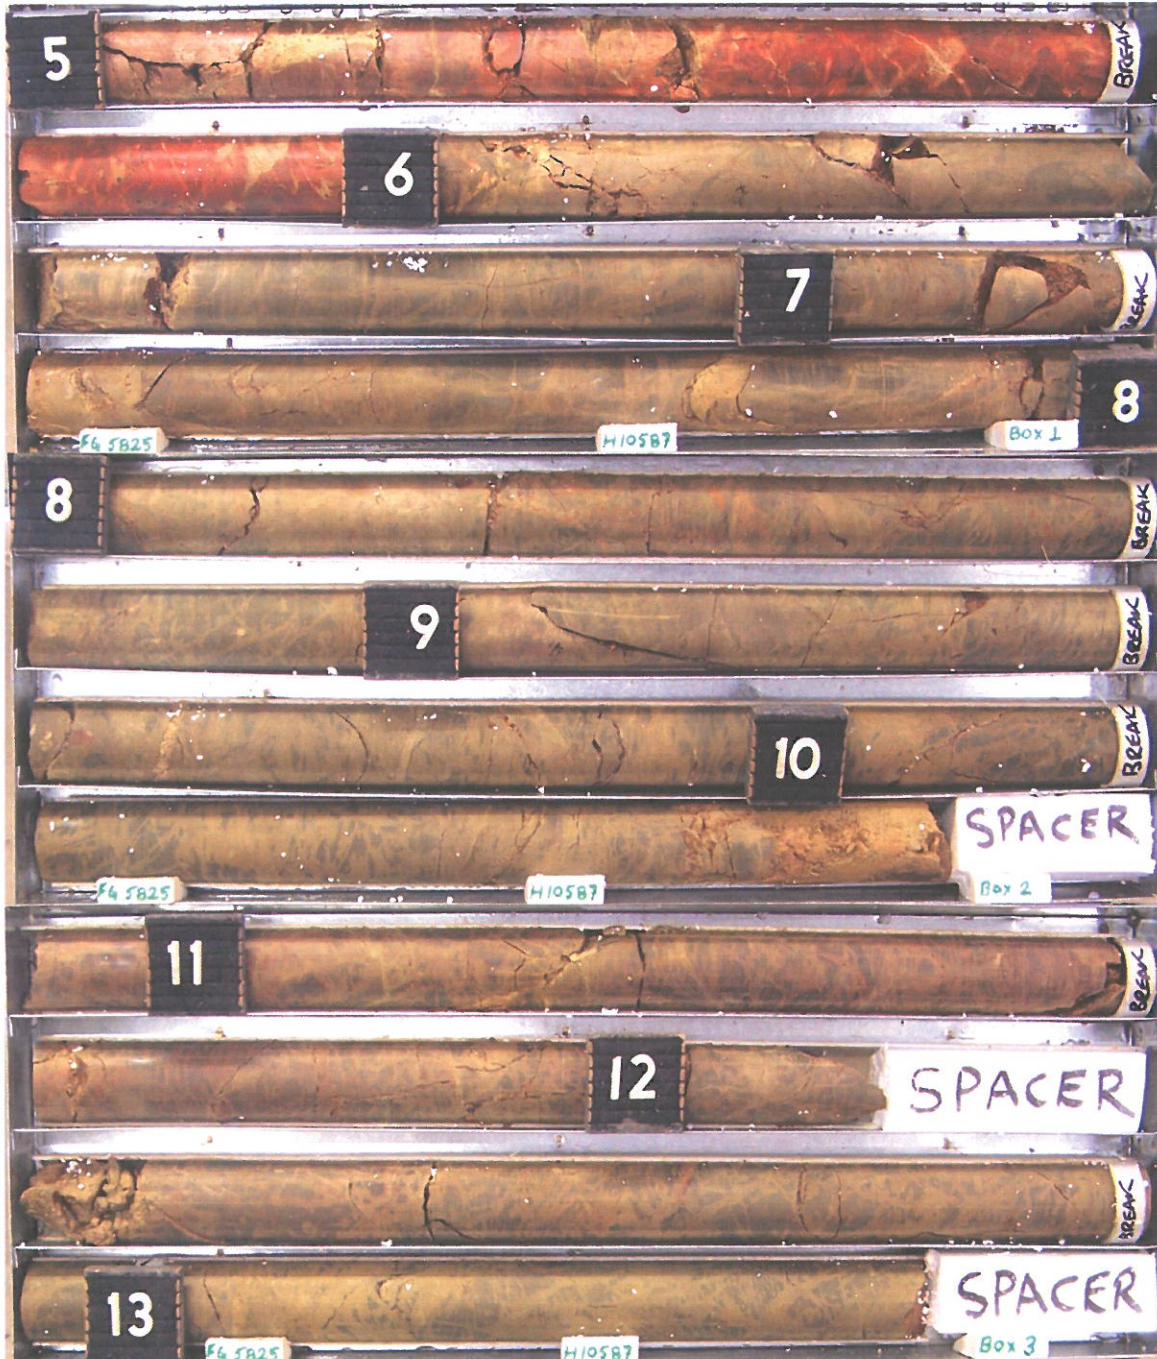
F:GEO043/1

SCALE 1:5

REMARKS Detailed defect descriptions are shown on Form GEOT533/8 attached.

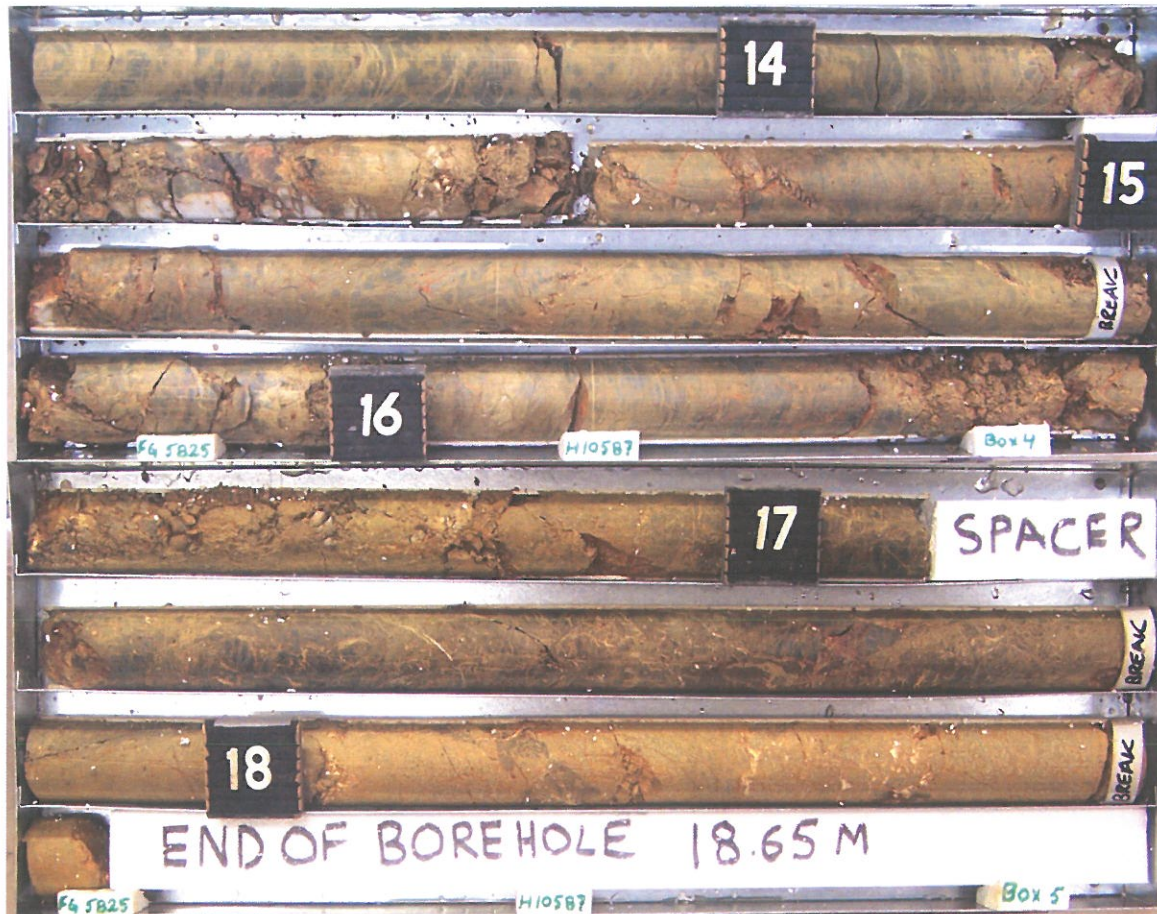
F:GEOT043/1

Project: **Bruce Highway Upgrade (Cooroy – Curra) Section A**
Borehole No: **BH42 Cut 14**
Start Depth: 5.00m
Finish Depth: 18.65m
Project No: FG5825
H No: 10587

SCALE 1:5

REMARKS Detailed defect descriptions are shown on Form GEOT533/8 attached.
