# ENGINEERING BOREHOLE LOG

BOREHOLE No BH C51  
SHEET 1 of 3  
REFERENCE No H11052

PROJECT Bruce Highway Upgrade (Cooroy to Curra) Section C  
LOCATION Cut 13 COORDINATES 470891.3 E; 7096433.6 N  
PROJECT No FG5799 SURFACE R.L. 81.10m PLUNGE \_\_\_\_\_ DATE STARTED 27/06/11 GRID DATUM MGA94  
JOB No 232/10A/2 HEIGHT DATUM AHD BEARING \_\_\_\_\_ DATE COMPLETED 27/06/11 DRILLER Drillsure Pty Ltd

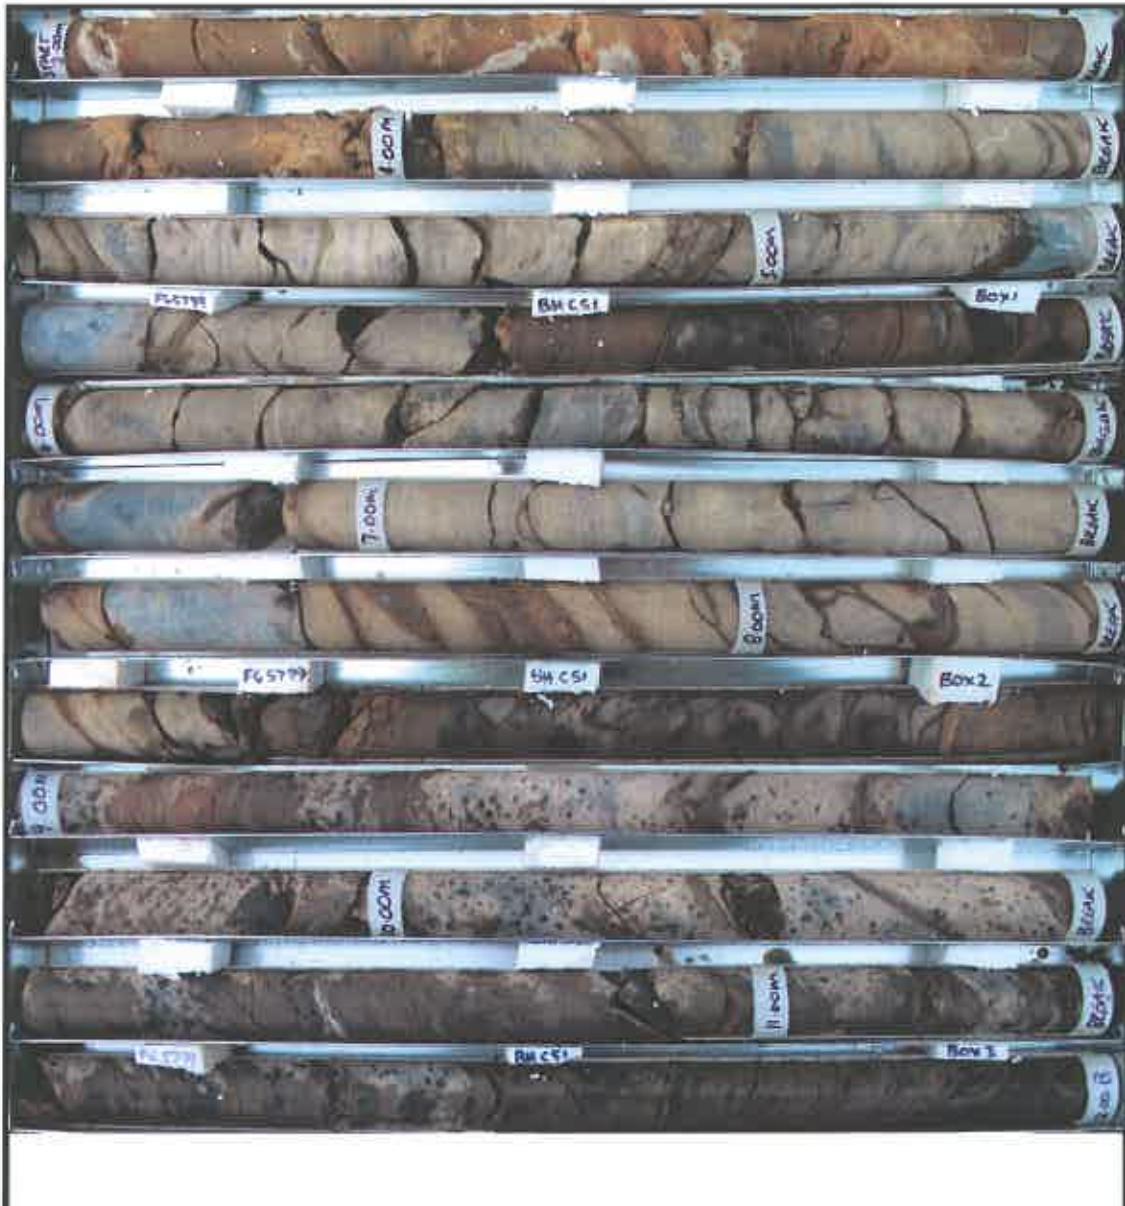
**CORE PHOTO LOG - BH C51**

| Details: | Cut 13 | Start Depth (m): | 3.00 |
| Reference No.: | H11052 | Finish Depth (m): | 20.70 |

SCALE 1:5

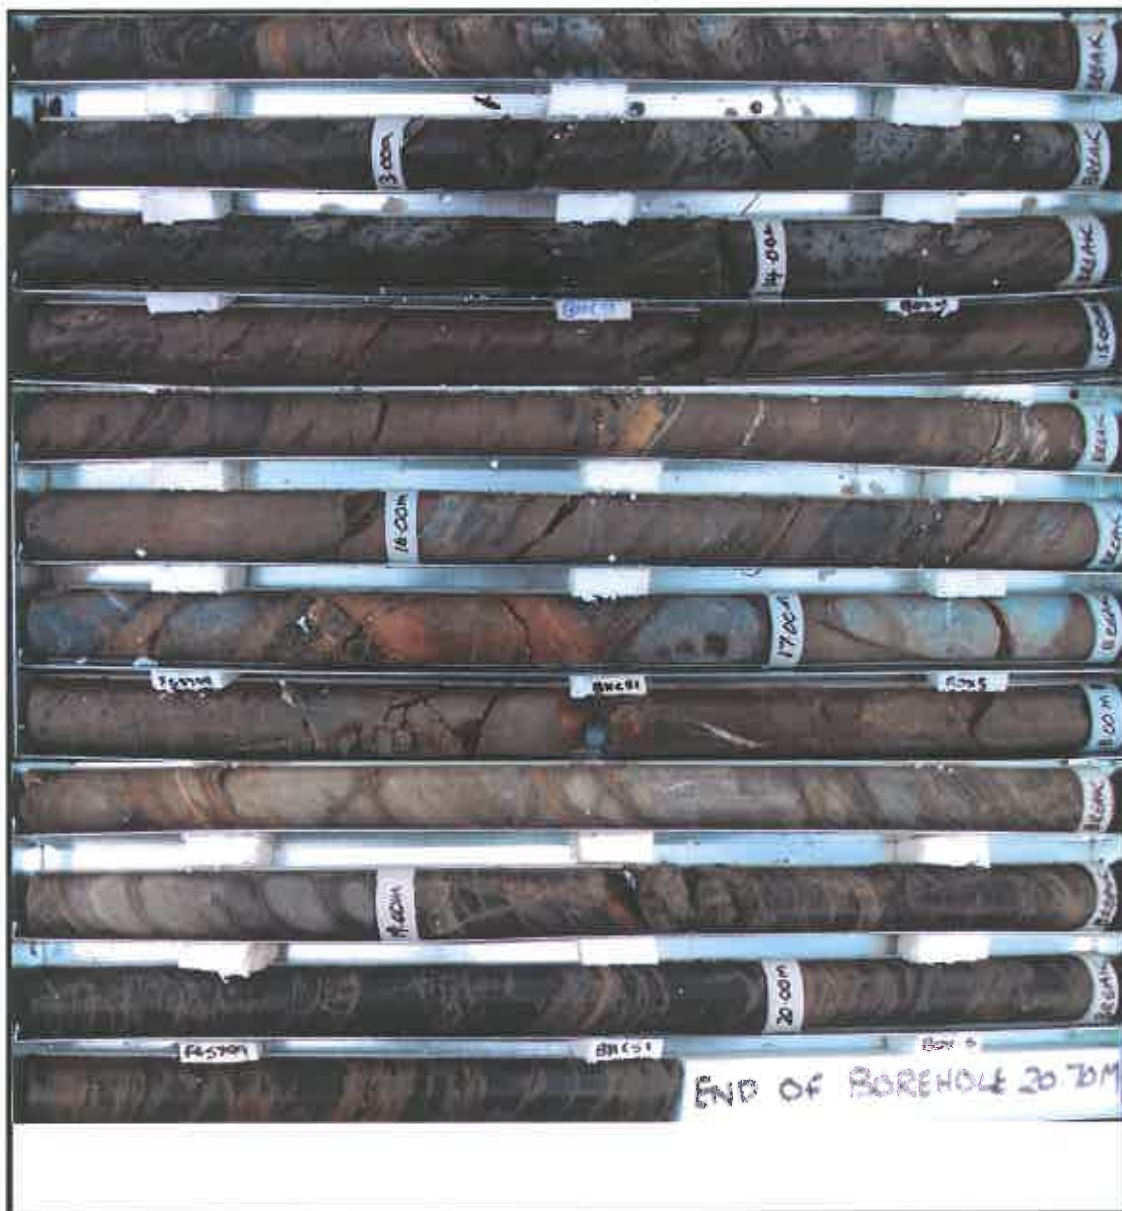
| Details: | Cut 13 | Start Depth (m): | 3.00 |
| Reference No.: | H11052 | Finish Depth (m): | 20.70 |

SCALE 1:5
