## REPORT ON CONE PENETROMETER TEST

Client **MAIN ROADS - GATEWAY UPGRADE PROJECT TEAM**  
 Project **GATEWAY UPGRADE PROJECT**  
 Job Ref.  
 Location **E 9286.90 N 169946.70 SET DATUM**  
 Chainage  
 Sounding **CPTU106**  
 Test Date **7/06/2004**  
 Remarks **Dissipation Tests @ 6.5m**

Project No. **FM2055**  
 Surface RL **2.720**  
 Water Table **1.300**  
 Start Depth **0.000**  
 Refusal **16.350**

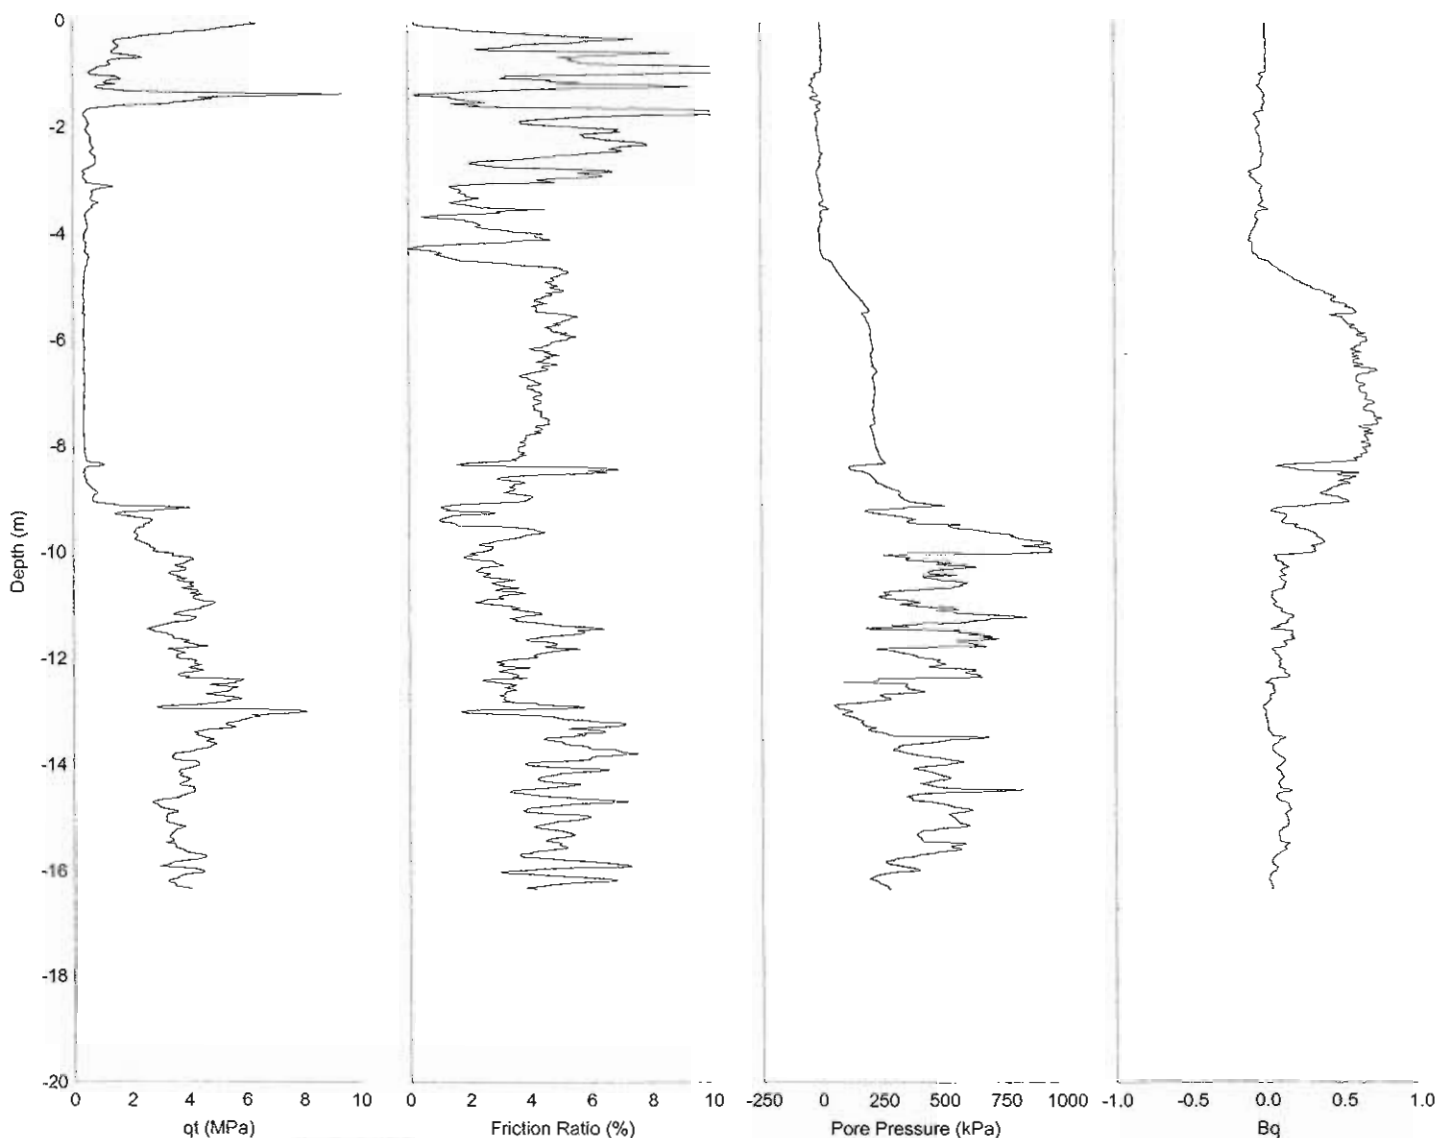
Date	<b>6/07/2004</b>	Cone Type	<b>Piezocone</b>
