ENGINEERING BOREHOLE

BOREHOLE No **BH14**

PROJECT **GATEWAY UPGRADE PROJECT - GATEWAY BRIDGE DUPLICATION FOUNDATION INVESTIGATION**

LOCATION **PIER 6 - NORTHERN FACE OF THE PILE CAP**

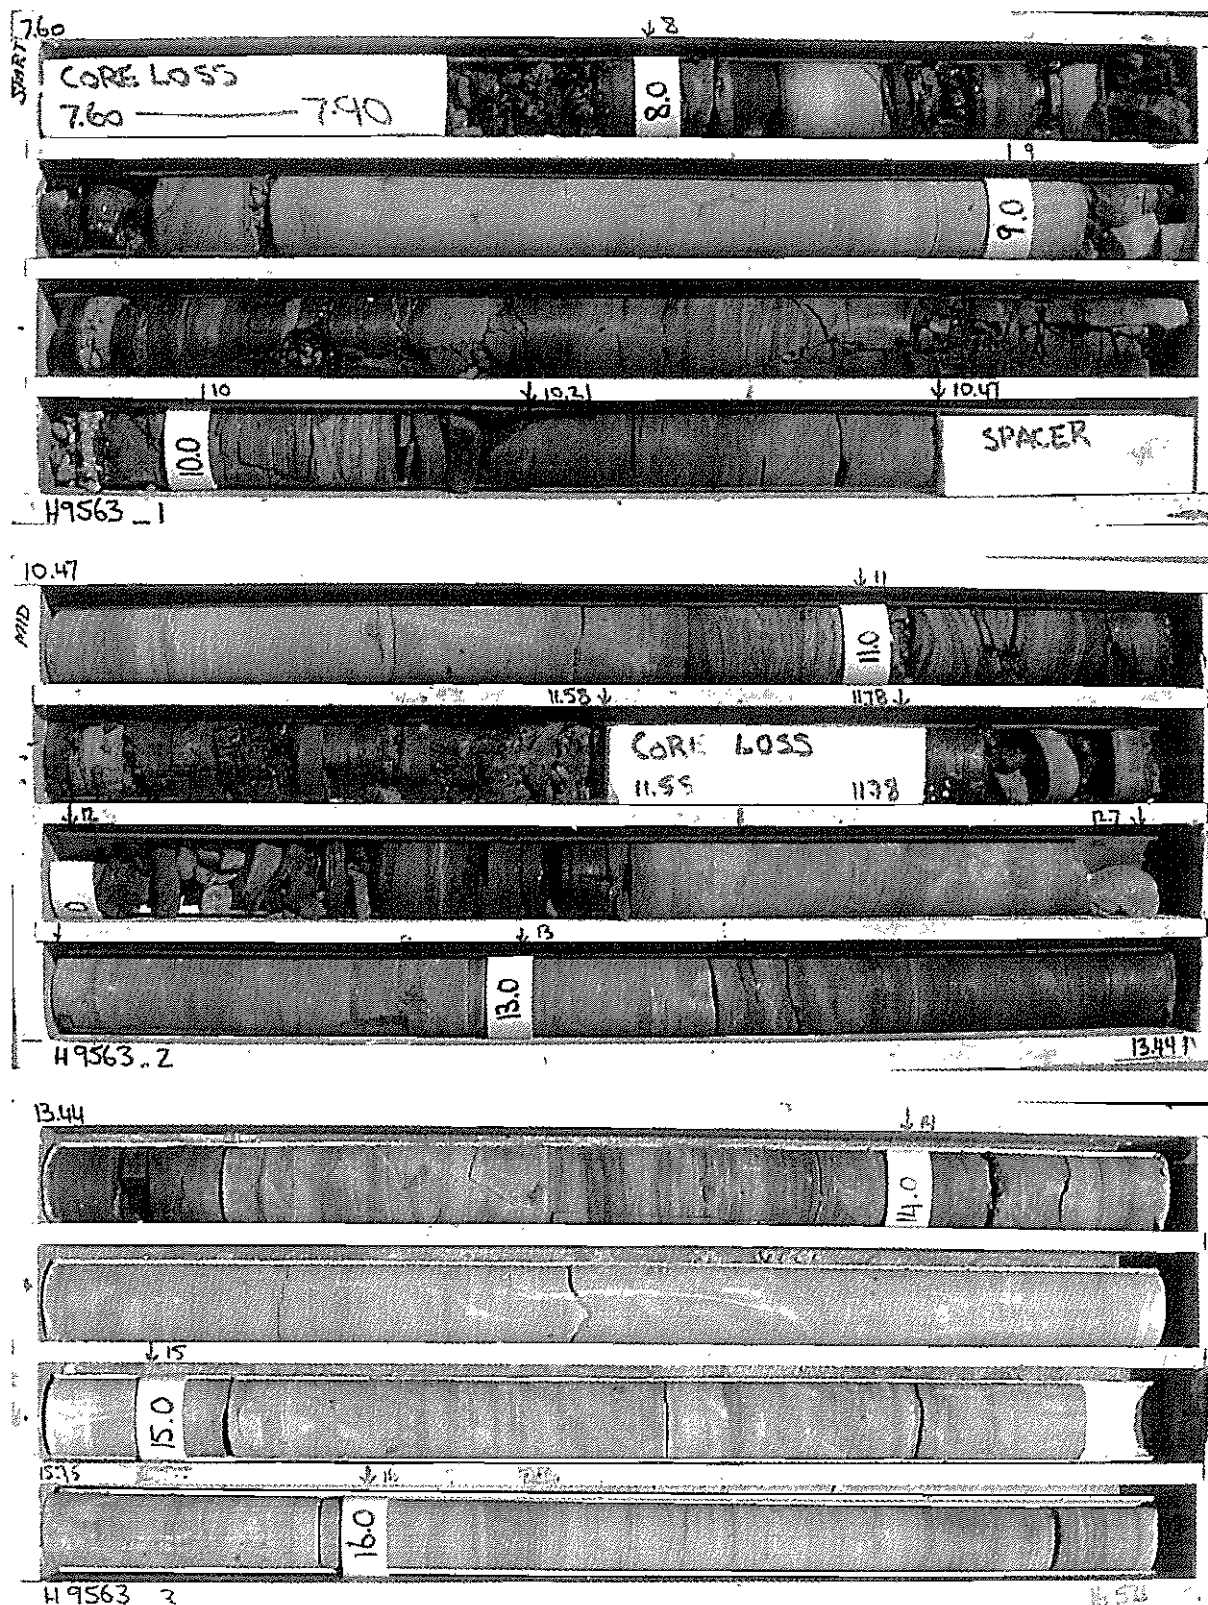
Project: **Gateway Upgrade Project - Gateway Bridge**

Borehole No: **BH 14**

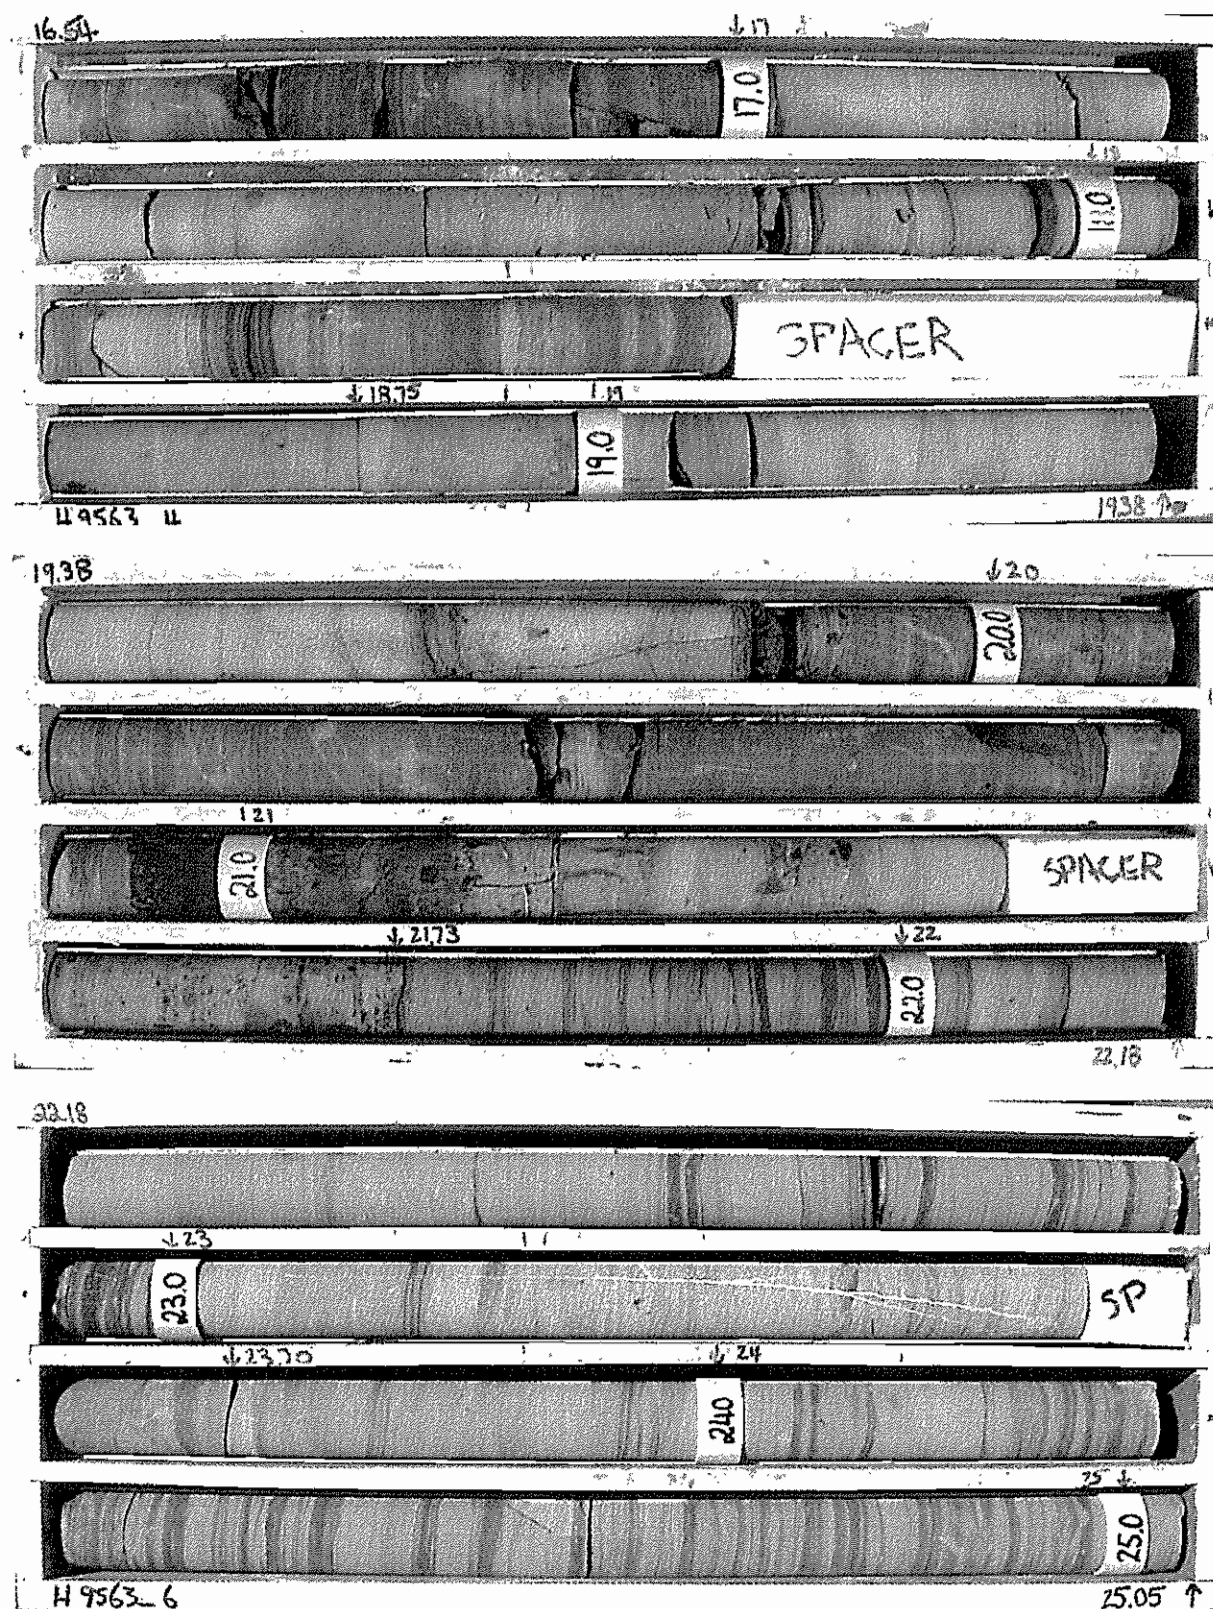
Project: **Gateway Upgrade Project - Gateway Bridge**
Borehole No: **BH 14**
Start Depth: 7.60m
Finish Depth: 32.40m
Project No: FG 5388
H No: 9563
