# ENGINEERING BOREHOLE LOG

BOREHOLE No BH17  
SHEET 1 of 2  
REFERENCE No H11027

PROJECT Moreton Bay Rail Link  
LOCATION Bridge 10, Ch.6890 COORDINATES 503284.0 E; 6987237.4 N  
PROJECT No FG5921 SURFACE R.L. 13.20m PLUNGE \_\_\_\_\_ DATE STARTED 25/5/11 GRID DATUM MGA94 Zone 56  
JOB No 250/120/3 HEIGHT DATUM AHD BEARING \_\_\_\_\_ DATE COMPLETED 25/5/11 DRILLER R&D Drilling Pty Ltd

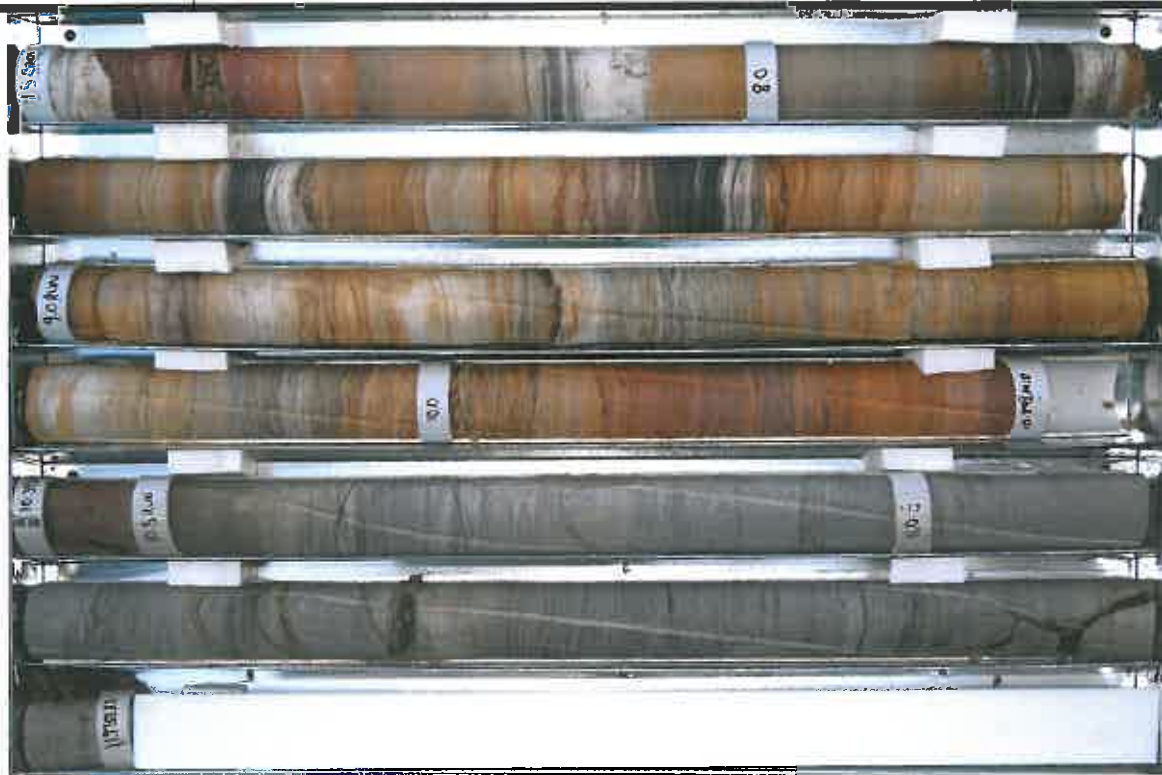
<b>Project Name</b>	<b>Moreton Bay Rail Link (MBRL)</b>		
<b>Project No</b>	FG5921	<b>Date</b>	25/05/11
<b>Borehole No</b>	BH 17	<b>TMR H No</b>	11027
<b>Location</b>	Kinsellas Rd East Bridge	<b>Start Depth (m)</b>	7.50
<b>Detail</b>	Structure	<b>Finish Depth (m)</b>	11.97
<b>Chainage</b>	6900	<b>Submitted By</b>	BW
<b>Remarks</b>

SCALE 1:5
