ENGINEERING BOREHOLE LOG

BOREHOLE NO.:	BH29	
SHEET:	1 of 2	
REFERENCE NO .	H10598

PROJECT: Bruce Highway (Cooroy – Curra) Section A Geotechnical Investigation

LOCATION: Cut 11

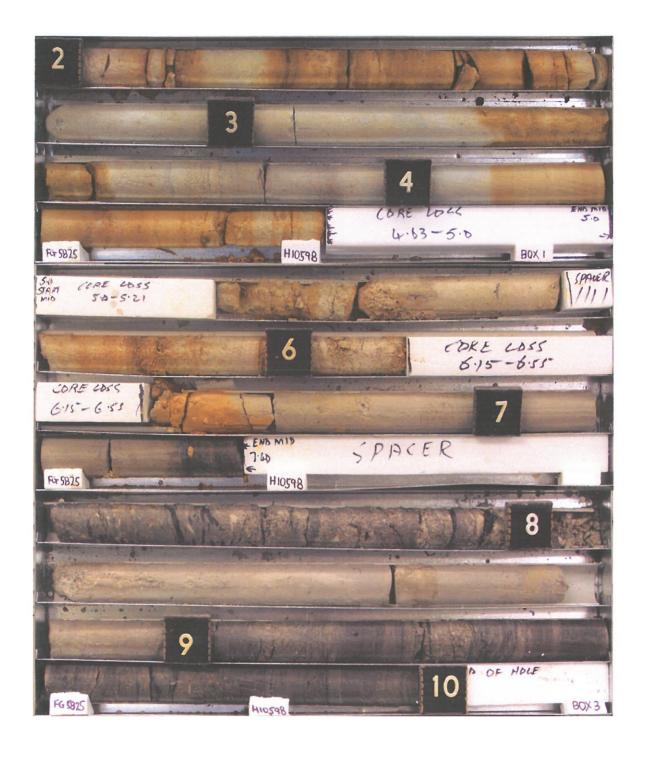
Borehole No: BH29
Start Depth: 2.00m
Finish Depth: 10.00m
Project No: FG5825

Project No: FG5825 H No: 10598

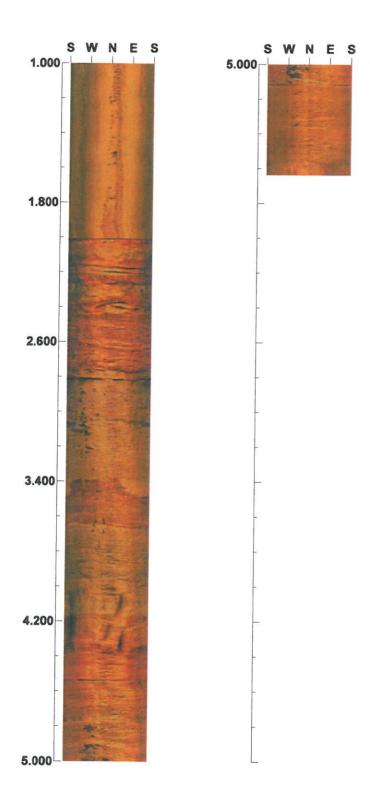
Inclination: -90

Depth range: 1.000 - 5.635 m

Scale: 1/20 Aspect ratio: 200 %

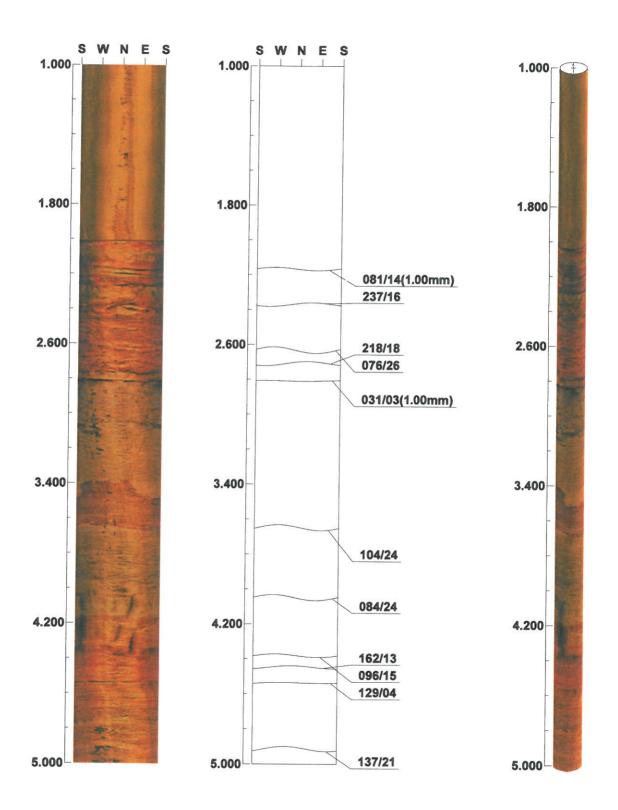
Project name: BRUCE HIGHWAY UPGRADE
Bore hole No.: BH29

Azimuth: 0

Inclination: -90

Depth range: 1.000 - 5.000 m

Scale: 1/20 Aspect ratio: 200 %

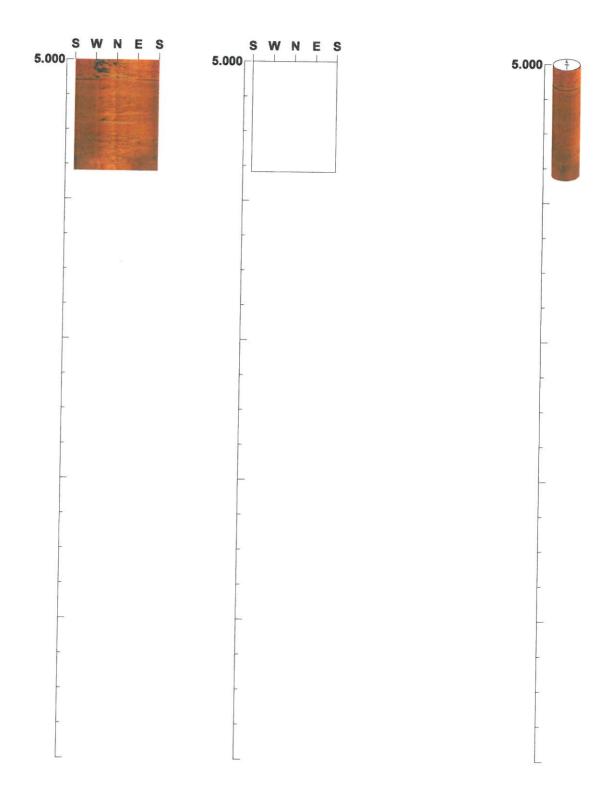
Project name: BRUCE HIGHWAY UPGRADE
Bore hole No.: BH29 Azimuth: 0

Inclination: -90

Depth range: 5.000 - 5.635 m

Scale: 1/20 Aspect ratio: 200 %

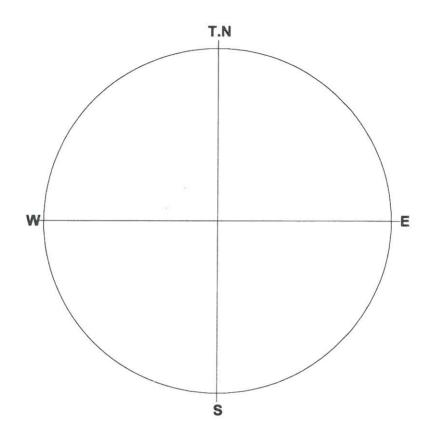
BH29.STR <<BEDDING/FOLIATION>>

Number of Data: 2/11

:Bed/foliat -- 2 :Boundary -- 0
:Joint -- 0
:Parting -- 0

Schmidt (L.H)

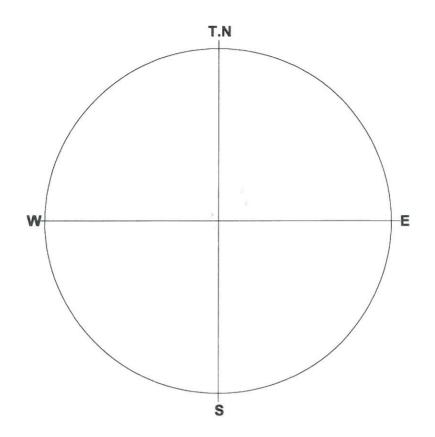
BH29.STR <<JOINT>>

Number of Data: 4/11

:Joint -- 4

Schmidt (L.H)

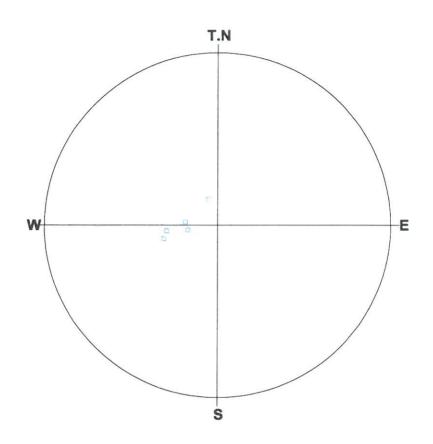
BH29.STR <<PARTING>>

Number of Data: 5/11

:Joint -- 0
:Parting -- 5

Schmidt (L.H)

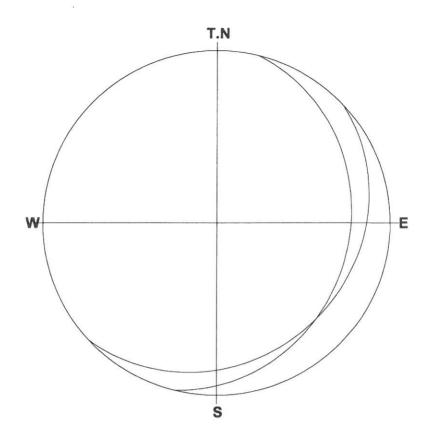
BH29.STR <<BEDDING/FOLIATION>>

Number of Data:2/11

1:104/24(6)

2:137/21(11)

Schmidt (L.H)

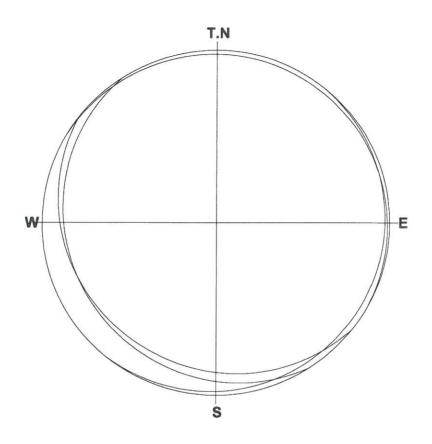
BH29.STR <<JOINT>>

Number of Data:4/11

1:237/16(2)

2:218/18(4)

3:031/03(5)

4:129/04(10)

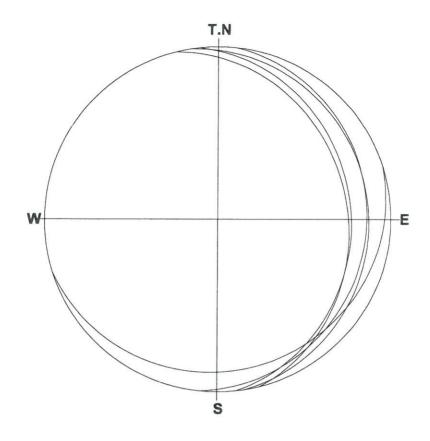
BH29.STR <<PARTING>>

Number of Data:5/11

1:081/14(1)

2:076/26(3)

3:084/24(7)

4:096/15(8)

5:162/13(9)

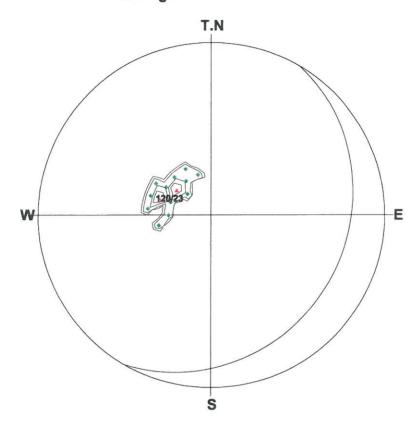
BH29.STR <<BEDDING/FOLIATION>>

***** % Diagram *****

Number of Data: 2

<legend> Sym. (%)</legend>	Contour Value (%)
A : 100	Contour 1: 0
V : 80 - 100	Contour 2: 20
V: 80 - 100	Contour 3: 40
: 60 - 80	Contour 4: 60
• : 40 - 60	Contour 5: 80
. 40 - 60	Contour 6: 100
: 20 - 40

Depth: 2.167 - 4.914 m

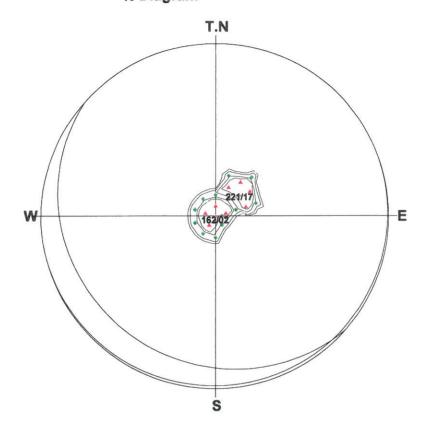
BH29.STR <<JOINT>>

***** % Diagram ******

Number of Data: 4

<legend> Sym. (%)</legend>	Contour Value (%)
A : 50	Contour 1: 0
. 40 50	Contour 2: 10
V : 40 - 50	Contour 3 : 20
: 30 - 40	Contour 4: 30
A : 20 20	Contour 5 : 40
* : 20 - 30	Contour 6: 50
: 10 - 20	
: 0 - 10

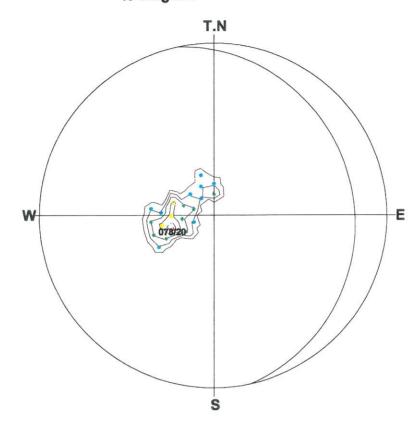
BH29.STR <<PARTING>>

***** % Diagram *****

Number of Data: 5

<legend> Sym. (%)</legend>	Contour Value (%)
<u> </u>	Contour 1: 0
W- C4 90	Contour 2: 16
V : 64 - 80	Contour 3: 32
: 48 - 64	Contour 4: 48
A 20 40	Contour 5: 64
• : 32 - 48	Contour 6: 80
: 16 - 32	
: 0 - 16

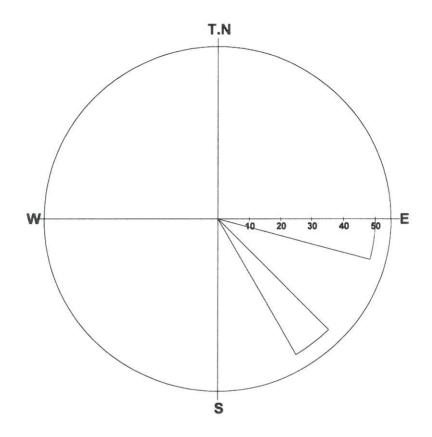
BH29.STR <<BEDDING/FOLIATION>>

Number of Data: 2/11

Max: 50.0% Grouping Angle: 15 deg

Dir	%	Dir	%	Dir	%
0-	0	135-	50	270-	0
15-	0	150-	0	285-	0
30-	0	165-	0	300-	0
45-	0	180-	0	315-	0
60-	0	195-	0	330-	0
75-	0	210-	0	345-	0
90-	50	225-	0		
105-	0	240-	0		
120-	0	255-	0

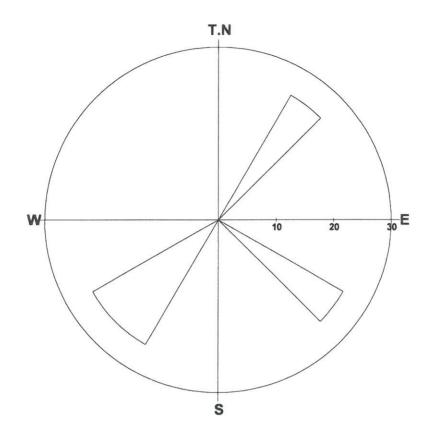
BH29.STR <<JOINT>>

Number of Data: 4/11

Max: 25.0% Grouping Angle: 15 deg

Dir	%	Dir	%	Dir	%
0-	0	135-	0	270-	0
15-	0	150-	0	285-	0
30-	25	165-	0	300-	0
45-	0	180-	0	315-	0
60-	0	195-	0	330-	0
75-	0	210-	25	345-	0
90-	0	225-	25		
105-	0	240-	0		
120-	25	255-	0

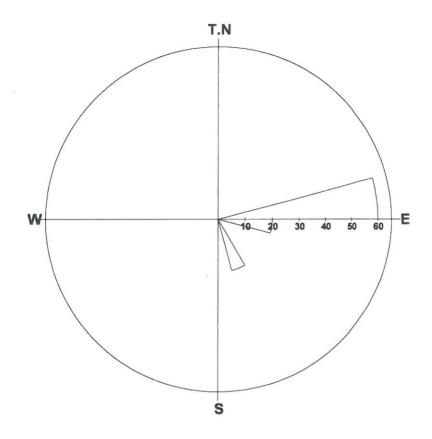
BH29.STR <<PARTING>>

Number of Data: 5/11

Max: 60.0%

Dir	%	Dir	%	Dir	%
0-	0	135-	0	270-	0
15-	0	150-	20	285-	0
30-	0	165-	0	300-	0
45-	0	180-	0	315-	0
60-	0	195-	0	330-	0
75-	60	210-	0	345-	0
90-	20	225-	0		
105-	0	240-	0		
120-	0	255-	0

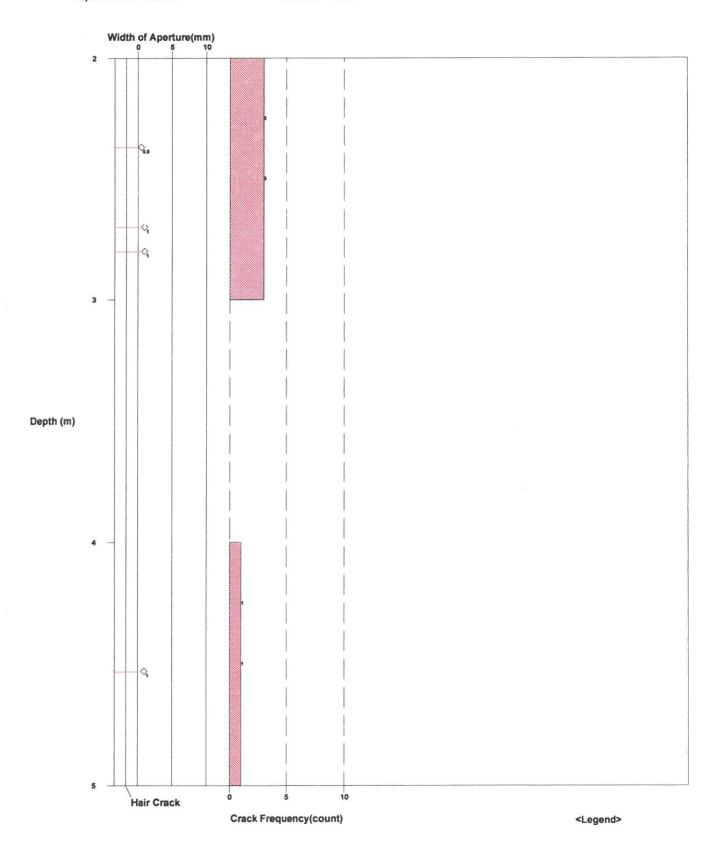
Fig. Rock Mass Condition Graph

Title: BH29.STR Comment: JOINT Depth: 2.167 - 4.914 m Aperture: 0.0 - 1.0 mm Sort: 1/7 Form: 8/8 Condition: 11/11 Remark: 11/11 2009/ 9/ 2

Elevation: 0.000m Water Level: 5.120m

All Crack Frequency
Open Crack Frequency

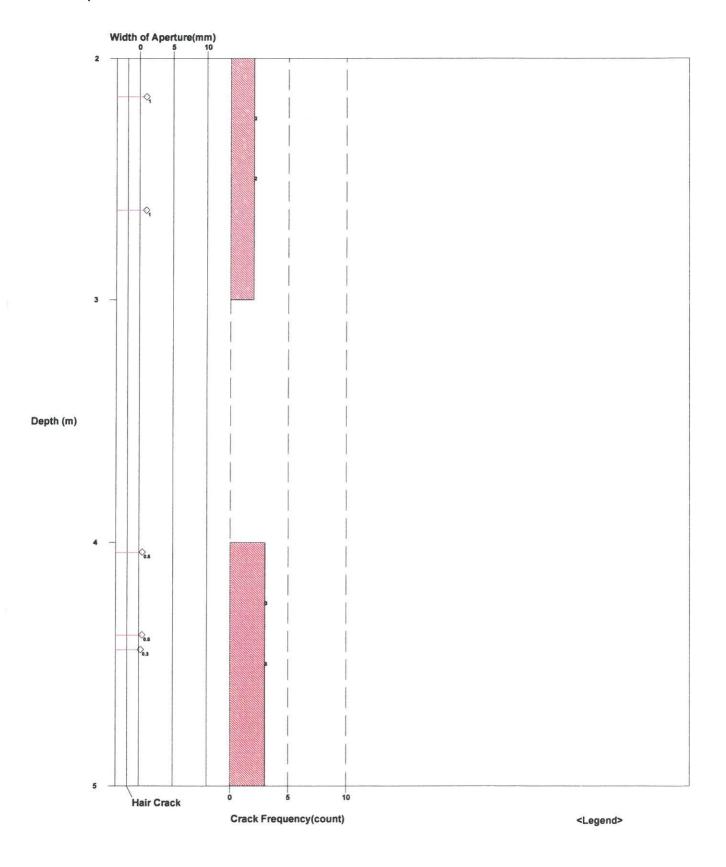
Fig. Rock Mass Condition Graph

Title: BH29.STR Comment: PARTING Depth: 2.167 - 4.914 m Aperture: 0.0 - 1.0 mm Sort: 1/7 Form: 8/8 Condition: 11/11 Remark: 11/11 2009/ 9/ 2

Elevation: 0.000m Water Level: 5.120m

All Crack Frequency
Open Crack Frequency
Water Level

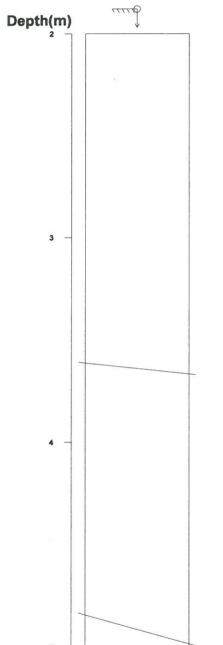
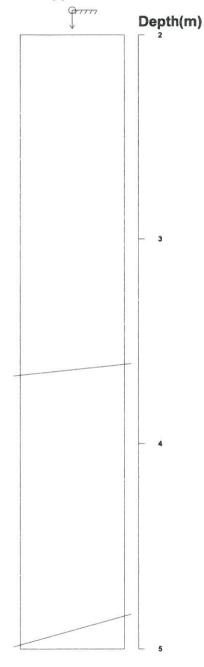
Fig. Apparent Dip

Title: BH29.STR

Comment: BEDDING/FOLIATION

Depth: 2.167 - 4.914 m Aperture: 0.0 - 1.0 mm Sort: 1/7
Form: 8/8

View Point 2 Profile of Apparent Borehole

View Point 1
Profile of Apparent Borehole

Direction: 0 deg

Inclination: Vertical(Down)

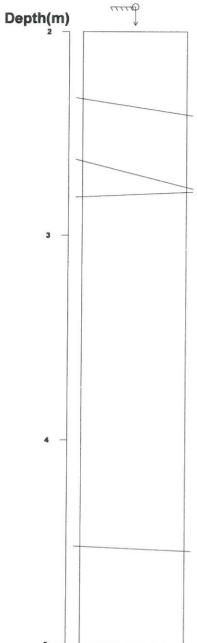
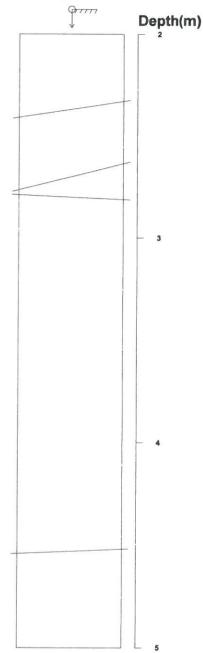
Fig. Apparent Dip

Title: BH29.STR Comment: JOINT Depth: 2.167 - 4.914 m Aperture: 0.0 - 1.0 mm

View Point 2 Profile of Apparent Borehole

View Point 1 Profile of Apparent Borehole

Direction: 0 deg

Inclination: Vertical(Down)

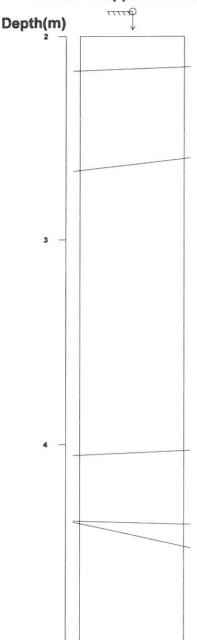
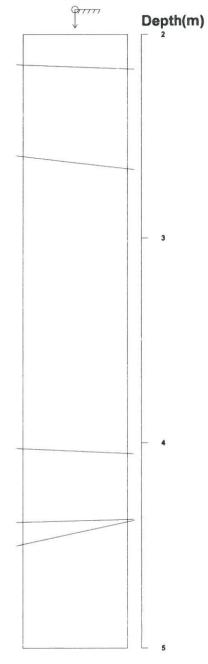
Title: BH29.STR Comment: PARTING Depth: 2.167 - 4.914 m Aperture: 0.0 - 1.0 mm

View Point 2
Profile of Apparent Borehole

View Point 1
Profile of Apparent Borehole

Direction: 0 deg

Inclination: Vertical(Down)
