## ENGINEERING BOREHOLE LOG

BOREHOLE No BH036

PROJECT BRUCE HIGHWAY (COOROY - CURRA) SECTION A GEOTECHNICAL INVESTIGATION

Project: **Bruce Highway Upgrade (Cooroy – Curra) Section A**  
 Borehole No: **BH36**  
 Start Depth: 6.65m  
 Finish Depth: 13.50m  
 Project No: FG5825  
 H No: 10592

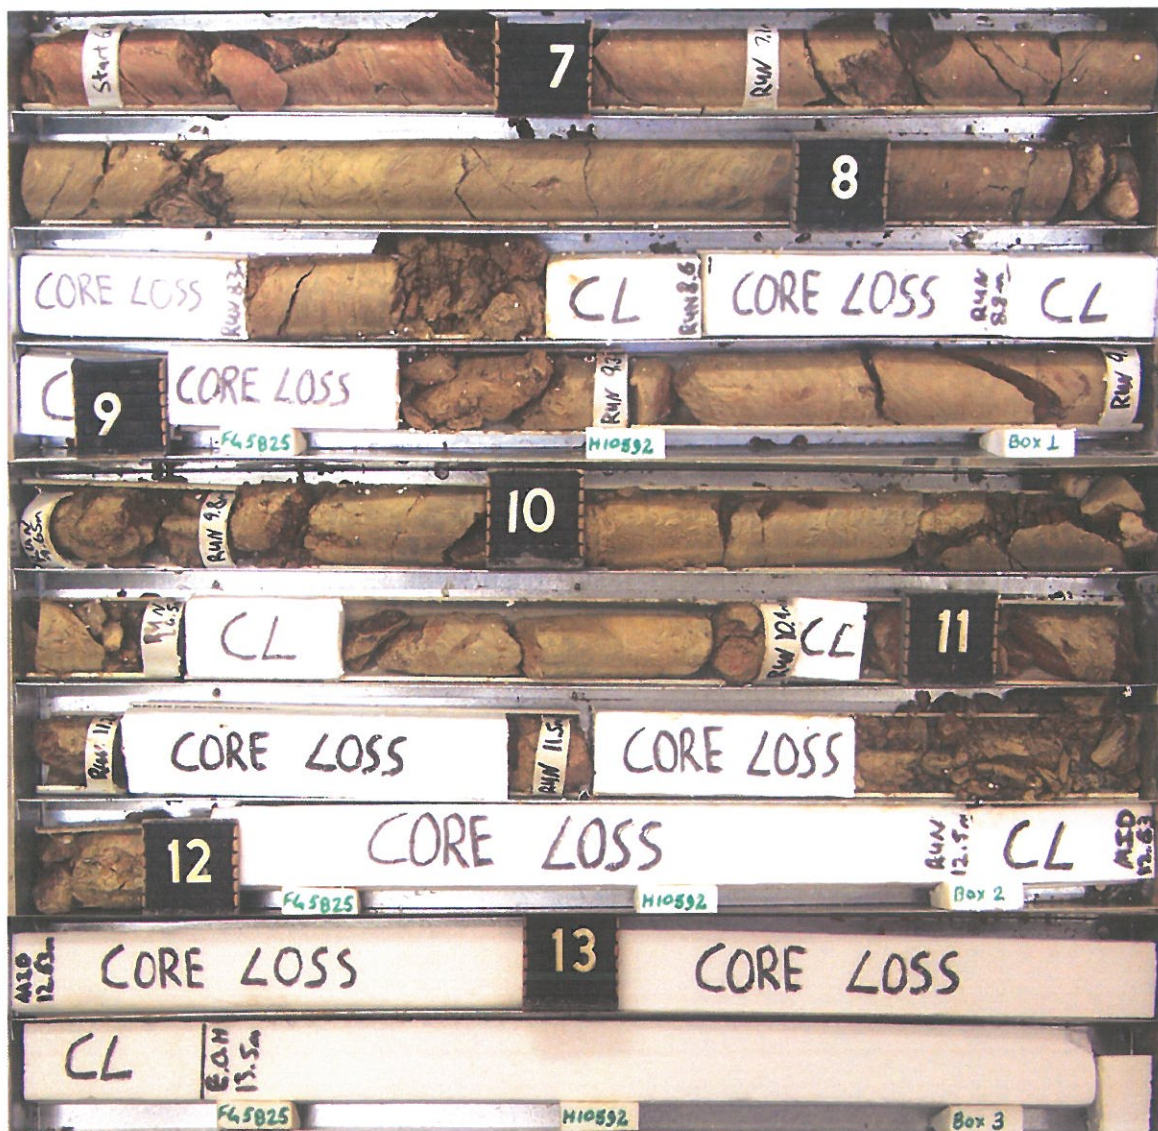
SCALE 1:5

REMARKS Detailed defect descriptions are shown on Form GEOT533/8 attached. Major core loss and damaged core in initial hole below 8.3m. Hole was shifted 0.5m and redrilled from 8.3m.
