Gateway Upgrade North (GUN)

ENGINEERING BOREHOLE LOG

BOREHOLE No	<u>BH10</u>
SHEET	<u>1</u> of <u>2</u>
REFERENCE No	<u>H10333</u>

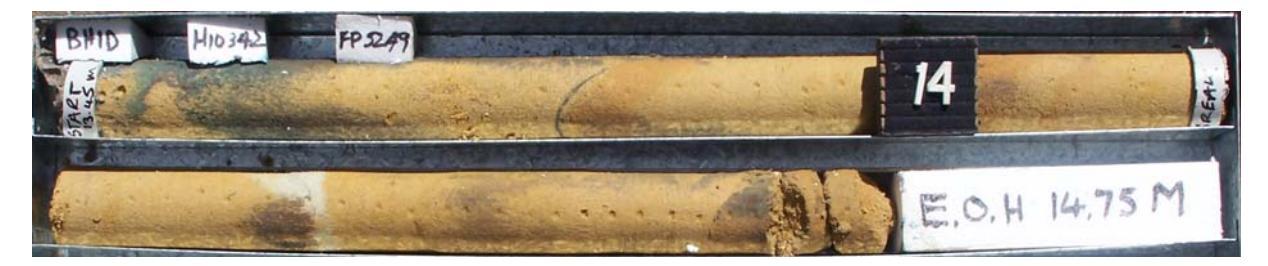
Borehole No: BH 10

(90)		MW: Pale orange, fine to medium grained, poorly cemented, mainly extremely low to low strength.	MW				Is(50) = 0.06MPa Is(50) = 0.03MPa	x -
-	-12.05			100		Defects: - Healed planar joints at 50° (1/m) - Drilling induced breaks (3/m)			-			-
						Borehole terminated at 14.75m						
<u>20</u>	REMARK	s <u>O</u> e	don	neter co	nsoli	l dation test - Q183/ AS1289.6.6.1 : Specimen number pro	videc	l, refer to test	report for r	esults	LOGGED BY

Start Depth:
 13.45m

Finish Depth:
 14.75m
