ENGINEERING BORELOG

BOREHOLE No : 394
 SHEET : 1 OF 1
 REFERENCE No : H8003

PROJECT : PACIFIC MOTORWAY - FOXWELL ROAD OVERPASS FOUNDATION INVESTIGATION
 LOCATION : Grid Reference 30744 E, 122107 N
 PROJECT No : MP1006 SURFACE R.L. : 10.85 DRILLER : Schneider
 JOB No : DATUM : AHD DATE DRILLED : 11/4/97

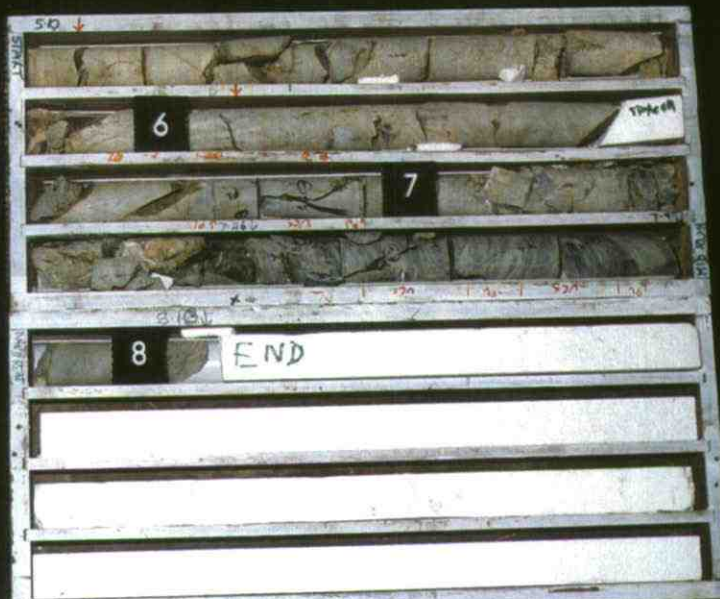
HOLE 394
START 5.10
END 8.10

PACIFIC MOTORWAY - FOXWELL ROAD O'PASS

H 8003
1 OF 1
APRIL 1997
