ENGINEERING BORELOG

BOREHOLE No :	116
SHEET :	1 OF 2
REFERENCE No :	H8185

PROJECT : SOUTH EAST TRANSIT PROJECT-SECTION 1
 LOCATION : 2247.245E 164159.364N
 PROJECT No : C60128 SURFACE R.L. : 5.40 DRILLER : DALY BROTHERS PTY LTD
 JOB No : DATUM : AHD DATE DRILLED : 7/1/98

SOUTH EAST TRANSIT PROJECT
SECTION ONE

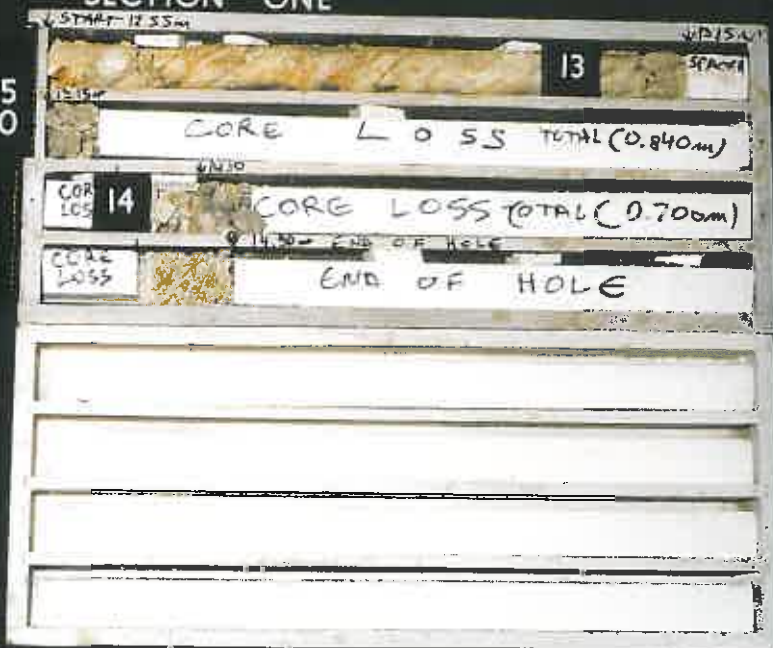
HOLE 116
START 12.55
END 14.90

H 8185
1 OF 1
JAN 1998

DEPTH (m)	R.L. (m)	AUGER CORE DRILLING CASING OTHER	RQD (%) CORE REC%	SAMPLE	MATERIAL DESCRIPTION	USC WEATHERING	INTACT STRENGTH					DEFECT SPACING (mm)				GRAPHIC LOG	ADDITIONAL DATA AND TEST RESULTS	SAMPLES TESTS
							EH	VH	H	M	LV	20	60	200	600			
10	-4.60				GRAVELLY SILTY CLAY As above..													
11						OH											3,4,5 N=9	SPT
12	-6.35				PHYLITE XW : Exhibits engineering properties of orange brown to green brown, moist, hard sandy silty clay. Medium to coarse grained sand.	XW											7,18,30/100=>50	SPT
13			(100) 100		HW : Grey brown to orange brown; frequent core stones and rock kernels in sandy silty clay matrix; Frequent medium to coarse grained quartz bands. Medium to coarse sand in matrix. Defects: Mainly foliation partings.												Quartz layer.	
14			(12%) 12			HW											Quartz layer.	
15	-9.50		(12%) 12															
15					END OF HOLE													
16
